Preliminary Information

PIP5504 Diagnosing Fishbite Chuggle Misfire Feeling Or Shudder Vibration, With A Light Tip In

Brand:	Model:	Model Years:	VIN:		Engine:	Transmissions:
			from	to		
Chevrolet	Silverado	2016 - 2017	All	All	L83	MYC
Chevrolet	Suburban	2016 - 2017	All	All	L83	MYC
Chevrolet	Tahoe	2016 - 2017	All	All	L83	MYC
GMC	Sierra Models	2016 - 2017	All	All	L83	MYC
GMC	Yukon Models	2016 - 2017	All	All	L83	MYC
Involved Region or Country	North America and N.A. Export Regions					
Additional Options (RPO)	N/A					
Condition	<p>Some customers may comment on any of the following conditions.</p> <p>A shake and/or shudder during light throttle acceleration between 48 and 104 km/h (30 and 65 mph) steady state driving when transmission is not actively shifting gears.</p> <p>A shudder feeling that may be described as driving over rumble strips or rough pavement.</p> <p>A shudder feeling that is evident in both Drive and M5 mode.</p>					
Cause	Please refer to the following information to aid in addressing these types of conditions

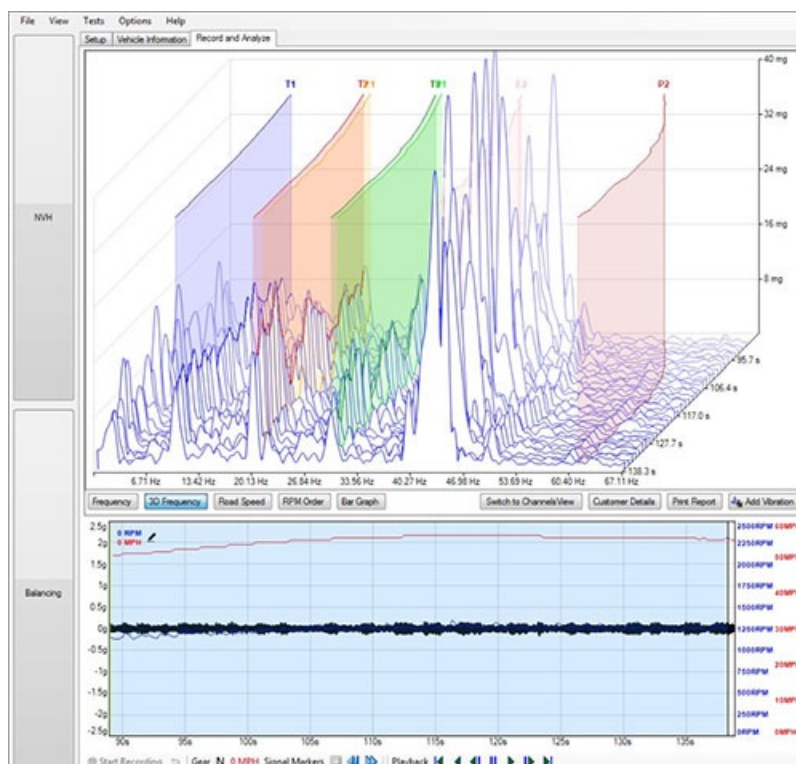
To confirm TCC Shudder, the vibration concern must be present in normal operation (Mode A), but not present with the torque converter clutch disabled (Mode B) or with the torque converter clutch locked (Mode C).

If TCC Shudder is present, a vibration peak will appear at approximately 43Hz +/-3Hz as shown in the picture above. If the vibration frequency follows engine, tire, or driveshaft speed, then it is NOT TCC Shudder. TCC Shudder vibration frequency should stay constant per gear while vehicle and engine speeds change.

C. Flush cooler lines, replace converter, drain, and refill ATF.
