Preliminary Information

PIP5493B Misfire with DTC's P0300, P0301-P0306

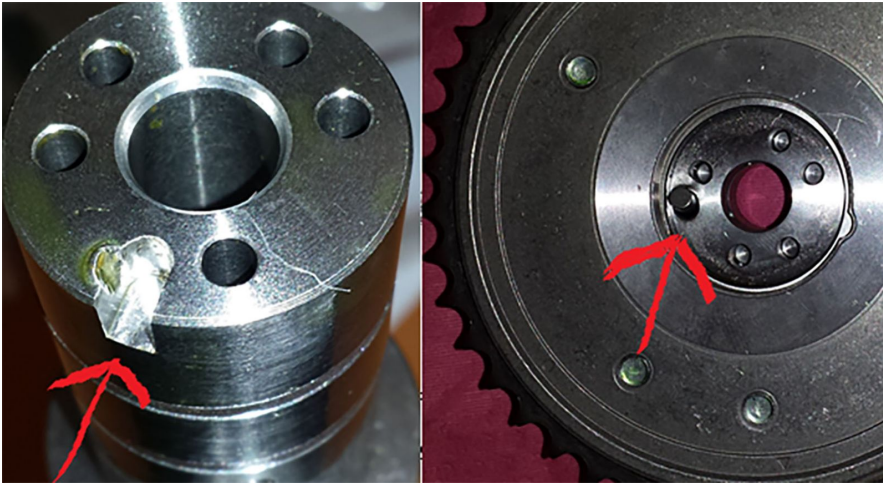
- If misfires continue, perform normal misfire diagnosis on ignition and injection systems per eSI.
- If no cause is found, remove the cam cover on the affected bank and inspect for a rocker concern.
- To ensure that the rocker is working as designed, turn the engine over by hand and make sure all rockers move to the point of opening all rockers.
- Remove the affected bank camshaft actuator and inspect the interface between the cam and actuator for a bent pin or camshaft damage.

see pics.

- Replace and or repair the rockers, lifters, actuator and camshaft as needed.
