40 Creaking/squeaking noises from front end on uneven roads

40 17 59 2043424/3 February 27, 2017. Supersedes Technical Service Bulletin Group 40 number 16-53 dated June 2, 2016 for reasons listed below.

Model(s)	Year	VIN Range	Vehicle-Specific Equipment
А3	2015 - 2017	All	Not Applicable

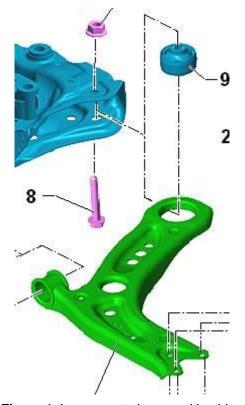
Figure 1. Lower control arm and bushing.

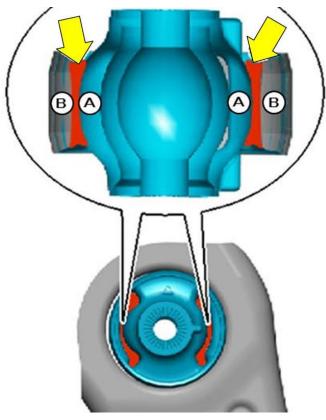
The rear bonded rubber bushings of the front lower control arms have a kidney-shaped slits (Figure 2). When the vehicle is driven on uneven roads, areas A and B (Figure 2) may come in contact, creating the creaking/squeaking noise.

Figure 2. Kidney-shaped slits (yellow arrows) of the rear bonded rubber bushings.

- 1. Remove both front lower control arms. Follow instructions in ElsaPro for *Repair Manual* >> Chassis >> Suspension, Wheels, Steering >> Front Suspension >> Lower Control Arm and Ball Joint >> Lower Control Arm, Removing and Installing.
- Evenly grease the kidney-shaped slits of the bonded rubber bushing (Figure 3, the area shown red) from above with 0.1g of lithium grease (part number G 052 150 A2). Use a paint brush to apply the grease.
