Technical Service Bulletin

70 Noises from headliner / sunroof area

70 17 56 2038029/5 February 6, 2017. Supersedes Technical Service Bulletin Group 70 number 15-48 dated October 14, 2015 for reasons listed below.

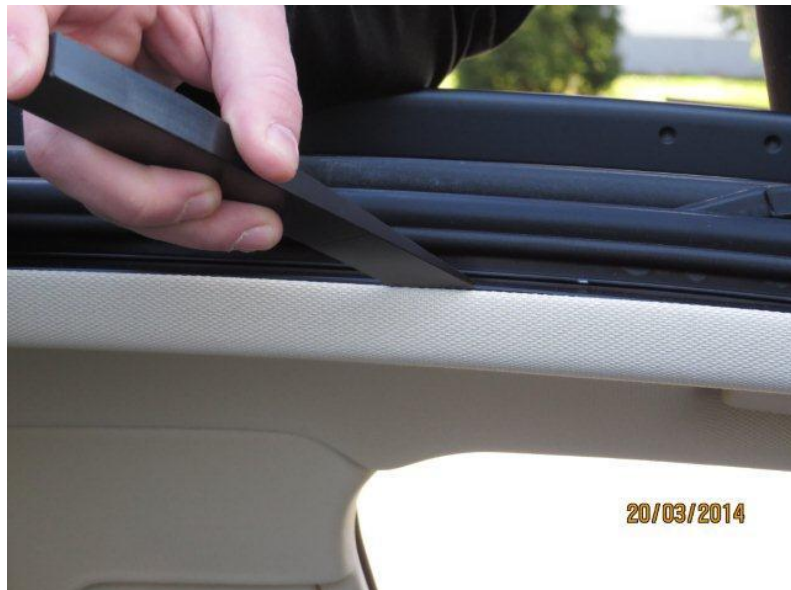
Figure 1. Unclipping the sunroof cover trim frame.

1. Remove the glass sliding roof panel(s). Remove the beam for the sunroof rollershade. Carefully unclip and remove the sunroof cover trim frame (Figure 1).

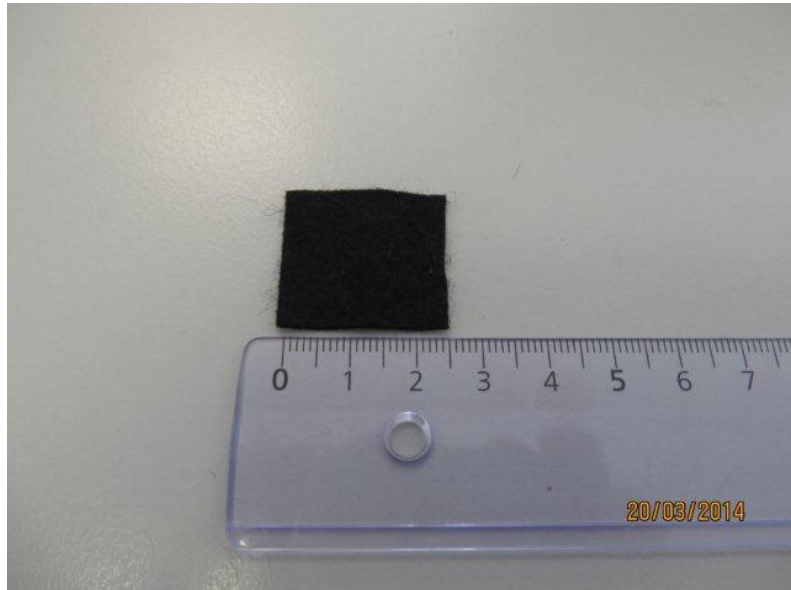
Figure 2. A 25mm section of fleece adhesive tape 533867910A.

2. The number of retaining clips will vary by model. A piece of dampening tape (fleece adhesive tape 533867910A) will be applied to each clipping point. Cut pieces of the tape 25mm long (Figure 2).

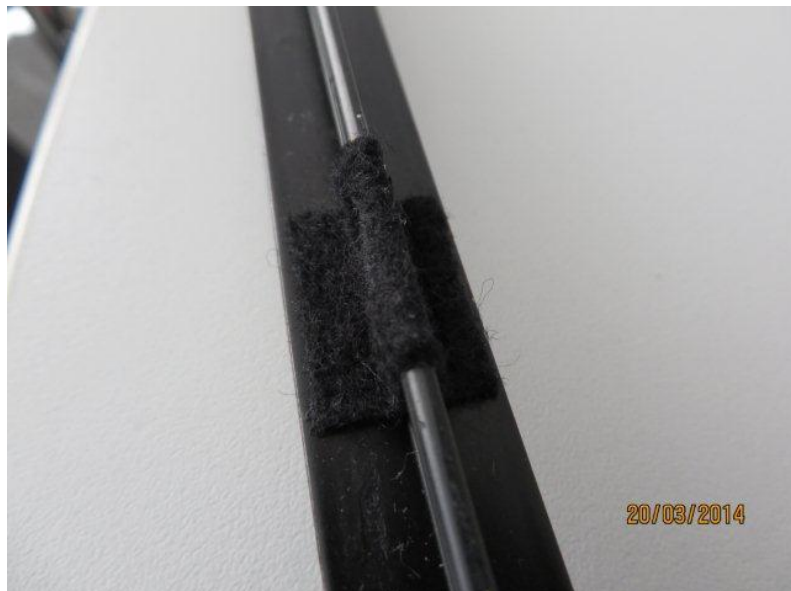
Figure 3. Fleece tape section applied.

3. Apply the sections of fleece tape to the sunroof cover trim frame to each clipping point as shown (Figure 3 and Figure 4).

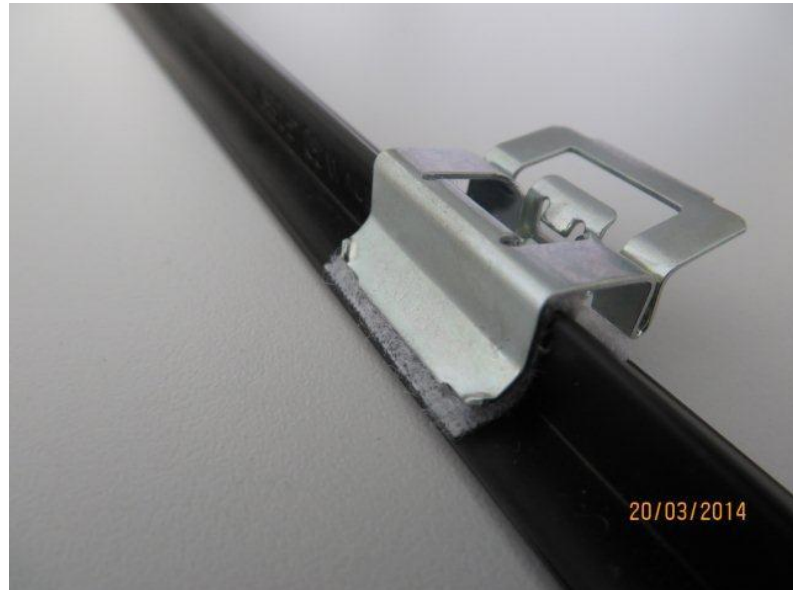
Figure 4. Retaining clip isolated with the fleece tape.

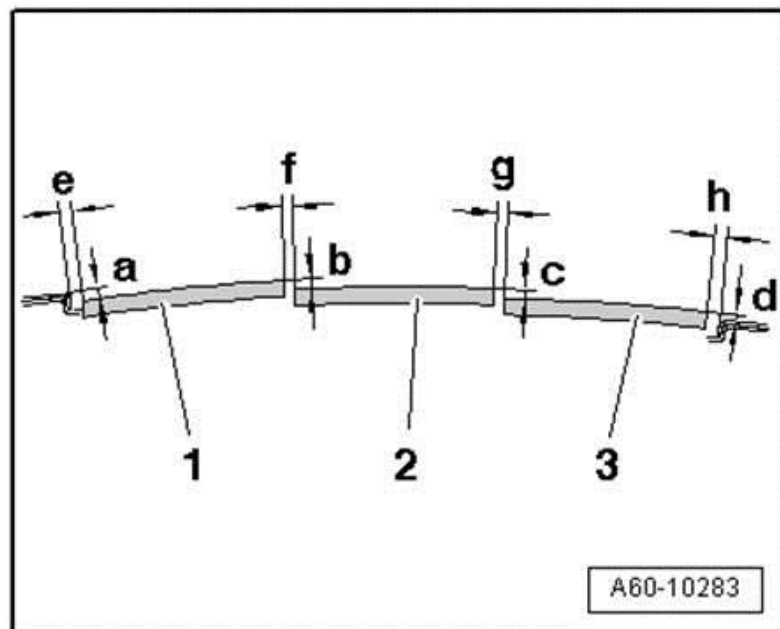
Figure 5. Adjustment of the glass sliding roof panels.

4. Reassemble the components removed for this modification. Ensure that the glass sliding roof panels are adjusted properly according to the repair manual (Figure 5).
