Technical Service Bulletin

70 Noises from headliner / sunroof area

70 17 57 2044417/2 February 10, 2017. Supersedes Technical Service Bulletin Group 70 number 16-51 dated June 3, 2016 for reasons listed below.

Model(s)	Year	VIN Range	Vehicle-Specific Equipment
Q7	2017	000001 - 005307	Not Applicable

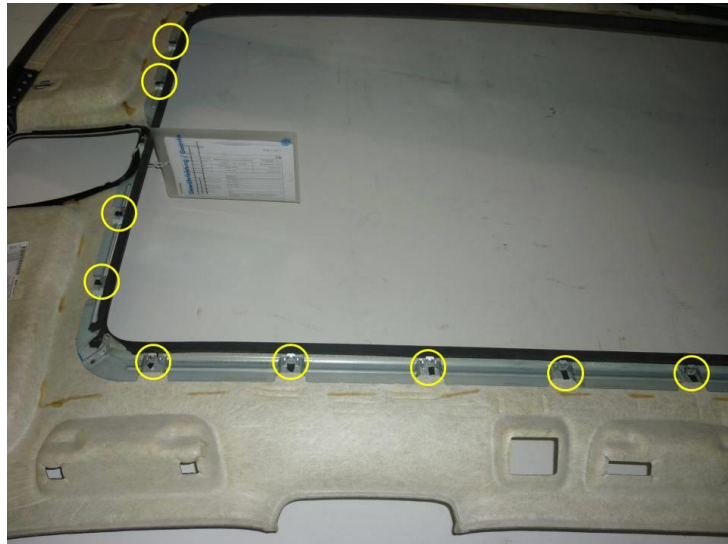
Figure 1. Location of the headliner to sunroof frame clips.

2. Remove the headliner. The clips shown in the illustration will need fleece adhesive tape (D 373125A2) (Figure 1).

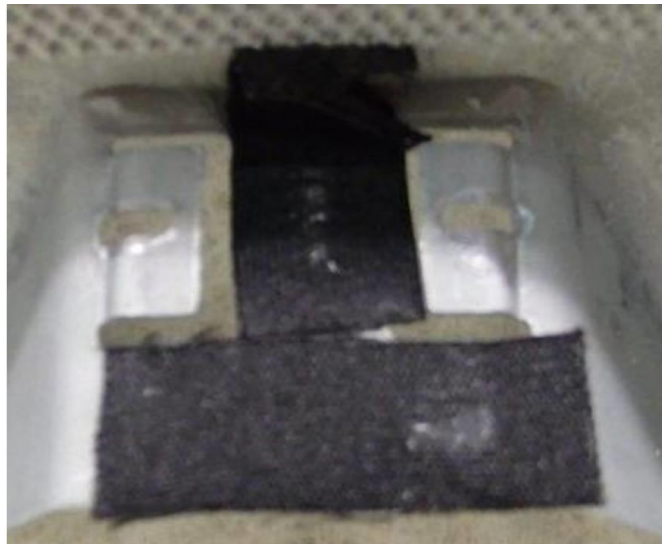
Figure 2. Location of the fleece adhesive tape application.

3. Remove the clips and apply the fleece adhesive tape underneath them, as shown (Figure 2).

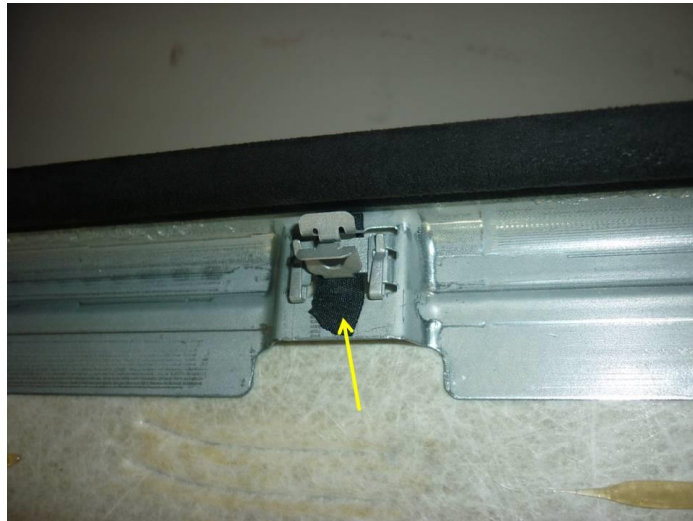
Figure 3. Clips reinstalled.

4. Reinstall the clips (Figure 3).

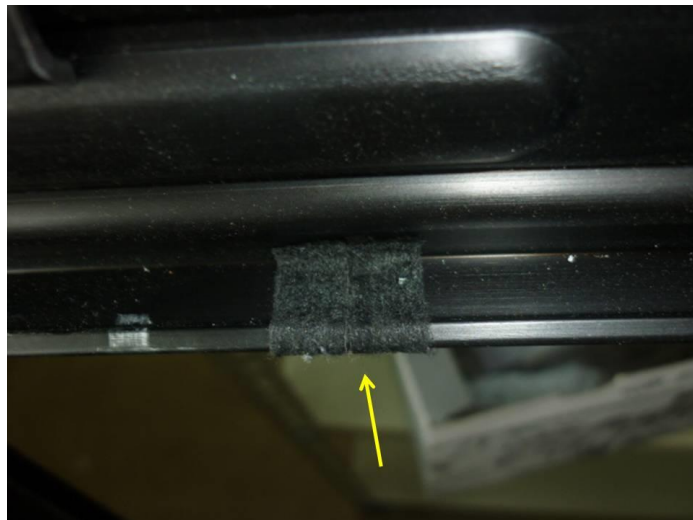
Figure 4. Application area on sunroof frame area of clip engagement.

5. Finally, apply fleece adhesive tape to the sunroof frame lip at each clipping point (Figure 4).
