Technical Service Bulletin

91 Voice recognition is not available or not enabled

91 17 07 2038136/2 February 10, 2017. Supersedes Technical Service Bulletin Group 91 number 14-60 dated September 9, 2014 for reasons listed below.

Model(s)	Year	VIN Range	Vehicle-Specific Equipment
A3 cabriolet	2015 - 2019	All	MIB MMI
A5 cabriolet	2010 - 2017	All	MMI3G or 3G+

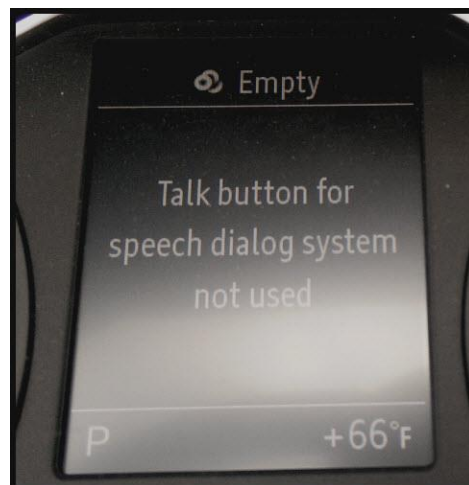
- The message “Talk button for speech dialog system not used” appears in the DIS for A3 cabriolet vehicles (Figure 1).
- The message “Not available” appears in the DIS for A5 cabriolet vehicles (Figure 2).

Figure 1. Message for A3 cabriolet.

If the customer requests to have the VR feature enabled, it can be done through a change to the coding of the information control unit 1, J794 (address word 005F). The labor to perform this change is not covered by warranty.

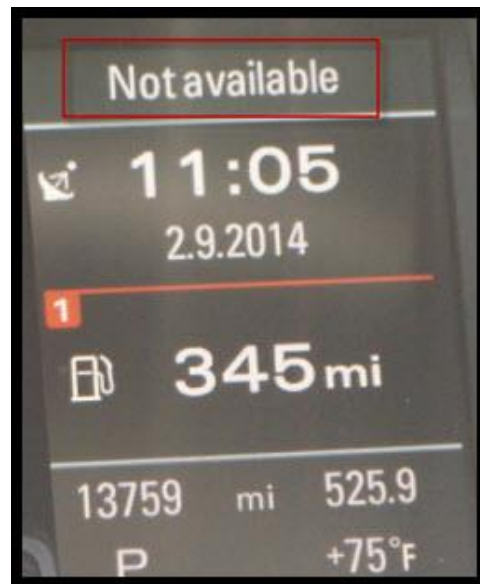
Figure 2. Message for A5 cabriolet.

Coding change for A5 cabriolet vehicles with MMI3G/MMI3G+: Byte 16 of the information control unit 1, J794 (address word 005F) long coding controls the activation of the VR/SDS system. Note that this is byte 16 when counting in decimal, i.e., 1, 2, 3,...9, 10, 11, 12, 13, 14, 15, 16. Some aftermarket diagnostic tools number the coding bytes using HEX, i.e., 1, 2, 3,...9, A, B, C, D, E, F, 10, 11.

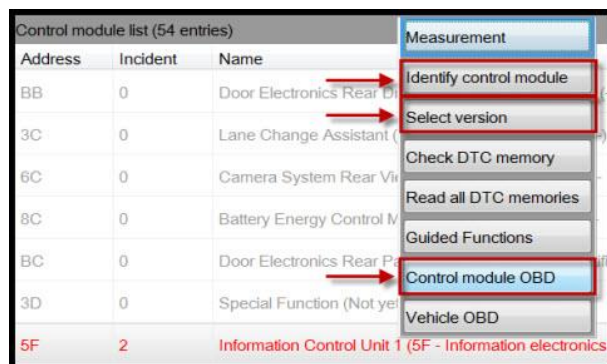
Figure 3. ODIS Options for 5F.

1. Start diagnosis with ODIS. Uncheck “Guided Fault Finding” to speed up the process, or use OBD (self-diagnosis) from the ODIS start screen. The instructions in this TSB will be from GFF.
2. Right-click 5F*. Choose “Identify Control Module”. Next, right-click 5F again and choose “Select version”. Then, right-click 5F again and choose “Control module OBD”, then select “Code” (Figure 3).

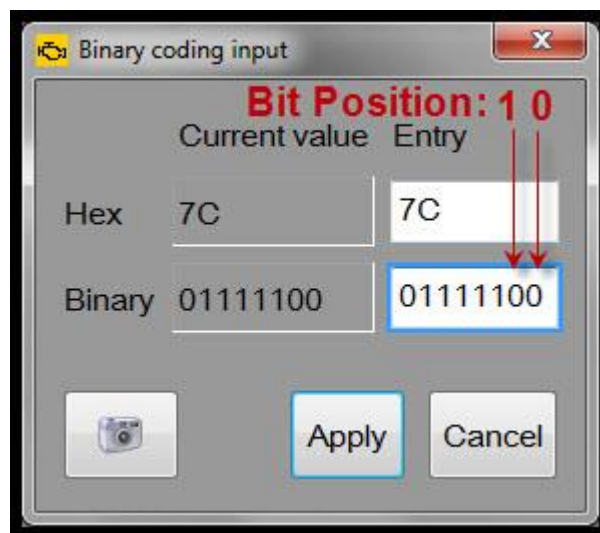
Figure 4. ODIS binary input for coding with indicated bit positions.

3. **For MMI3G/MMI3G+:** Scroll down to byte 16 and select it.
For MIB High: Scroll down to byte 24 (which should be the last option) and select it.
4. At the bottom of the screen, choose “Binary Coding”. The Binary coding input window will appear (Figure 4).

5. **For MMI3G/MMI3G+:** Change bit 0 from “1” to “0”. Bit position 0 is indicated in Figure 4.
For MIB High: Change bit 1 from “0” to “1”. Bit position 1 is indicated in Figure 4.

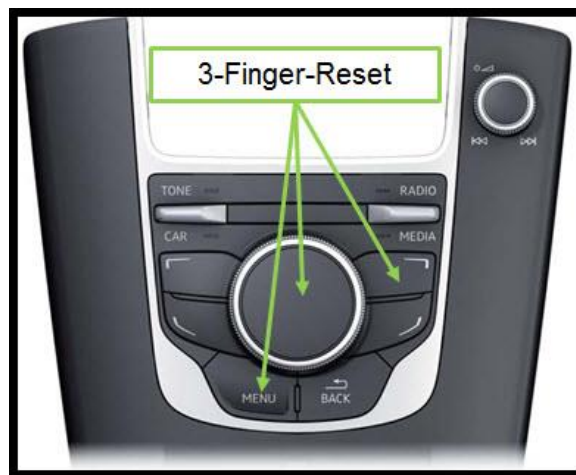
Figure 6. Three-finger reset for MIB1.

- Hit “Apply” in the pop-up window, then hit “Apply” at the bottom of the main window.
- Perform a three-finger reset of the main unit using the MMI control panel (Figure 6, Figure 7, Figure 8, and Figure 9).

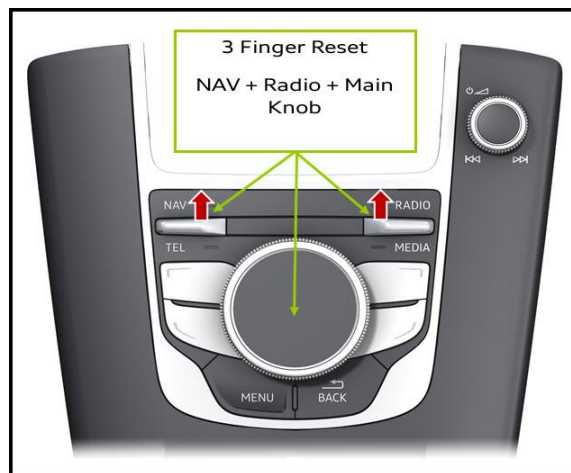
Figure 7. Three-finger reset for MIB2.

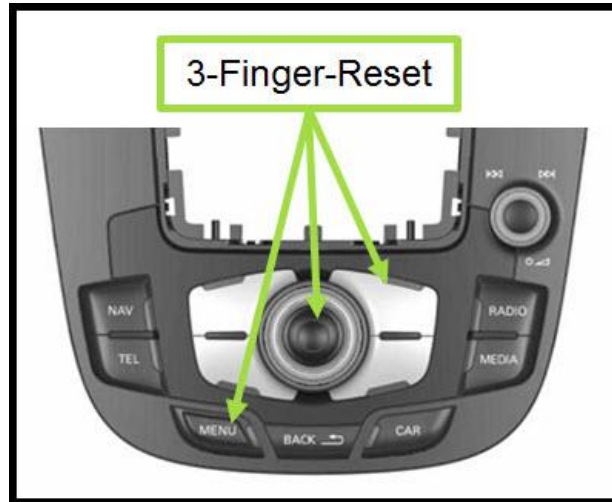
Figure 8. Three-finger reset for MMI3G+.

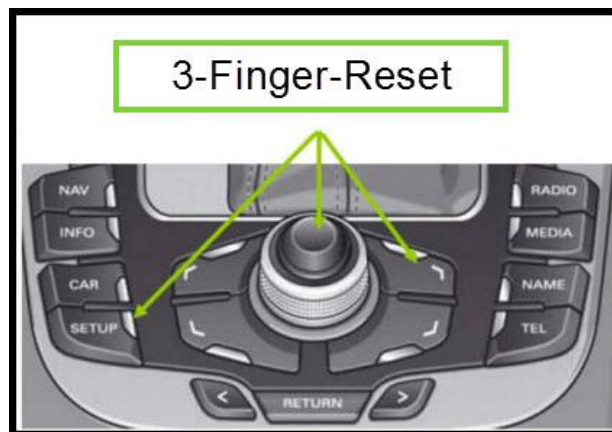
Figure 9. Three-finger reset for MMI3G.

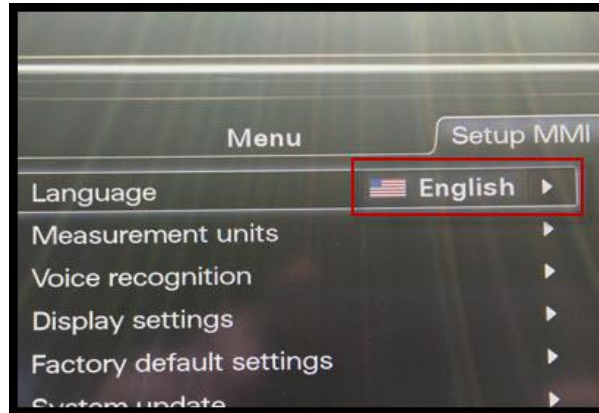
Figure 8. System language setting.

8. Test the system to verify all functionality. If the VR/SDS system does not fully function, or if it is in a different language, go to *Menu >> Setup MMI >> Language* (Figure 8) and change the language to any language other than English (either Spanish or French). Perform a three-finger reset, then set the language back to English and test the system again.
