Technical Service Bulletin

91 Audi Smartphone Interface: Apple CarPlay or Android Auto Does Not Function in the MMI (Activation Instructions)

91 17 08 2046293/2 February 10, 2017. Supersedes Technical Service Bulletin Group 91 number 16-96 dated December 16, 2016 for reasons listed below.

Model(s)	Year	VIN Range	Vehicle-Specific Equipment
A3	2017	All	Without ASI

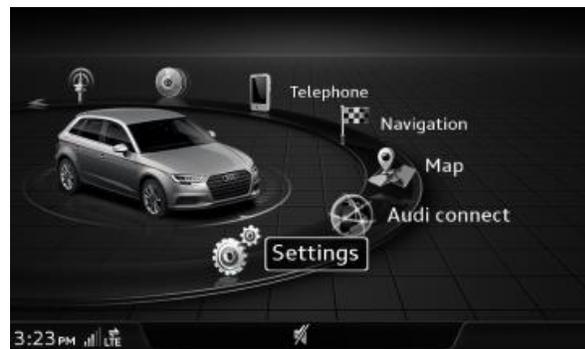
Figure 1. Connection Manager without ASI.

The customer states that Apple CarPlay & Android Auto do not function in the MMI, with no option in the MMI's connection manager (Figure 1), and the vehicle is a 2017 A3 e-tron with MMI Navigation plus (PR Code 7UG + UE7).

Certain early build 2017 A3 e-tron vehicles were built without the Audi Smartphone Interface (ASI) functionality despite the USB ports present in the vehicle (PR Code UE7). As a result, the MMI connection manager has no option for the “Audi Smartphone Interface” (Figure 1).

The ASI function consists of two major parts, a special Apple approved IC in the USB port and an activation code stored in the MMI. For certain early build 2017 A3 e-tron vehicles, the activations are missing in the MMI. This caused the lack of the ASI function in the MMI, despite the presence of the correct USB ports.

The Audi Smartphone Interface can be activated in the MMI using the repair instructions listed below.

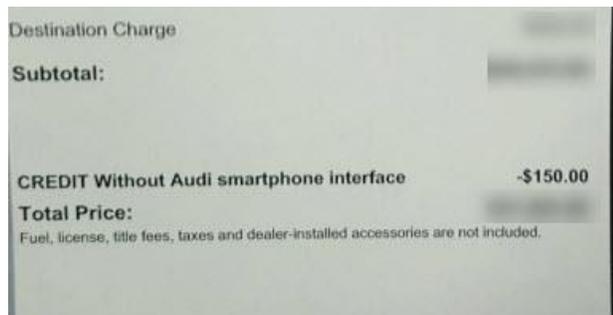
Figure 3. Monroney Label Credit.

1. Check PR Code in ElsaPro using the Vehicle Data option (Figure 2): the vehicle will have PR code UE7 = Audi Music Interface only (UI7 = ASI)
2. Check the Monroney label: the label on the vehicle will have a \$150 credit for “without ASI” (Figure 3).
