Technical Service Bulletin

91 Apple CarPlay black screen immediately after using backup camera or distorted audio during Bluetooth call

91 17 09 2046294/1 February 24, 2017.

Model(s)	Year	VIN Range	Vehicle-Specific Equipment
A4	2017	All	MIB2 High Scale

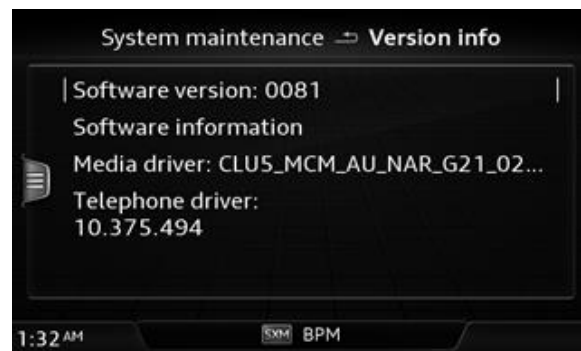
Figure 1. MMI Version Information

1. Verify the customer's MMI requires the software update by going to the *Main Menu>>Settings>>Left drawer option>>Version Information* (Figure 1).

Software versions 0061 & 0081 are only the versions which can be updated. If the MMI is at a level greater than 0110 (e.g. 0112, or 0118), then this TSB does not apply.
