Technical Service Bulletin

94 Headlight moisture accumulation

94 17 86 2030960/2 February 14, 2017. Supersedes Technical Service Bulletin Group 94 number 12-89 dated September 25, 2012 for reasons listed below.

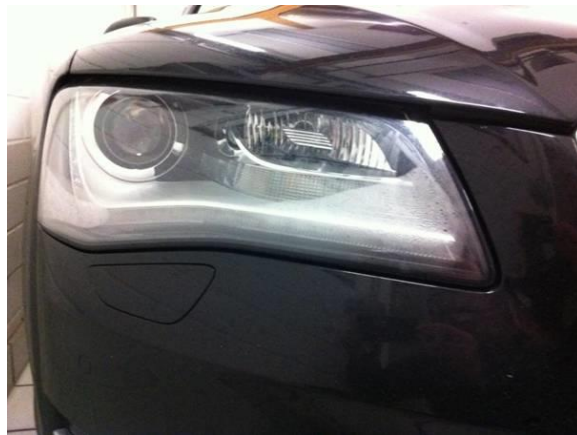
1. Condensation, for example, during in the rain or through a car wash. Also, described as “steaming up” or “fogging”.

Figure 1. Example of a headlight with condensation inside the lens.

1. Remove and dry out the headlight(s) with compressed air (less than 30 PSI).
2. Replace the ventilation hose (Figure 3, 1) and adapter (Figure 3, 3) on both sides and attach it to the mounting (Figure 3, 2). Use the part numbers indicated in the Parts table below.

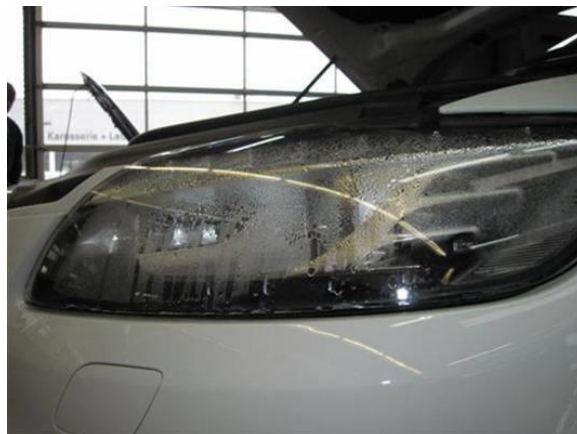
2. Water leaking into the headlight assembly.

Figure 2. Example of a headlight with a leaking condition.

When replacing the headlight, follow the headlight condensation repair instructions above using a new ventilation hose (Figure 3, 1) and adapter (Figure 3, 3) according to the Parts table below. Route the new ventilation hose behind the bumper carrier.

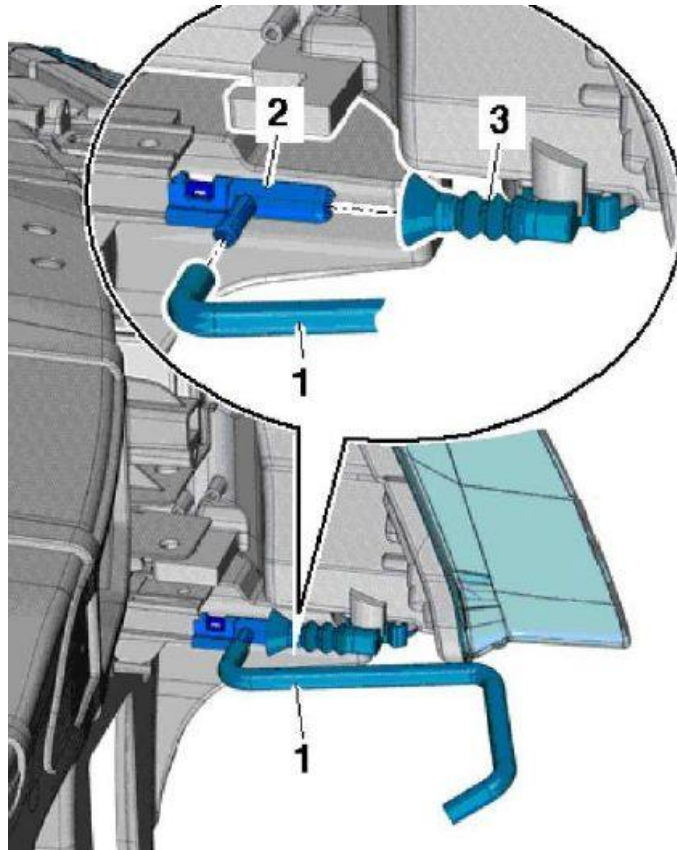
Figure 3. Illustration of the ventilation components.

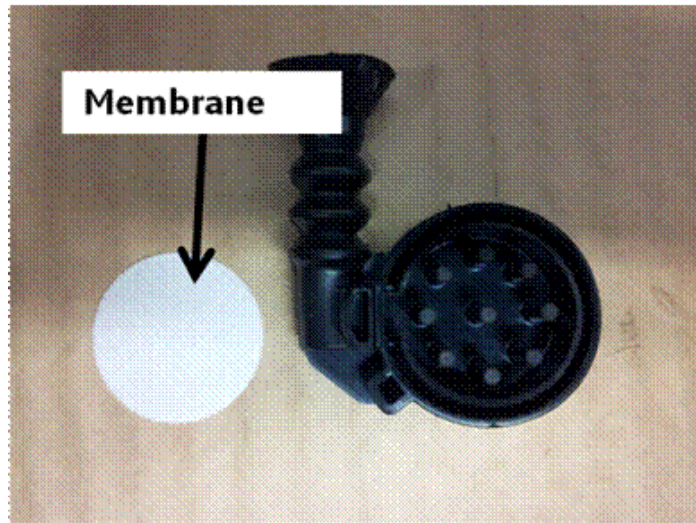
Figure 4. Membrane from original adapter.

3. It is not necessary to use the membrane from the original adapter.

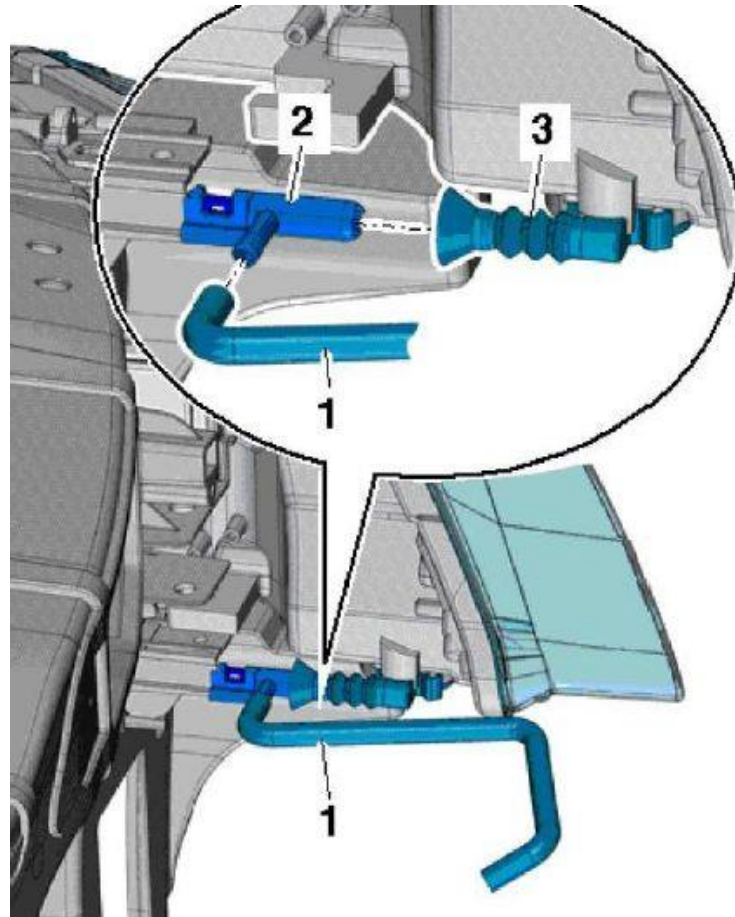
Figure 5. Illustration of the ventilation components.

2. Replace the ventilation hose (Figure 5, 1) on both sides and attach it to the mounting (Figure 5, 2). Use the part numbers indicated in the Parts table below.
