# Technical Service Bulletin

**CHECK ENGINE LIGHT ON WITH DTC P2183:00**

**Bulletin No.:** 01-011/17

2014-2017 Mazda3 with VINS starting with 3MZ

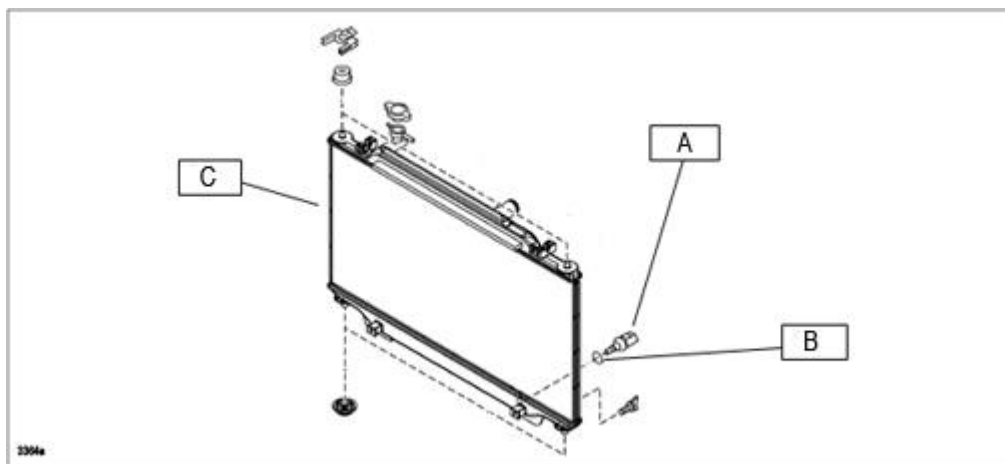
This is caused by the ECT sensor No.2 located near the bottom of the radiator getting wet and water entering the part due to insufficient water resistance. To correct this issue, the water resistance of the ECT sensor No.2 has been improved.

**NOTE:** Corroded contact pins can be seen if badly corroded, but no corrosion may be seen if the pins are only corroded in back.

3.If the ECT sensor No.2 is determined to be "NO GOOD", replace it with a modified one according to the Workshop Manual "ENGINE COOLANT TEMPERATURE (ECT) SENSOR REMOVAL/INSTALLATION [SKYACTIV-G 2.0, SKYACTIV-G 2.5]."
