Technical Service Bulletin

Subject: EXCESSIVE CONDENSATION OR WATER WITHIN THE HEADLAMP ASSEMBLY - CAUTION	Bulletin No.: 09-001/17
	Last Issued: 08/09/2017

2011-2014 Mazda2	2007-2017 Mazda6	2013-2017CX-5	2007-2011 RX-8
2007-2018Mazda3	2008-2011 Tribute	2007-2012 CX-7	2006-2017 MX-5
2006-2015 Mazda5	2016-2018CX-3	2007-2017CX-9

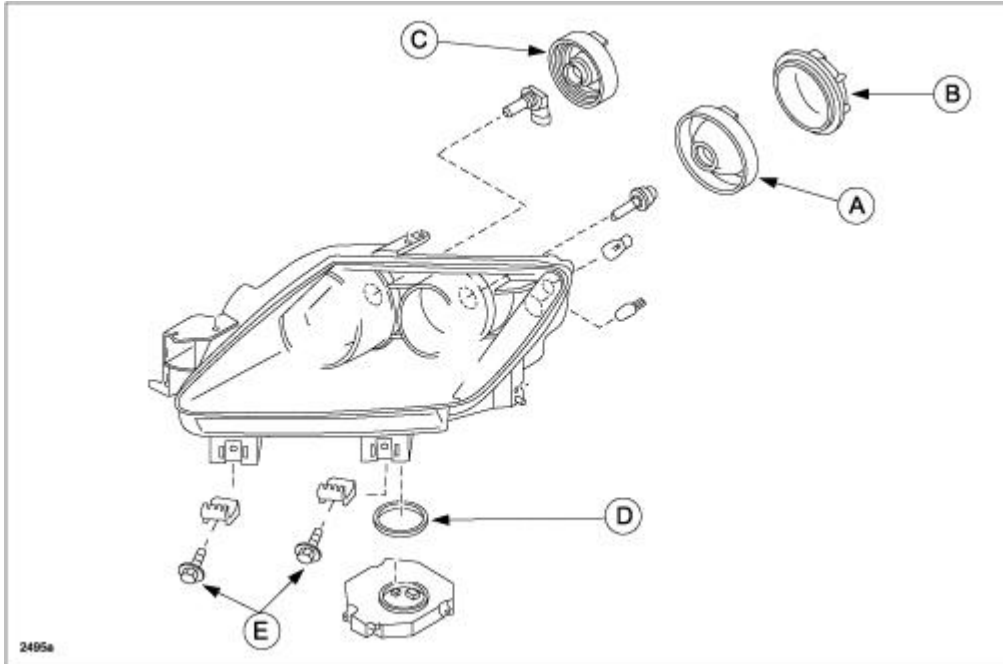
When dealing with customer complaints of excessive condensation and/or water within the headlamp unit, first determine if all the bulb sockets (including O-ring), seals and covers are present and correctly installed. In most cases you will find that the Bulb Seal No. 1 (A) or HID Bulb Seal No. 1 (B) and Bulb Seal No. 2 (C) socket covers have not been correctly installed or are missing due to improper prior repairs (i.e., customer replacing the headlamp bulbs or body shop not transferring them when replacing the headlamp unit(s) due to a collision). Any damage caused by missing socket covers, HID module seal (D), or missing bumper brackets (E) is not covered by warranty policy.

NOTE: LED headlamp assembly with LED turn signal lamp replacement part include seals. Seal transfer is not required.
