<b>Subject:</b> <b>SECOND-ROW SEAT WALK-IN LEVER DOES NOT WORK</b>	<b>Bulletin No.:</b> 09-036/17
	<b>Last Issued:</b> 08/09/2017

2016-2017 CX-9 vehicles with VINs lower than JM3TC\*\*\*\*\*142166 (produced before May 22, 2017)

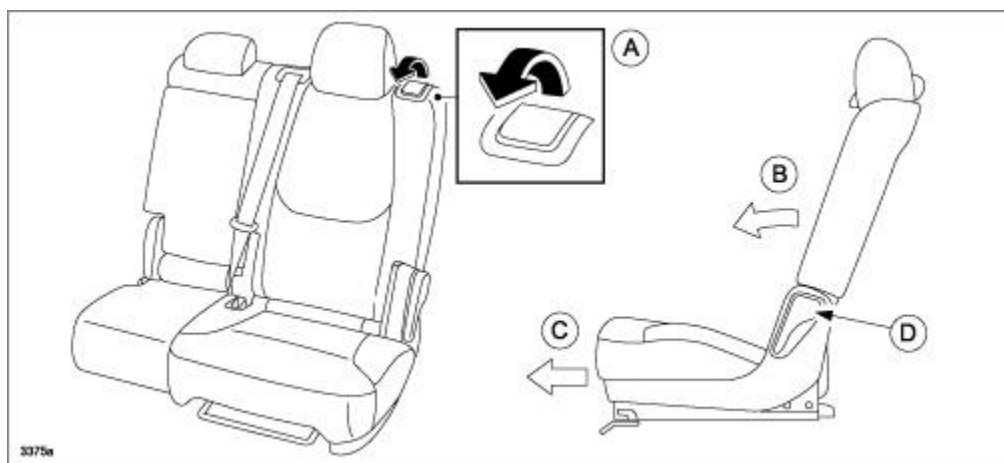
On some vehicles, the second-row seat back does not fold (B) or slide (C) forward when the walk-in lever (A) is pulled up to access to the 3rd row seats. Also, the recliner lever knob (D) may not operate on some vehicles.

These concerns may be caused by a disconnected walk-in lever cable. To eliminate these concerns, the design of the walk-in lever has been changed according to the following:

1. Verify the customer concern.
2. Replace the walk-in lever with a modified one according to the "WALK-IN LEVER REMOVAL/INSTALLATION PROCEDURE" instructions below.

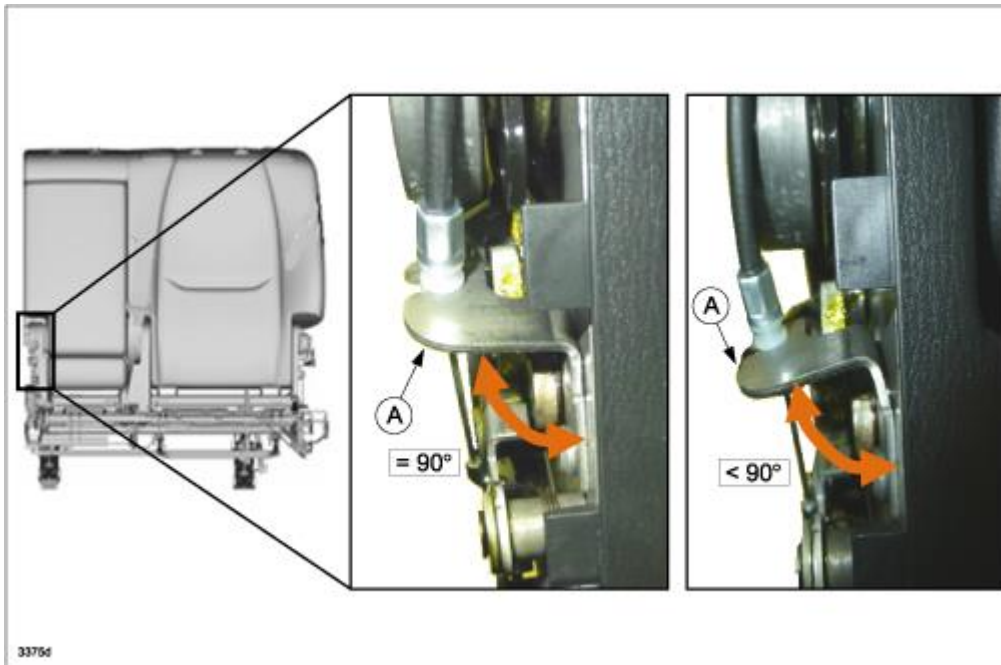
5. Inspect the cable bracket (A) for deformation / bending.

- If the cable bracket is bent (as shown above-right), replace the second-row seat cushion frame assembly with a modified one according to the instructions on MGSS online (SECOND-ROW SEAT BACK

COMPONENT REMOVAL/INSTALLATION)and (SECOND-ROW SEAT CUSHION REMOVAL/INSTALLATION).

**NOTE:** When replacing the frame, check the cable for damage and replace if necessary.

- If the cable bracket is not bent (as shown above-left), go to the next step.

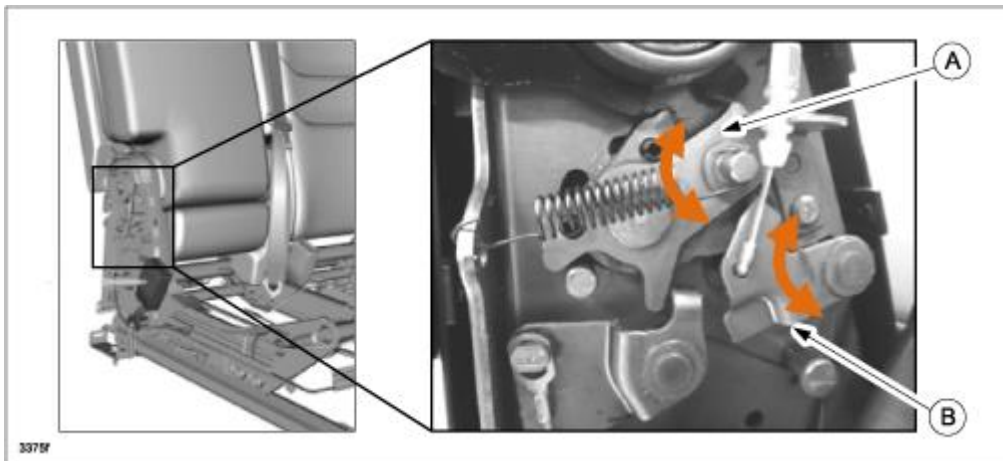
6. Verify links (A and B) move smoothly.

- If the links do not move, they may be binding with each other (C). Push link (B) with a screw driver (A) to release the binding. Verify the links move smoothly, then go to the next step.

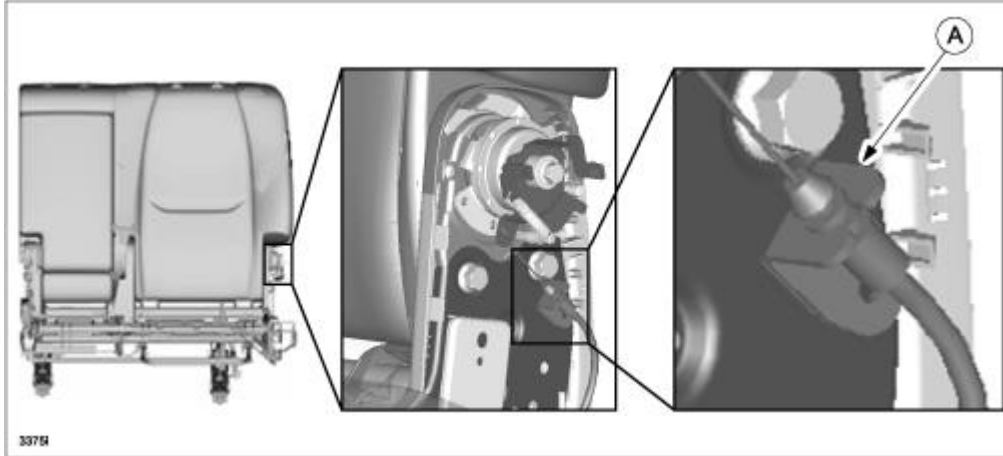
8. Inspect cable bracket (A) for bending.

- If the cable bracket is bent, replace the second-row seat cushion frame assembly with a modified one according to the instructions on MGSS online (SECOND-ROW SEAT BACK COMPONENT REMOVAL/INSTALLATION) and (SECOND-ROW SEAT CUSHION REMOVAL/INSTALLATION).

**NOTE:** When replacing the frame, check the cable for damage and replace if necessary.

- If the cable bracket is not bent, go to the next step.

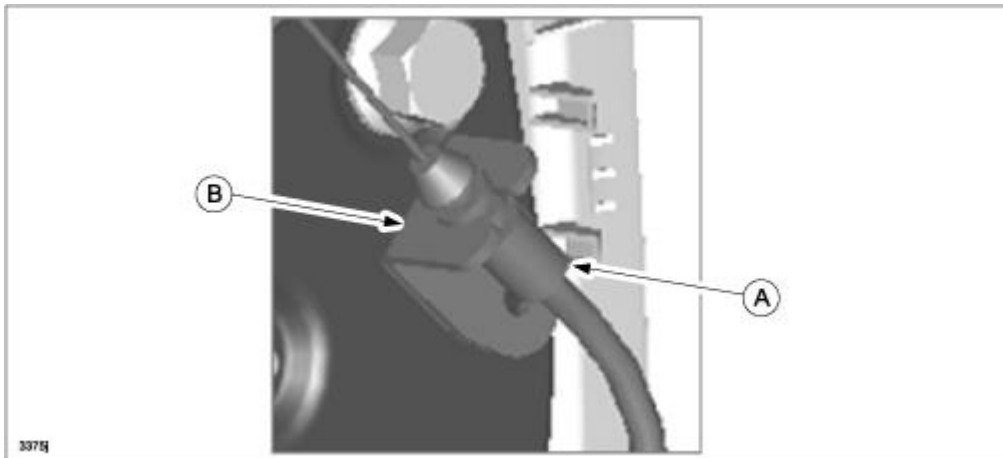
9. Inspect cable (A) for damage / coming out of bracket (B).

- If the cable is coming out of the bracket, check the white plastic part for damage.
- If the cable is damaged, replace it with a new one.
- If the cable is not damaged, install it back to the bracket.

**NOTE:** Use the same groove position to reinstall the cable.

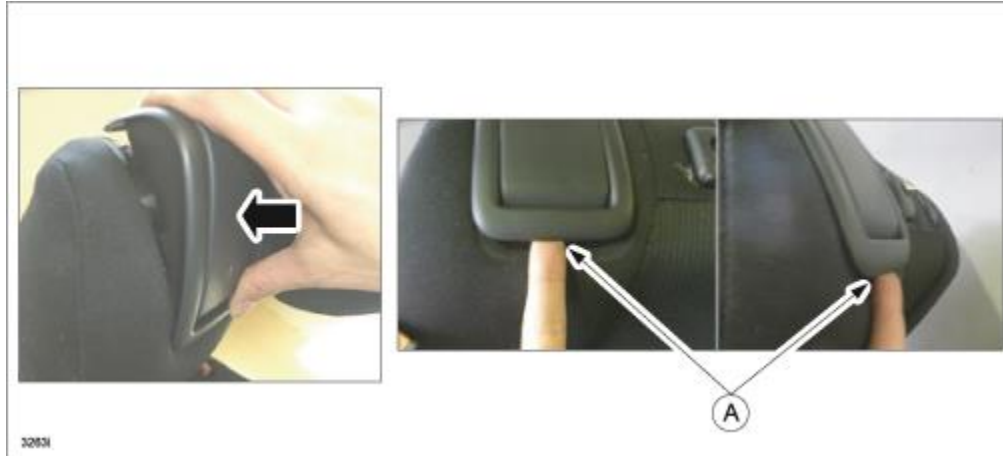
**NOTE:** The example shown below (A) is NO GOOD. There should not be any clearance.

3. Push the lever assembly into the seat back, verifying that the front edge is securely engaged in the anchor.
