# Technical Service Bulletin

MIDDLE HEADLINER LOOKS LOOSE

**Bulletin No.:** 09-037/17

2017 MX-5 (RF)

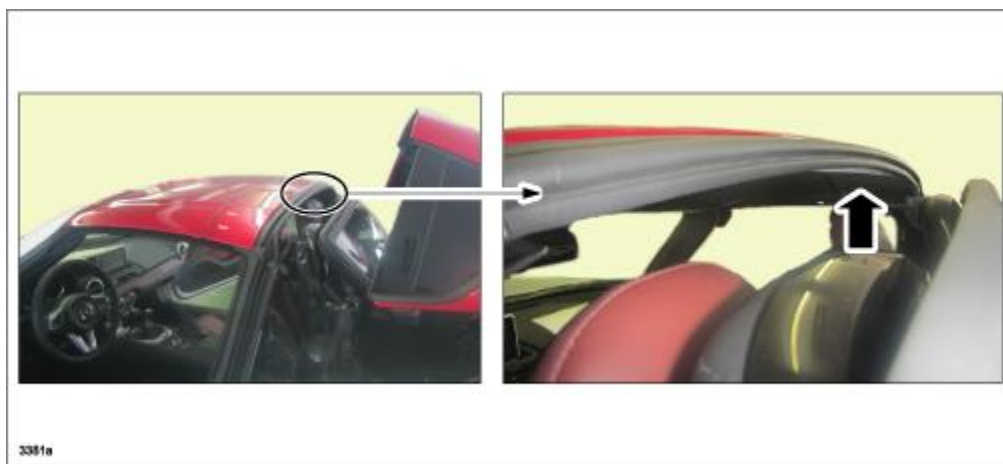
Some customers may complain that the the middle headliner looks loose at the center rear. This is caused by parts variation. To correct the concern, an additional fastener can be installed in the headliner.

Customers having this concern should have their vehicle repaired using the following repair procedure.
