<b>Subject:</b>  <b>CHECK ENGINE LIGHT ON WITH DTC P2183:00</b>	<b>Bulletin No.:</b> 01-011/17
	<b>Last Issued:</b> 08/25/2017

2014-2017 Mazda3 with VINS starting with 3MZ

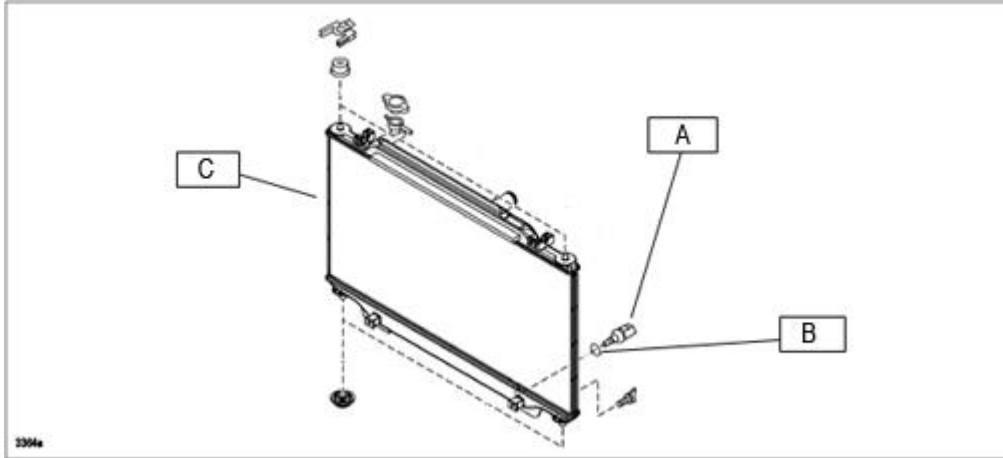
This is caused by the ECT sensor No.2 located near the bottom of the radiator getting wet and water entering the part due to insufficient water resistance. To correct this issue, the water resistance of the ECT sensor No.2 has been improved.

Parts Number	Description	Qty.
PE18-18-840	Sensor, Temp Eng Coolant (A)	1
9956-21-200	Gasket (B) at Radiator (C)	1

3.If the ECT sensor No.2 is determined to be "NO GOOD", replace it with a modified one according to the Workshop Manual "ENGINE COOLANT TEMPERATURE (ECT) SENSOR REMOVAL/INSTALLATION [SKYACTIV-G 2.0, SKYACTIV-G 2.5]."
