Technical Service Bulletin

KNOCKING / SQUEAKING NOISE FROM FRONT SHOCK ABSORBER, CREAKING NOISE FROM FRONT LOWER ARM BUSHING Bulletin No.: 02-003/17

Last Issued: 08/29/2017

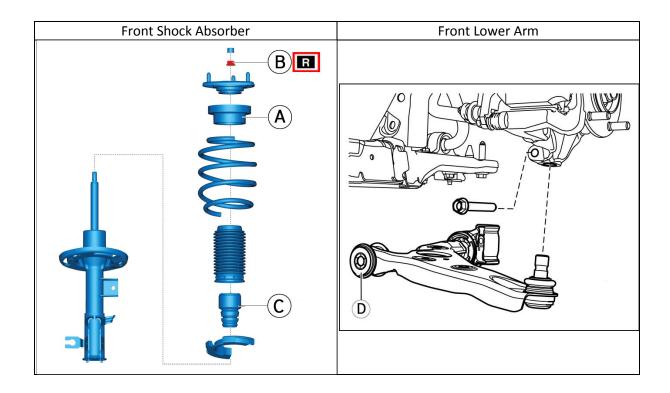
Some vehicles may exhibit a knocking / squeaking noise from the front shock absorber when driving on rough roads and/or when turning the steering wheel while the vehicle is stopped.

The noise may be due to:

- Upper front strut bearing (A) damage. (CX-5 and Mazda6)
- Squeak type noise between the front strut bearing and coil spring. (CX-3, CX-5 and Mazda6)
- The bump stopper (C) may be contacting the strut bearing when the front shock absorber is compressed, causing a popping noise. (Mazda6 only)
- The front lower arm bushing (D) is making a creak type noise in wet road conditions. (CX-5 and Mazda6).

To eliminate the noise, the following mass-production changes have been made:

- 1. The material and production method of the front strut bearing (A) has been changed. (CX-5 and Mazda6)
- 2. A protector has been installed onto the coil spring. (CX-5 and Mazda6)
- 3. The shape of the bump stopper (C) will be modified in the future. (Mazda6 only)
- 4. The shape of the coil spring has been changed. (CX-3 only)
- 5. Friction of the lower arm bushing has been reduced by adding a dry coating. (CX-5 and Mazda6).
