JTB00553NAS1

TECHNICAL BULLETIN

Roof Blind Does Not Open Correctly

MODEL:	MODEL YEAR:	VIN:	ASSEMBLY PLANT:
XE (X760)	2017	P00001-P21577	Castle Bromwich
XF (X260)	2016-2017	Y00001-Y41198	Castle Bromwich
F-PACE (X761)	2017 Onwards	045000-086391	Solihull

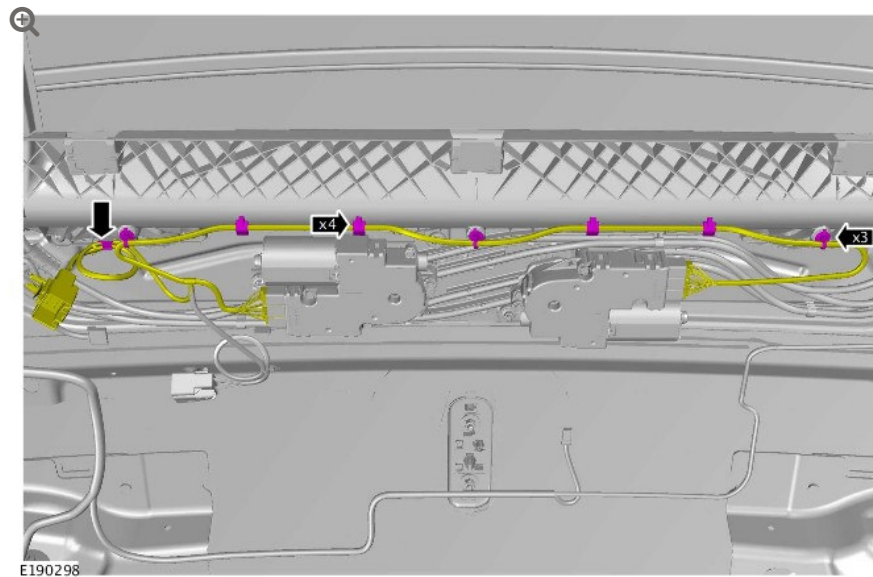
NOTE:

Vehicles with roof opening panel only.

Replace the roof blind wiring harness.

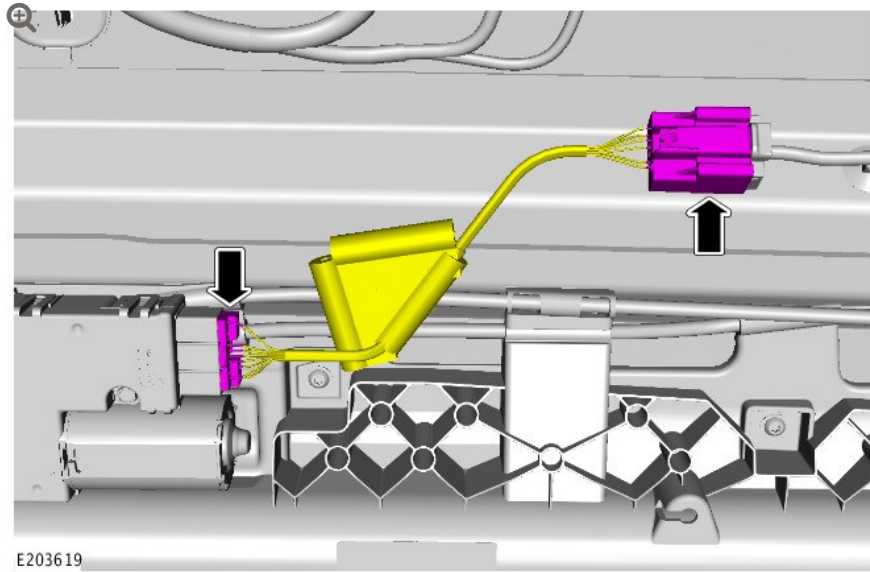
NOTE:

Vehicles with fixed roof only.

Replace the roof blind wiring harness.

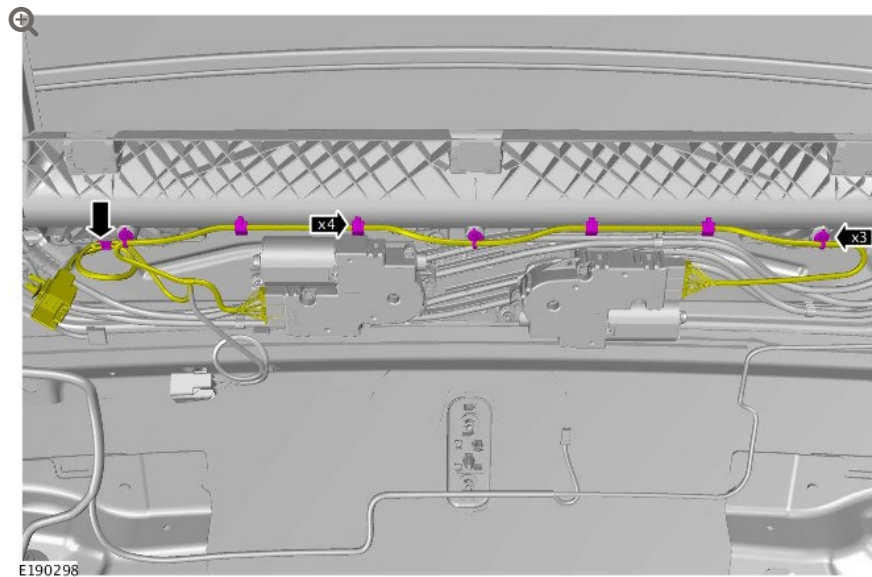
NOTE:

Vehicles with roof opening panel.

Replace the roof blind wiring harness.

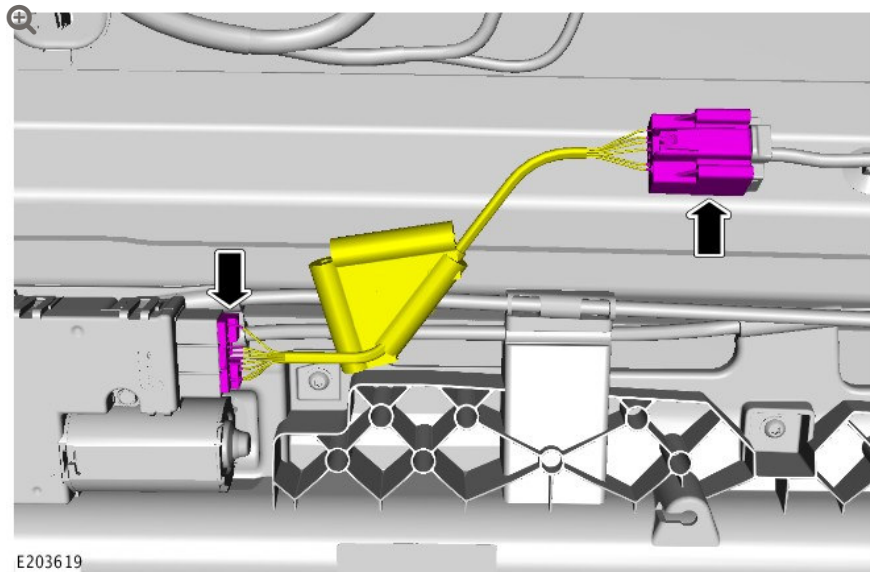
NOTE:

Vehicles with fixed roof.

Replace the roof blind wiring harness.
