October 4, 2017

07444 Version 4

Steering Wheel Noise When Driving

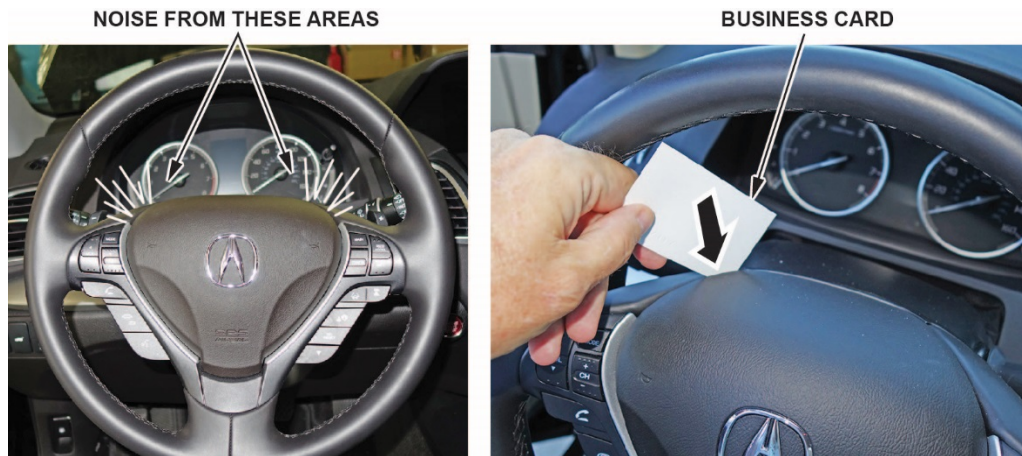
The driver's airbag rib, located below the surface of the cover, contacts the leather wrap on the steering wheel spokes at the 3 and 9 o'clock positions.

Drive the vehicle to confirm the source of the noise. Insert a business card or your finger, between the steering wheel spoke and airbag module on the side making the noise.

- If the noise stops or changes, continue to REPAIR PROCEDURE.
- If the noise does not change, this bulletin does not apply. Continue with normal troubleshooting.
- **NOTE: Do not do this repair on vehicles that are not included in the VIN range. You may damage the steering wheel leather, and your claim may be debited. You may not notice the damage immediately, but the vehicle will likely come back. For vehicles outside the VIN range, follow normal diagnosis and repair procedures.**
