## SERVICE ACTION

| Reference number: | SA-15-0293 | Issued: 15 September 2017 |
| Subject: | DB11 Head Unit SCN coding update – EU TMC | |
| Model(s): | DB11 | |

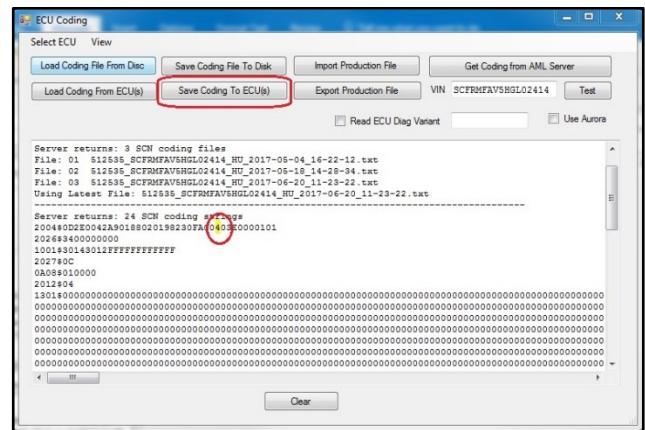
Figure 5

**Note:** Do a check of the highlighted digit (refer to Figure 5) to make sure that the new code is correct. For the initial code the digit will be "0". For the updated code, the digit will be "4".

14. Click "Save Coding to ECU(s)" to save the new SCN coding to the HU module (refer to Figure 5).
