Warranty Field Campaign

Campaign Number: c1794	Revision: F	Released Date: 08-Sep-2017
ISX15 CM2350 Fuel Pump Tappet Campaign		Expiration Date (U.S. and Canada): 01-Dec-2017
		Expiration Date (International): 01-Dec-2017

ISX15 CM2350 Fuel Pump Tappet Campaign

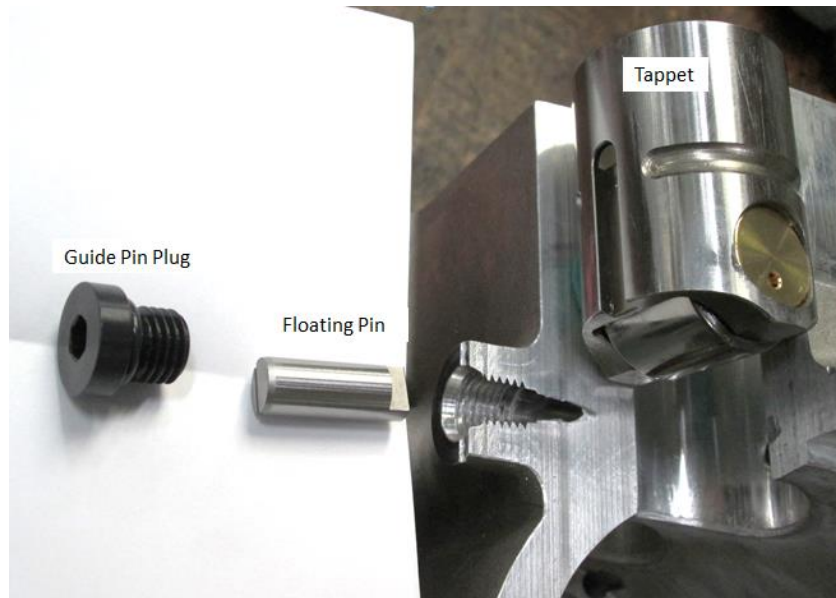
The tappet guide pin is a floating pin and plug design, as shown in Figure 1 below. The floating pin has a rectangular end that engages the groove on the tappet. Refer to Figures 2 and 3. The pin can be rotated by hand. Be certain the pin engages the tappet properly before installing the fuel pump head.

Figure 1: Tappet guide plug, floating pin, and the tappet roller with guide slot.

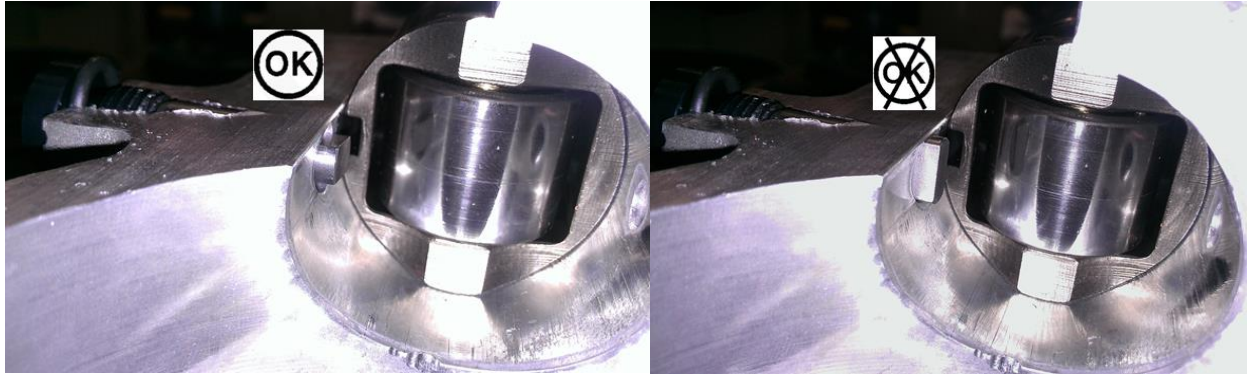
Note : Warning! The tappet guide pins may rotate during the removal of the tappet. The tappet cannot be correctly installed if the tappet guide pin is out of position. Please refer to Attachment B for the proper orientation of the tappet guide pin.

Figure 2: Bottom view using cut-away cam housing. (a) Tappet guide pin correctly oriented within the bore. (b) Tappet guide pin incorrectly oriented within the bore.

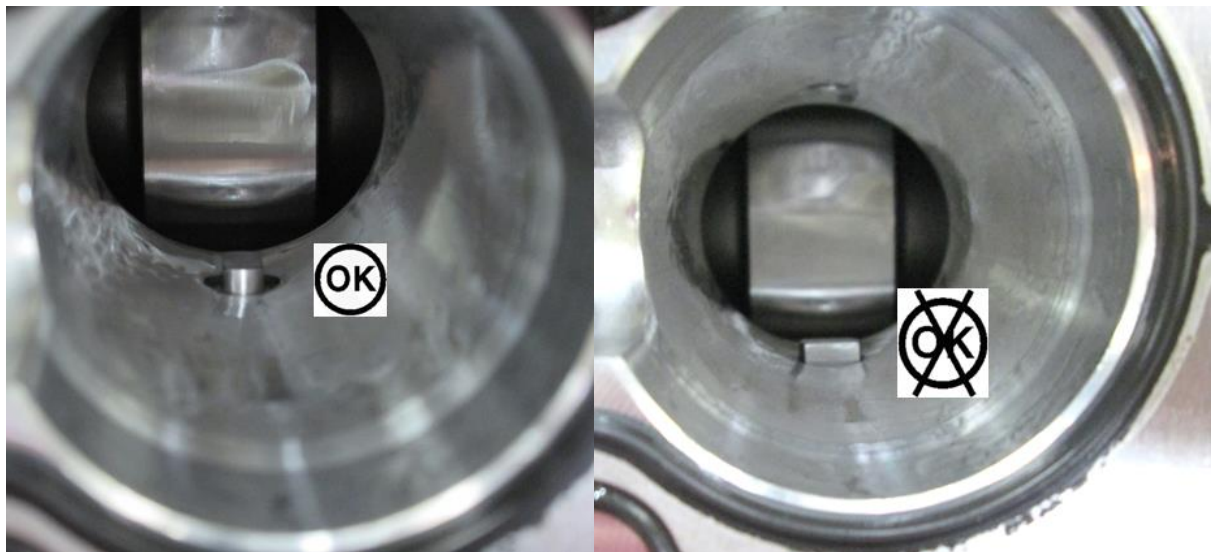
Figure 3: Top view looking down into bore. (a) Tappet guide pin correctly oriented within the bore. (b) Tappet guide pin incorrectly oriented within the bore.
