Ferrari North America

Technical Information

Date: June 2017
Bulletin #: 2392
Campaign #:
Supersedes:
Section: 3

Model Type: 488 GTB/Spider
Model Year: All
Subject: Procedures for repairing the DCT gearbox

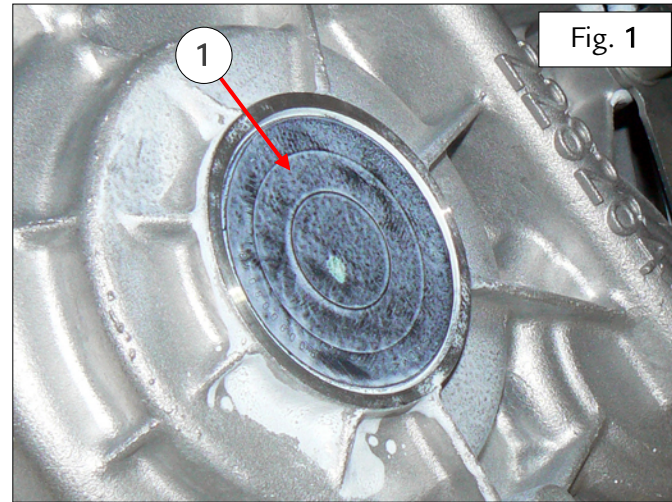
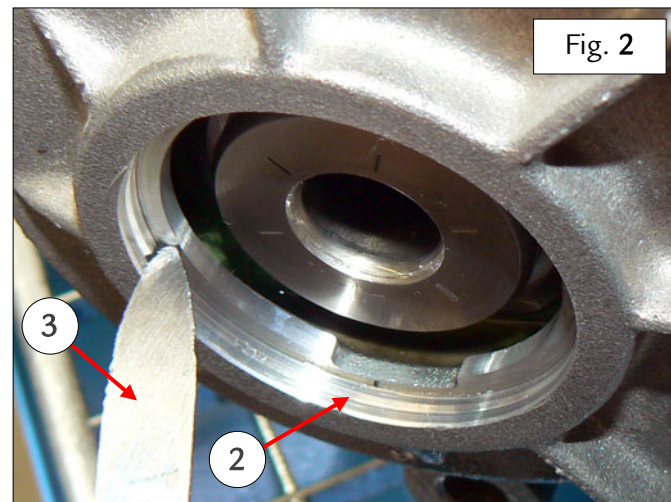
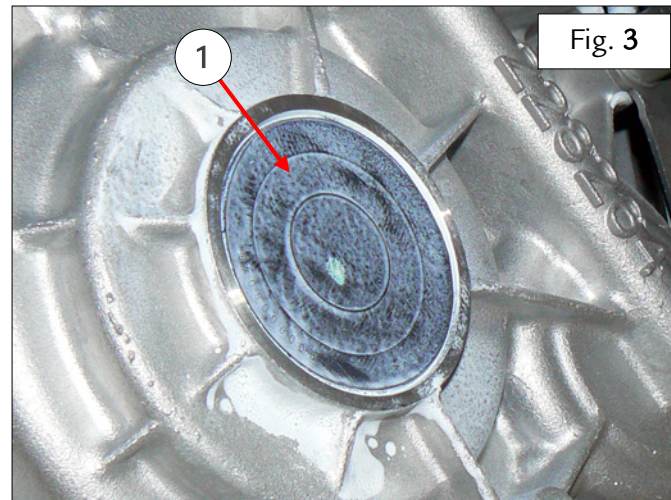
- Drill the plug (1) – Fig. 1.
- Use the screwdriver to prise the rear rubber cap out of its seat (1) – Fig. 1.
- There are grooves in the seat (3) of the rear rubber cap used to improve the seal. Any residue from machining, a burr and/or dirt limit the seal of the cap with consequent oil leakage – Fig. 2.
- Using a suitable tool (3), scrape the circular surface (2) very gently to remove all debris/burr, taking particular care not to damage or scratch the surface itself – Fig. 2.
- Fit a new rear rubber plug (1) in the relative seat – Fig. 3.
- Push the plug into its seat so that it is recessed by 1.15 ± 0.3 mm relative to surrounding edge – Fig. 3.
- Check that the rear rubber cap is installed correctly (1) – Fig. 3.

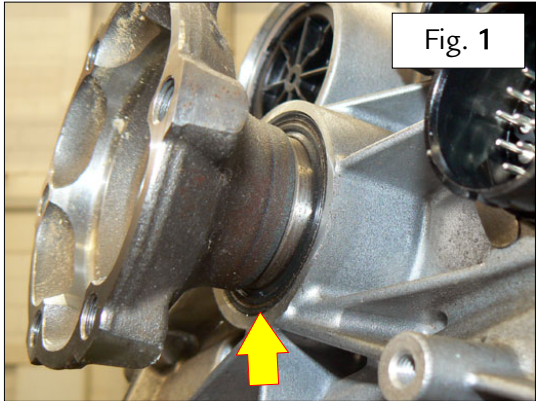
Oil leaks from Corteco seal rings/differential flanges		
Fault	Procedure	
Oil leaks from Corteco seal rings/differential flanges (Fig. 1)	Perform procedure 1. ➤ Replacing Corteco seal rings and differential flanges.

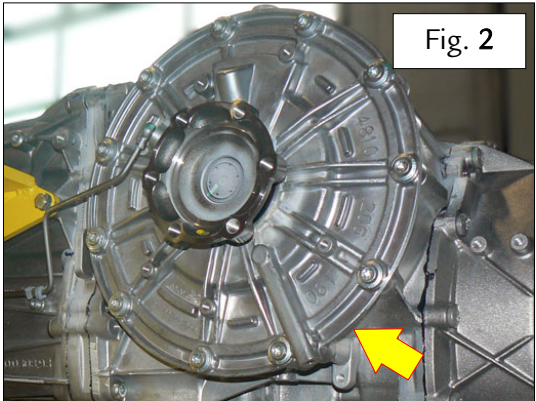
Oil leak from differential casing cover		
Fault	Procedure	
Oil leakage from differential cover (Fig. 2)	Perform procedure 2. ➤ Replace O-ring on differential cover.

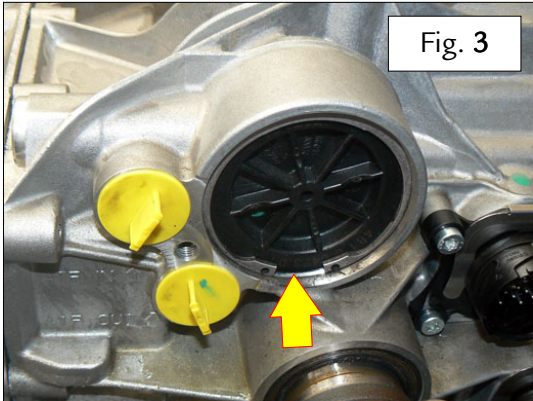
<p style="text-align: right; margin-right: 10px;">Fig. 3</p>

Fluid leak from ATF fluid filter		
Fault	Procedure	
<p>Fluid leakage from ATF fluid filter (Fig. 3)</p>	<p>Perform procedure 3.</p> <ul style="list-style-type: none"> ➤ Replace the ATF fluid filter.

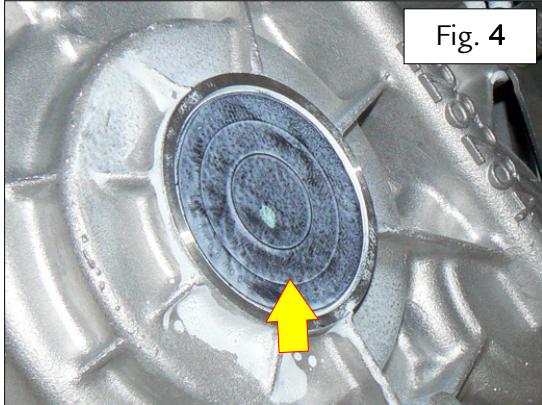
<p style="text-align: right; margin-right: 10px;">Fig. 4</p>

Oil leak from rear plug		
Fault	Procedure	
<p>Oil leakage from rear gearbox plug (Fig. 4)</p>	<p>Perform procedure 4.</p> <ul style="list-style-type: none"> ➤ Replace rear plug.

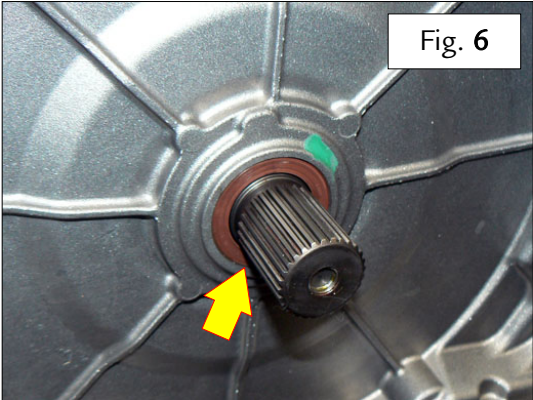
Oil leakage from front connector casing		
Fault	Procedure	
Oil leakage from Corteco seal ring on front connector casing (Fig. 6)	Perform procedure 6. ➤ Replacing Corteco seal ring.

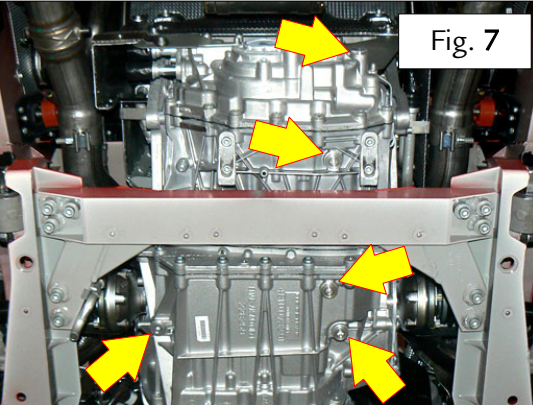
Leakage from oil plugs on gearbox		
Fault	Procedure	
Oil leakage from gearbox oil plugs (Fig. 7)	Perform procedure 7. ➤ Replace the plug.

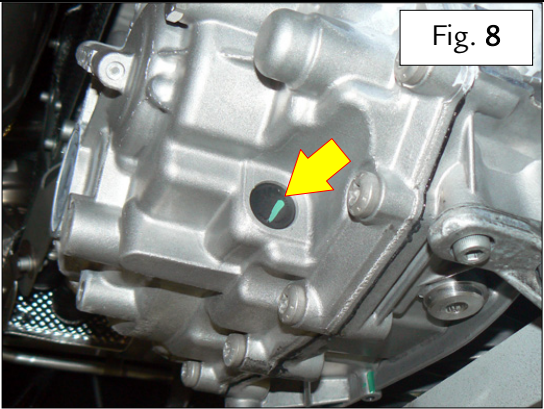
Leakage from seal plugs		
Fault	Procedure	
<p>Oil leakage from the two oil seal plugs (Fig. 8)</p>	<p>Perform procedure 8.</p> <ul style="list-style-type: none"> ➤ Replace the seal plug.
