# Ferrari North America

Date: June 2017  
Bulletin #: 2406  
Campaign #:  
Supersedes:  
Section: 3

**Model Type:** 458 Italia/Spider/Speciale/Speciale A, FF , F12 Berlinetta, California/California T  
**Model Year:** All  
**Subject:** Replacing CCP temperature sensor

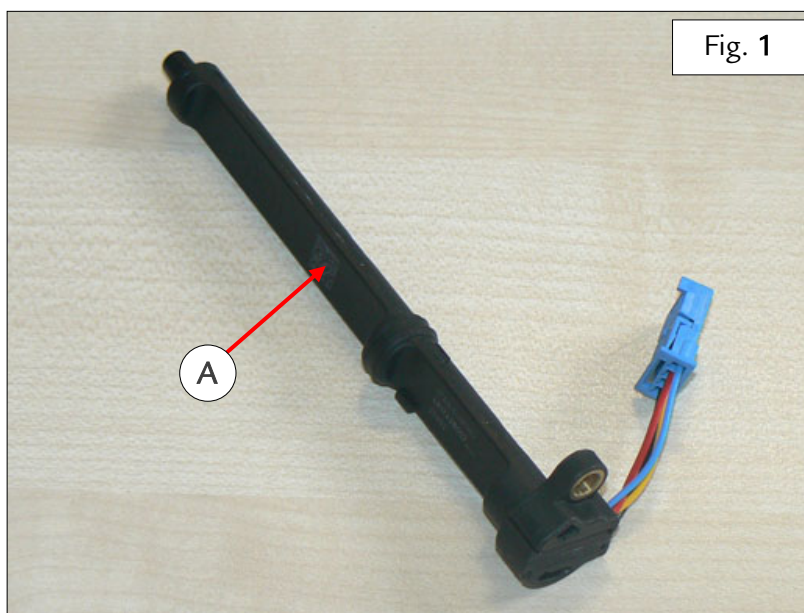
- CCP temperature sensor (A) (Fig. 1)

### ➤ Replacing CCP temperature sensor (Fig. 1)
