HYUNDAI Technical Service Bulletin

GROUP SUSPENSION	NUMBER 17-SS-003
DATE SEPTEMBER, 2017	MODEL(S) Tucson (TL)

SUBJECT: REAR TRAILING ARM REPLACEMENT INFORMATION

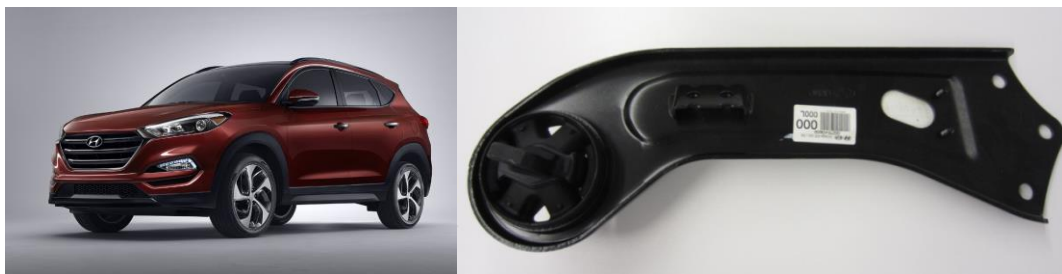
Due to parts comunization, the rear trailing arms on (TL) Tucsons produced after July 26, 2016 have been revised. This change also affects service parts. Therefore, anytime a rear trailing arm is replaced on (TL) Tucsons produced on or before July 26, 2016 it is necessary to replace both sides. Refer to the repair procedure located in the applicable Service Shop Manual: Suspension System → Rear Suspension System → Trailing Arm → Repair Procedures.

If replacement is required on one-side, for the previous part, the other side must be replaced at the same time.
