# HYUNDAI Technical Service Bulletin

NUMBER  
**17-BE-009**

MODEL(S)  
**TUCSON (TL)**

**SUBJECT:** NO SOUND FROM AUDIO SYSTEM - INSTRUMENT CLUSTER UPDATE

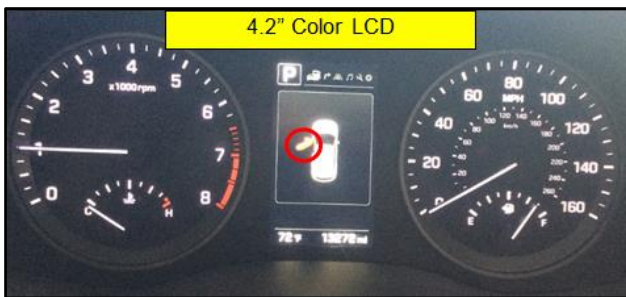
Supervision Cluster  
(Limited Ultimate)

**Description:** On certain 2016 - 2017 MY Tucson (TL), intermittently there is no sound from the audio system. This is caused by the instrument cluster not sending the proper CAN signals to the amplifier. This bulletin describes the procedure to reprogram the instrument cluster to correct the signal transmission timing.
