SERVICE BULLETIN

Classification:	Reference:	Date:
EC13-012d	NTB13-100d	September 15, 2017

ENGINE TURNS OFF OR HESITATES WHEN ACCELERATING FROM A STOP DURING HOT AMBIENT TEMPERATURES (+100° F)

APPLIED VEHICLES: 2012-2017 Versa Sedan (N17)
2014-2017 Versa Note (E12)

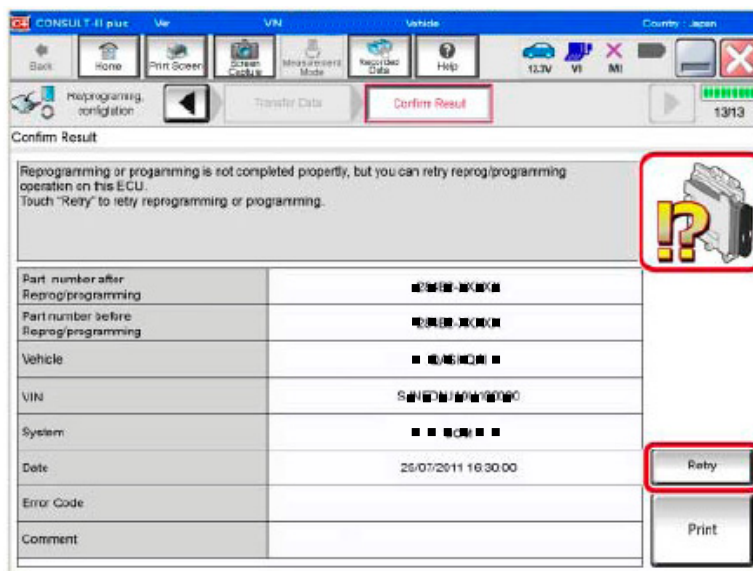
Figure 5

If reprogramming does not complete and the “!?” icon displays as shown in Figure 5:

- Check battery voltage (12.0–15.5 V).
- Ignition is ON, engine OFF.
- External Bluetooth® devices are OFF.
- All electrical loads are OFF.
- **Select retry and follow the on screen instructions.**
- “Retry” may not go through on first attempt and can be selected more than once.

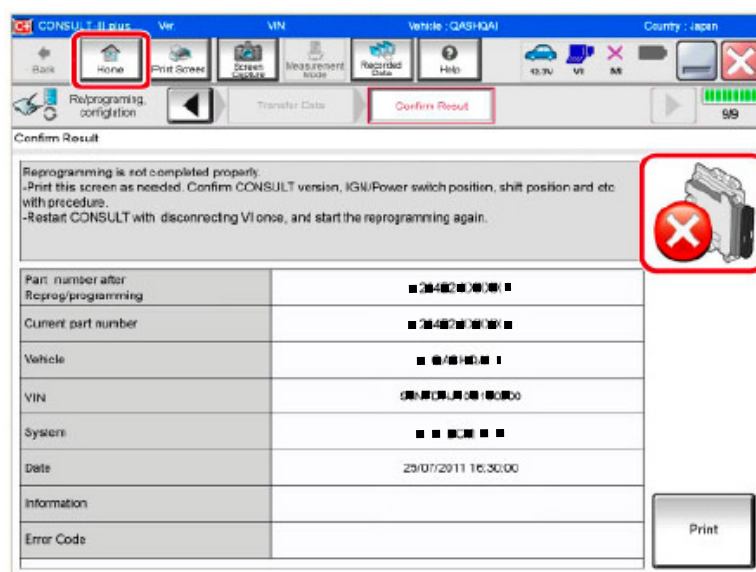
Figure 6

If reprogramming does not complete and the “X” icon displays as shown in Figure 6:

- Check battery voltage (12.0 – 15.5 V).
- CONSULT A/C adapter is plugged in.
- Ignition is ON, engine OFF.
- Transmission is in Park.
- All C-III plus / VI cables are securely connected.
- All C-III plus updates are installed.
- **Select Home, and restart the reprogram procedure from the beginning.**
