# SERVICE BULLETIN

Classification: EC16-026a	Reference: NTB16-086a	Date: September 28, 2017
------------------------------	--------------------------	-----------------------------

## 2013-2014 SENTRA; ENGINE TURNS OFF OR HESITATES WHEN ACCELERATING FROM A STOP DURING HOT AMBIENT TEMPERATURES (100° F OR MORE)

**APPLIED VEHICLE:** 2013-2014 Sentra (B17)

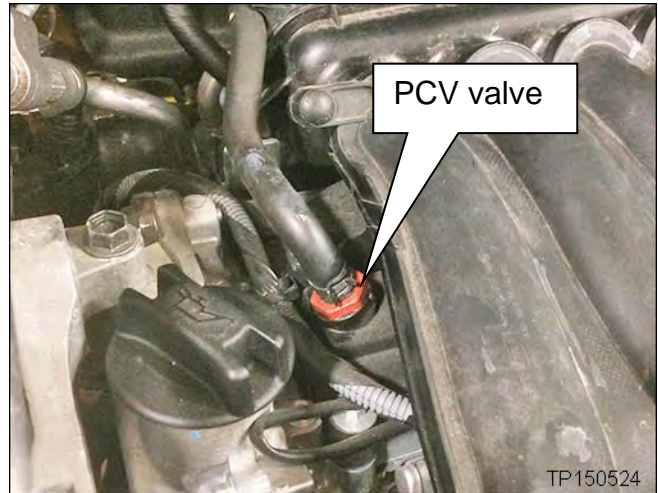
Figure A

#### **If PCV valve is orange, as shown in Figure A:**

- Replace the PCV valve.
- If needed, refer to the Electronic Service Manual ESM, section EM-Engine Mechanical, for replacement information.
- Use the new PCV valve listed in the Parts Information.
- The new PCV valve is “black” color.

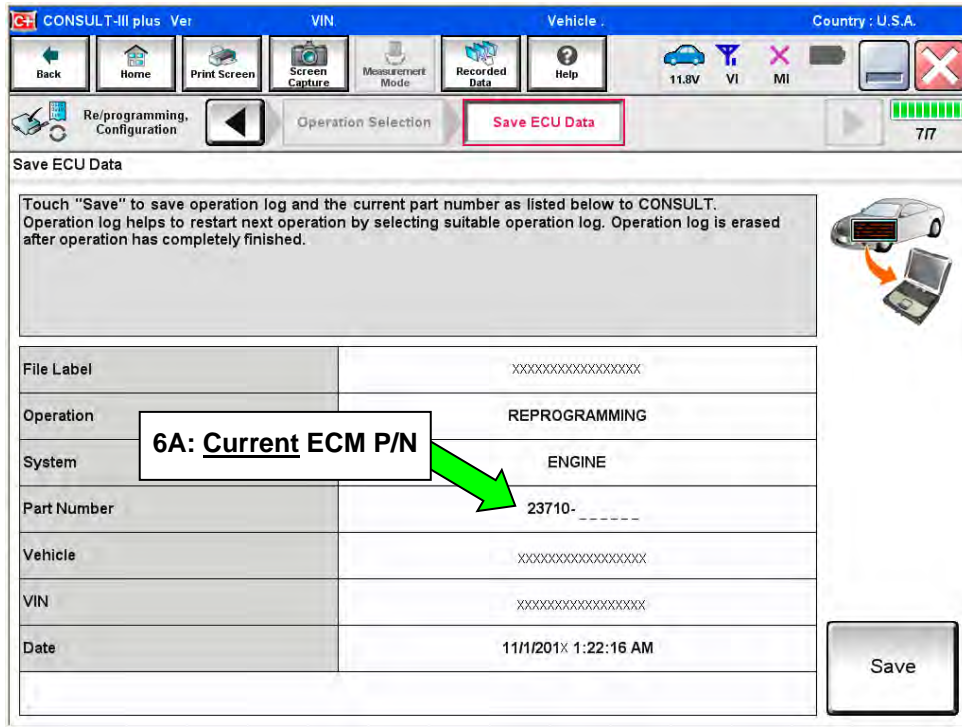
Figure 2

6. When you get to the screen shown in Figure 2, confirm this bulletin applies as follows.

A. Find the ECM **Part Number** and write it on the repair order.

B. Compare the P/N you wrote down to the numbers in the **Current ECM Part Number** column in **Table A** on the next page.

- If there is a match, continue with the reprogramming procedure.
- If there is not a match, reprogramming is not needed.

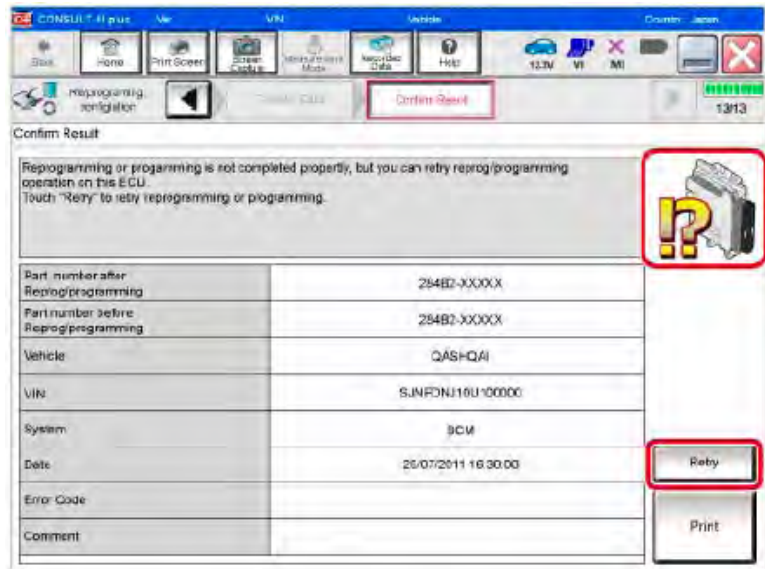
Figure 5

If reprogramming does not complete and the “!?” icon displays as shown in Figure 5:

- Check battery voltage (12.0–15.5 V).
- Ignition is ON, engine OFF.
- External Bluetooth® devices are OFF.
- All electrical loads are OFF.
- **Select retry and follow the on screen instructions.**
- “Retry” may not go through on first attempt and can be selected more than once.

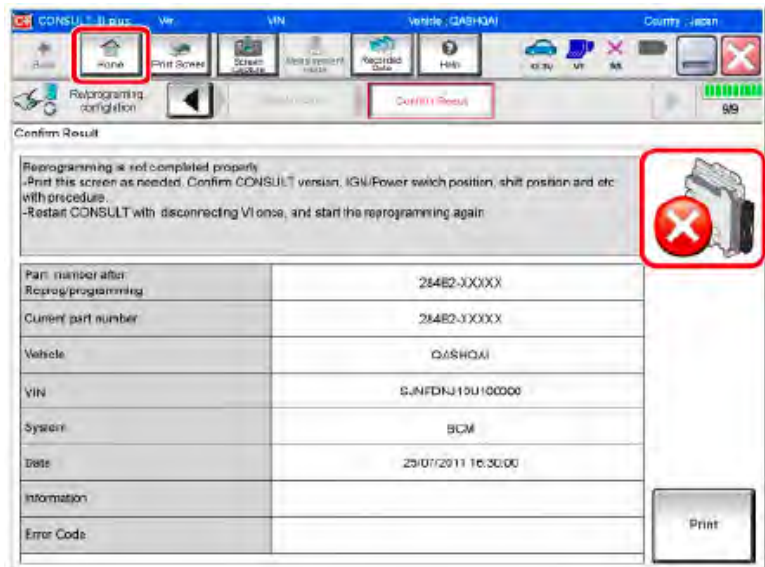
Figure 6

If reprogramming does not complete and the “X” icon displays as shown in Figure 6:

- Check battery voltage (12.0 – 15.5 V).
- CONSULT A/C adapter is plugged in.
- Ignition is ON, engine OFF.
- Transmission is in Park.
- All C-III plus / VI cables are securely connected.
- All C-III plus updates are installed.
- **Select Home, and restart the reprogram procedure from the beginning.**
