# SERVICE BULLETIN

EC17-029

September 21, 2017

## 2017 NV; MIL ON WITH DTC P0527 STORED

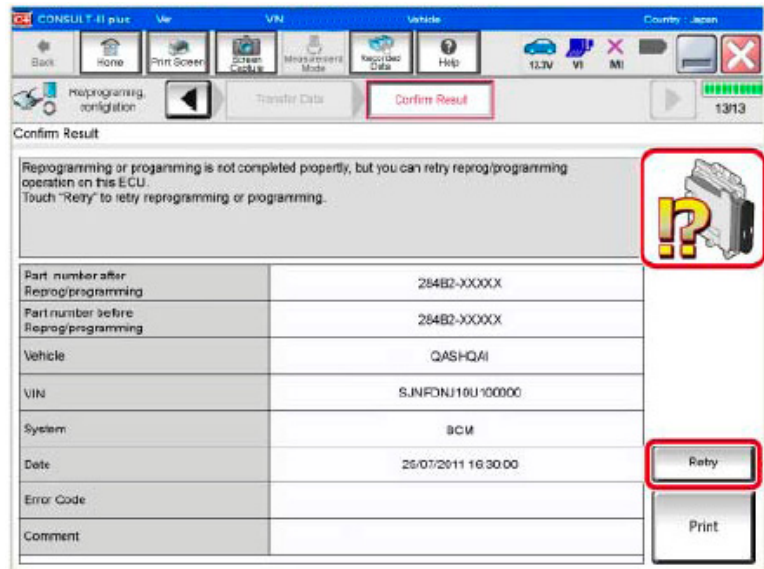
Figure 5

If reprogramming does not complete and the “!” icon displays as shown in Figure 5:

- Check battery voltage (12.0–15.5 V).
- Ignition is ON, engine OFF.
- External Bluetooth® devices are OFF.
- All electrical loads are OFF.
- **Select retry and follow the on screen instructions.**
- **“Retry” may not go through on first attempt and can be selected more than once.**

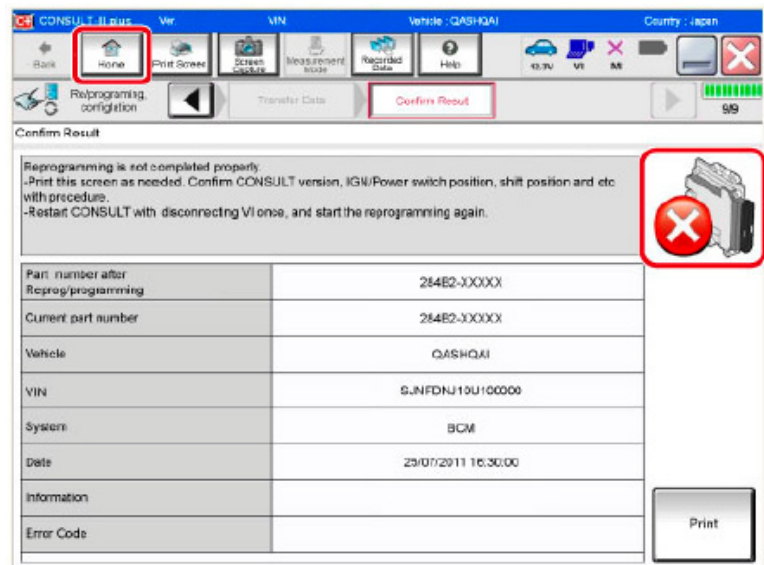
Figure 6

If reprogramming does not complete and the “X” icon displays as shown in Figure 6:

- Check battery voltage (12.0 – 15.5 V).
- CONSULT A/C adapter is plugged in.
- Ignition is ON, engine OFF.
- Transmission is in Park.
- All C-III plus / VI cables are securely connected.
- All C-III plus updates are installed.
- **Select Home, and restart the reprogram procedure from the beginning.**
