SERVICE BULLETIN

Classification: RA17-004	Reference: NTB17-107	Date: September 26, 2017
-----------------------------	-------------------------	-----------------------------

2016-2017 MAXIMA AND ALTIMA; POP/CLUNK NOISE FROM REAR WHEN DRIVING OVER BUMPS

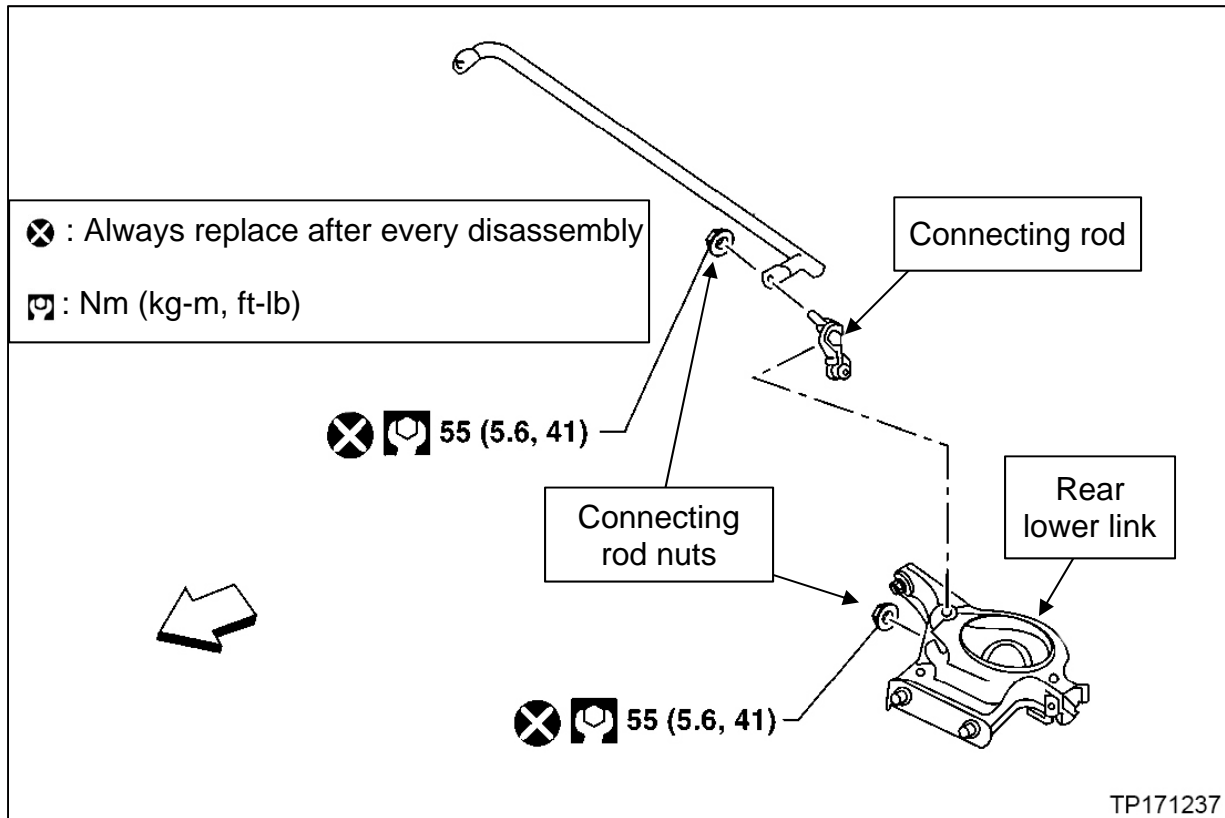
Figure 1

A pop or clunk noise from the rear of the vehicle, especially when driving over bumps,

The rear suspension connecting rod nuts are found to be loose on the left and/or right side.

Replace the connecting rod and nuts on the left and/or right side with the ones listed in Parts Information.

1. Remove the connecting rod nuts on the affected side.
2. Remove the connecting rod.
3. Install the new connecting rod and nuts.
 - New connecting rods and nuts are listed in the Parts Information.
