Subject: TIB 34-060 - T680/T880 Cab Fuse Box Enhancement

# **Technical Information Bulletin**

#### 34-060

T680/T880 Trailer Power Polyfuse Overheating

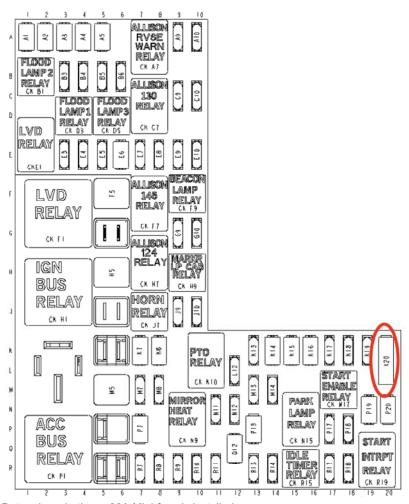
The Cab fuse block may have a polyfuse switch installed in the Trailer Hot line/Trailer Power circuit (position K20) on vehicles equipped with a seventh wire Trailer Power option.

- 1. Locate the Power Distribution Center (Fuse Box) behind the kick panel close to the driver's left foot.
- Locate the Trailer Power fuse position K20.

- Determine whether a 30A Mini-fuse is installed.
  - If a 30A Mini-fuse is installed, do not replace it.

If a Poly-fuse is installed, replace it with a 30A Mini-fuse.
