T880 SBFA and all W9 MY2017 MX-11 REPTO Idler Gear Hub PRE-CAMPAIGN BULLETIN

E202

Non-Safety Campaign – Some MY 2017 W900 chassis with PACCAR MX-11 engines with the REPTO option are experiencing premature failure of the REPTO idler hub and gear.

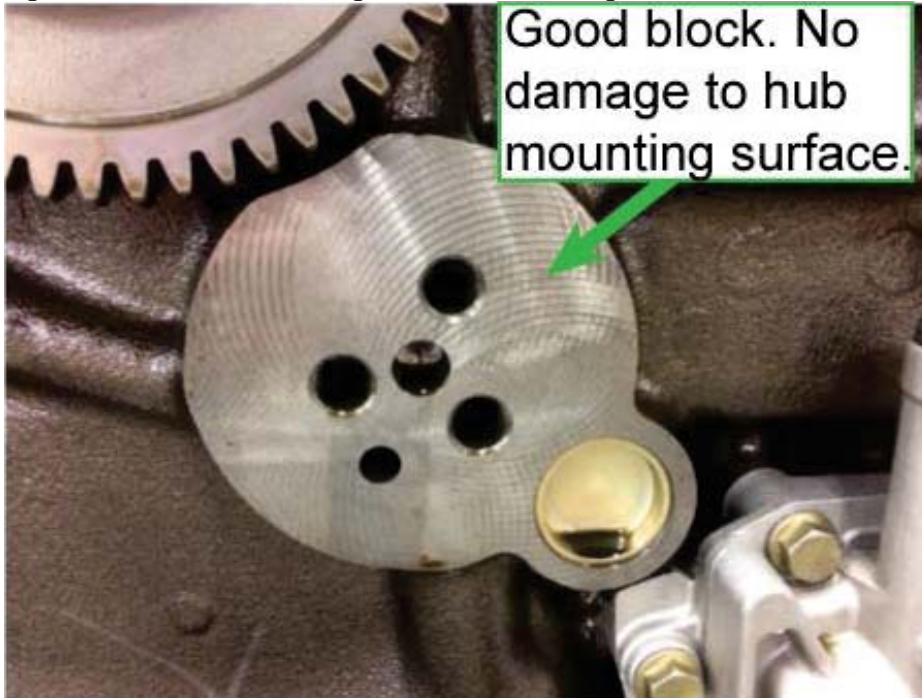
Figure 1 Good block. No damage to the hub mounting surface.

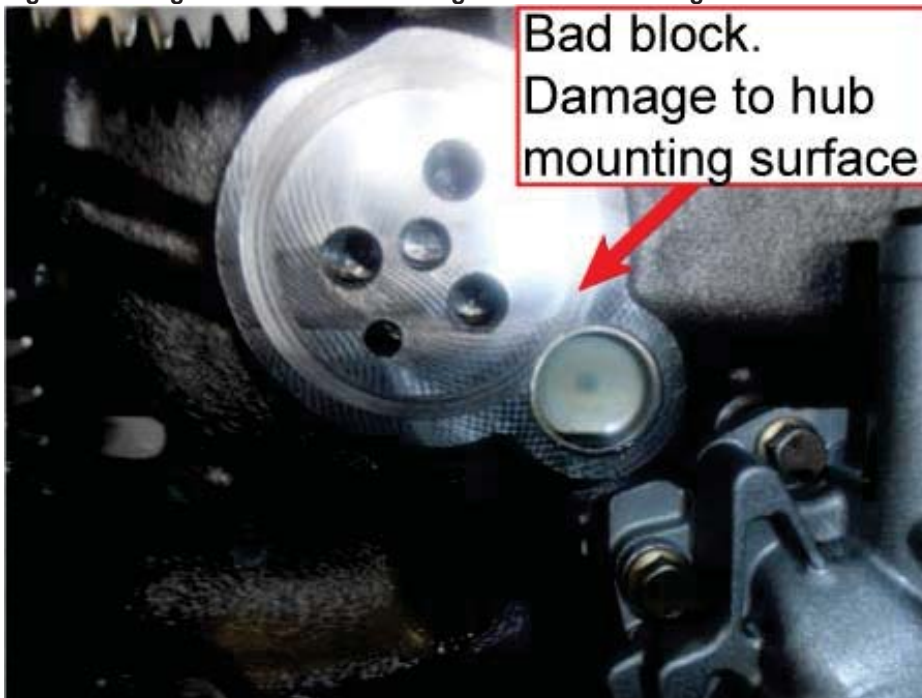
Figure 2 Damaged block. Visible scoring to the hub mounting surface.

2. Use the instructions in Service Manual [KM813022 One-Piece Rear Engine Mount Installation](#) (or Peterbilt [bulletin 8-11](#)) when you install the motor mounts.
3. Inspect the engine block for damage. The following figures show examples of an undamaged hub mounting surface and a damaged hub mounting surface. Take a clear and in-focus photo of the block to be submitted with the warranty claim.
 - If no damage is found, install a new hub and gear with new bolts.
 - If damage is found, start a SupportLink case and contact your RESM.
