T880 SFFA MY2017 MX-11 REPTO Idler Gear Hub PRE-CAMPAIGN BULLETIN

E203

Non-Safety Campaign – Some MY 2017 T880S chassis with PACCAR MX-11 engines with the REPTO option are experiencing premature failure of the REPTO idler hub and gear.

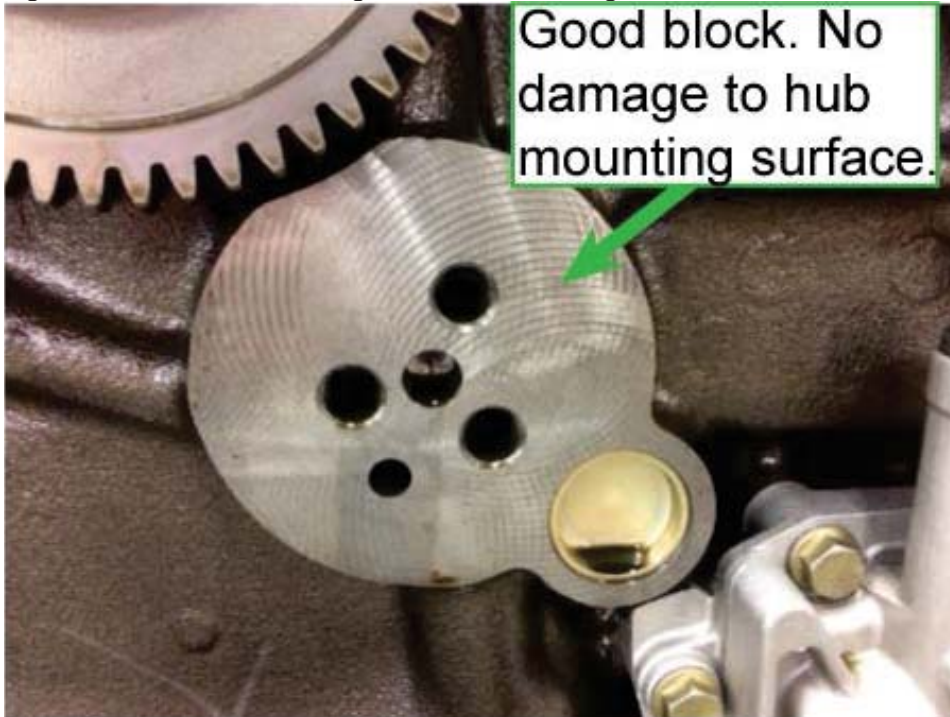
Figure 1 Good block. No damage to the hub mounting surface.

1. Use the instructions in Service Manual [KM813022 One-Piece Rear Engine Mount Installation](#) (or Peterbilt [bulletin 8-11](#)) when you install the motor mounts.
2. Inspect the engine block for damage. The following figures show examples of an undamaged hub mounting surface and a damaged hub mounting surface. Take a clear and in-focus photo of the block to be submitted with the warranty claim.
 - If no damage is found, install a new hub and gear with new bolts.
 - If damage is found, start a SupportLink case and contact your RESM.

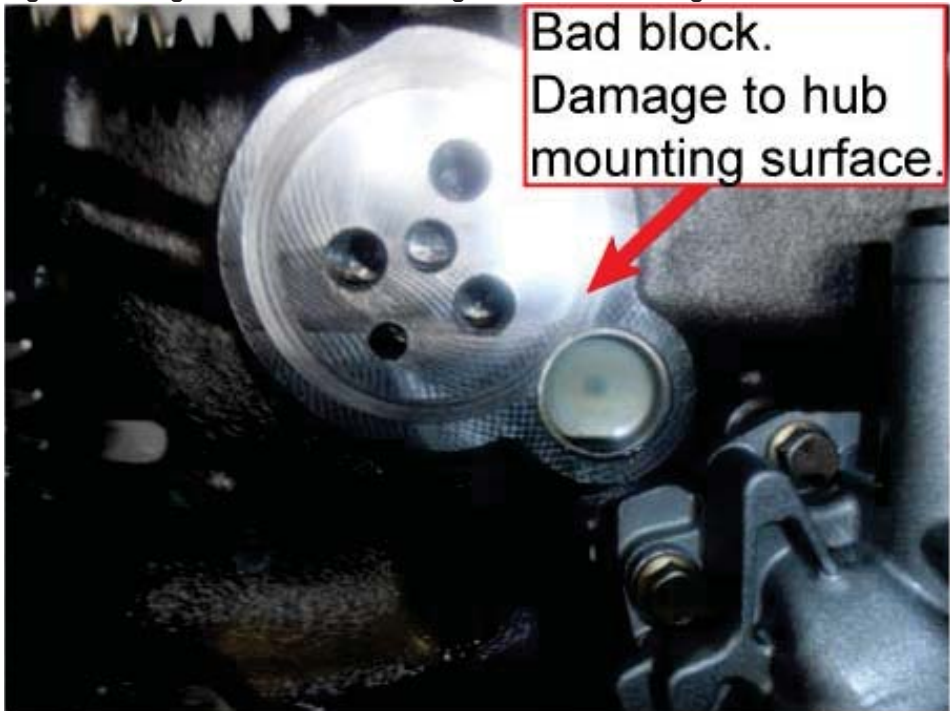
Figure 2 Damaged block. Visible scoring to the hub mounting surface.
