## **VOLUNTARY CAMPAIGN BULLETIN**

PARTICULATE SENSOR (PM) SENSOR  
REPLACEMENT/COLLECTION

CAMPAIGN NO: T1010  
DATE: 9-29-2017

**SUBJECT VEHICLES:** 17MY Conventional Trucks equipped with a J08 engine or 17MY Cab Over Engine (COE) Trucks equipped with a J05 engine.

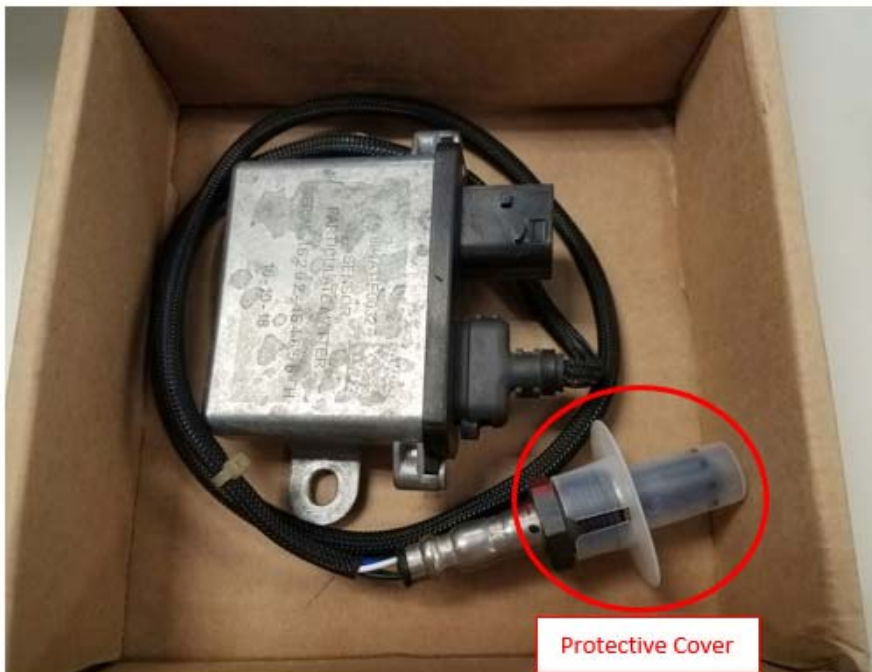
This VIN has been identified for this service campaign based on it's operating conditions. Engineering is requesting the particulate matter (PM) sensor be replaced for a reliability study. Beginning with 2017 model year, all Hino vehicles are equipped with a PM sensor near the exhaust exit. A ceramic sensing element is used in the PM sensor and can be damaged or broken if the sensor is dropped or impact occurs to the head of the sensor. If removal or replacement of the PM sensor is necessary, care should be taken with both the old and new sensors to prevent any damage or additional damage to the sensor. For this campaign, the PM sensor **MUST** be returned in the original box and the plastic protective cap installed. Please tag the part with the T1010 campaign number and return the part to Hino warranty.
