TT8045EN  
September, 2017  
Page 1 of 5

**SUBJECT:** Incorrect Calibration Setting for Primary Mode: Gears in Freightliner Custom Chassis Corporation (FCCC) Motorhome Chassis

**MODELS AFFECTED:** FCCC Motorhome Chassis MC, XBS, XCR, and XCS with 2500MH Series Transmission

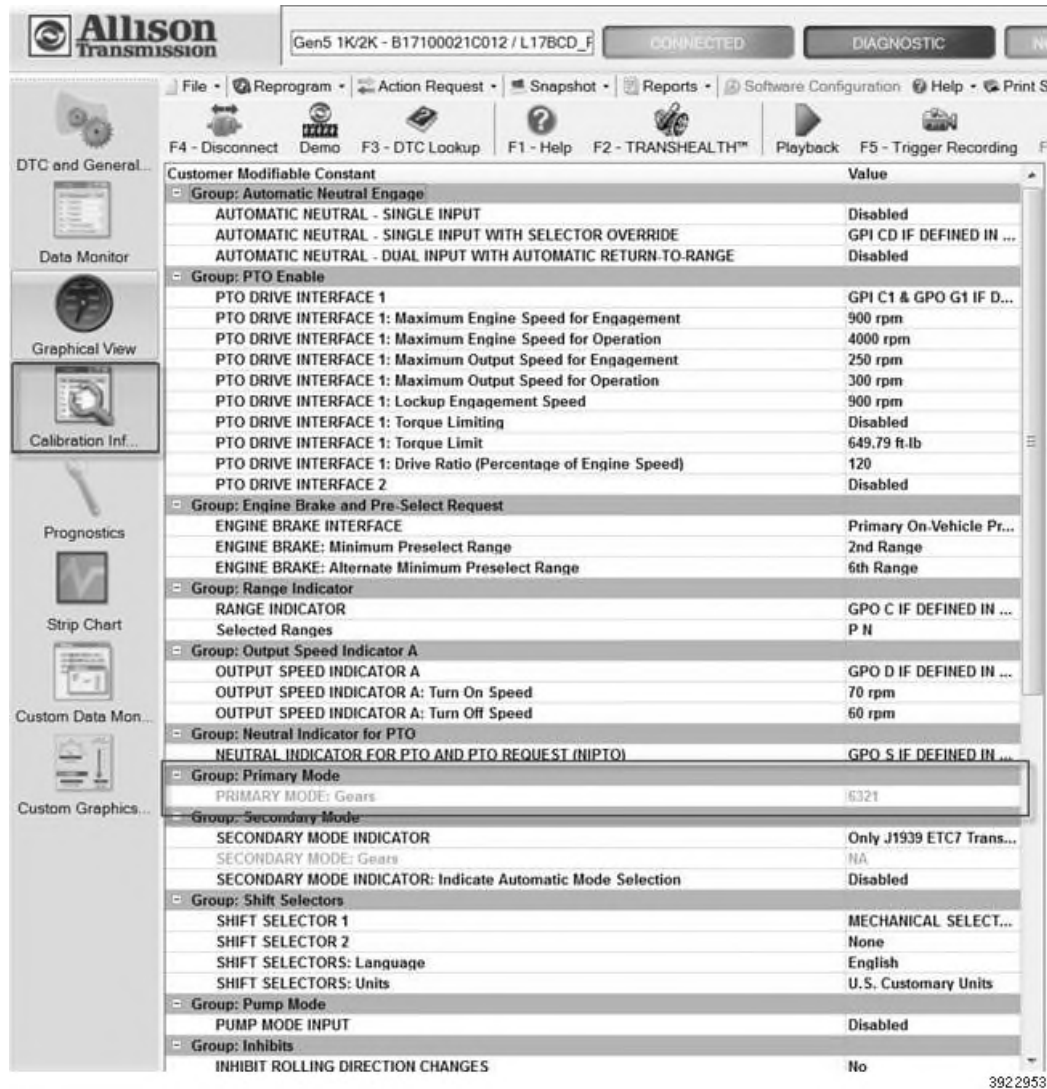
The Primary Mode: Gear calibration setting was incorrectly set to 6321 instead of the proper setting of 6M1 for 6-speed units in the affected population. 5-speed units were incorrectly set to 5321 instead of the correct setting of 5M1 for units in the affected population. This correction will allow preselect downshift, which allow an increase in engine speed, thus increasing the amount of engine braking.

Figure 1. Example of the Incorrect Setting Prior to Reflashing

Connect to the TCM using Allison DOC® to verify that the calibration parameters are set to correct settings. Once connected to the TCM, select the Calibration Information icon. Look at Group: Primary Mode to verify the correct setting. Figure 1 is an example of the incorrect setting prior to reflashing. Notice the Value for Primary Mode: Gears is set to 6321. The value may be 5321 on some of these motorhomes.

Using Allison DOC®, determine the current setting for the Primary Mode: Gears parameter. Once connected to the TCM, select the Calibration Information icon. Look at Group: Primary Mode to verify the current Primary Mode: Gears setting. Refer to Figure 1. Record the current setting for later reference. Using Allison TCM Reflash™, enter the TCM serial number into the 5th Generation Controls database. The system will correct the calibration settings for the specific TCM when the calibration is downloaded. Flash the TCM with the updated calibration.

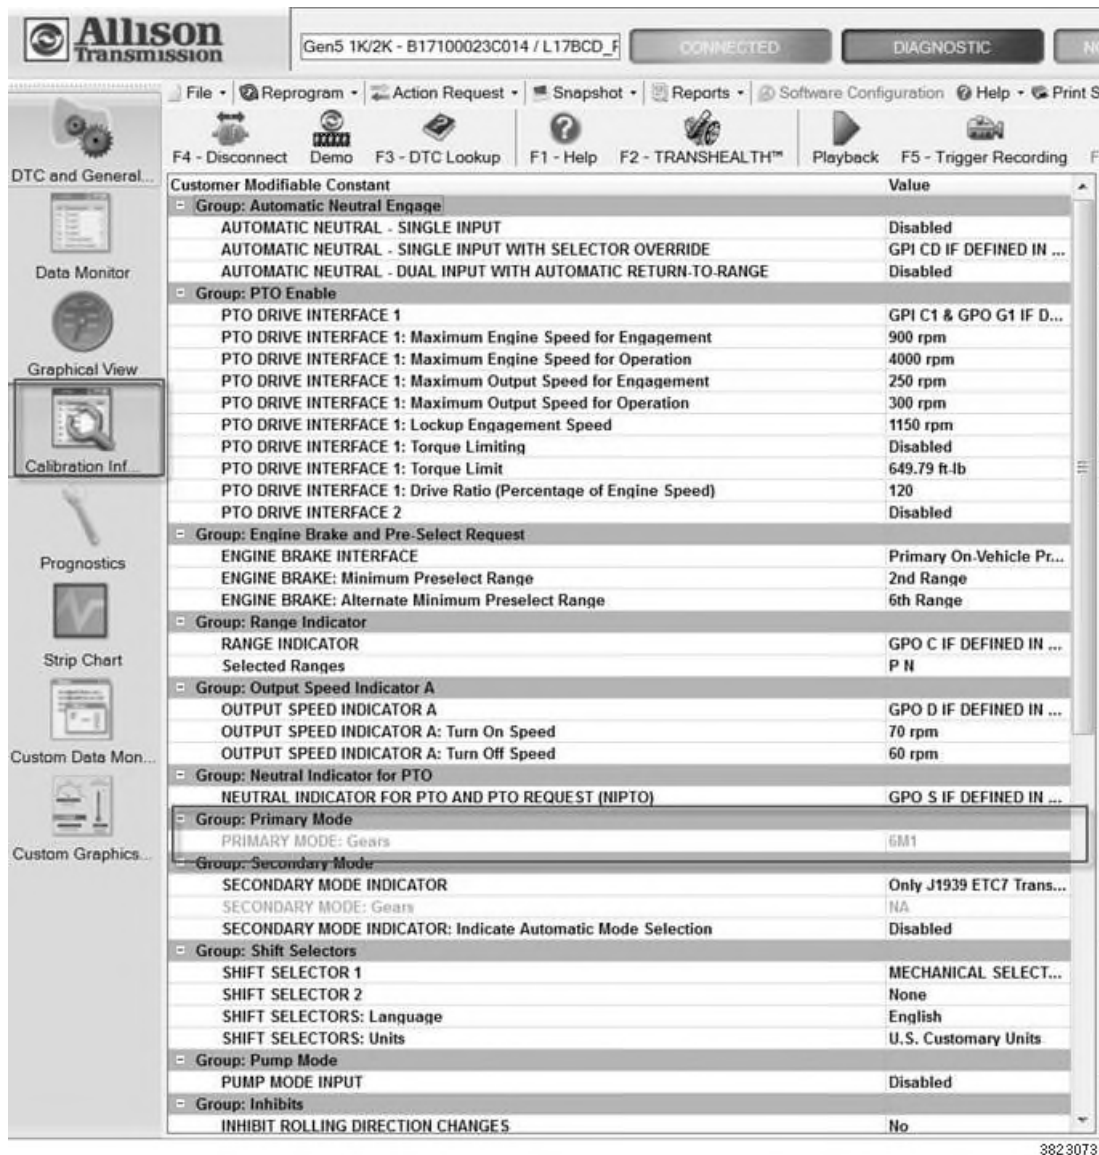
Figure 2 is an example of the correct setting after reflashing. Notice the Value for Primary Mode: Gears is set to 6M1. The value may be 5M1 on some of these motorhomes.

Figure 2. Example of the Correct Setting After Reflashing

**NOTE:** 6-speed transmission will use 6M1 and 5-speed transmissions will use 5M1.
