TT8009EN, Rev. A  
September, 2017  
Page 1 of 4

**SUBJECT:** Incorrect Engine Governed Speed Calibration Setting in Freightliner Custom Chassis Corporation (FCCC) Motorhomes

**MODELS AFFECTED:** 2500MH Transmissions in FCCC Motorhomes

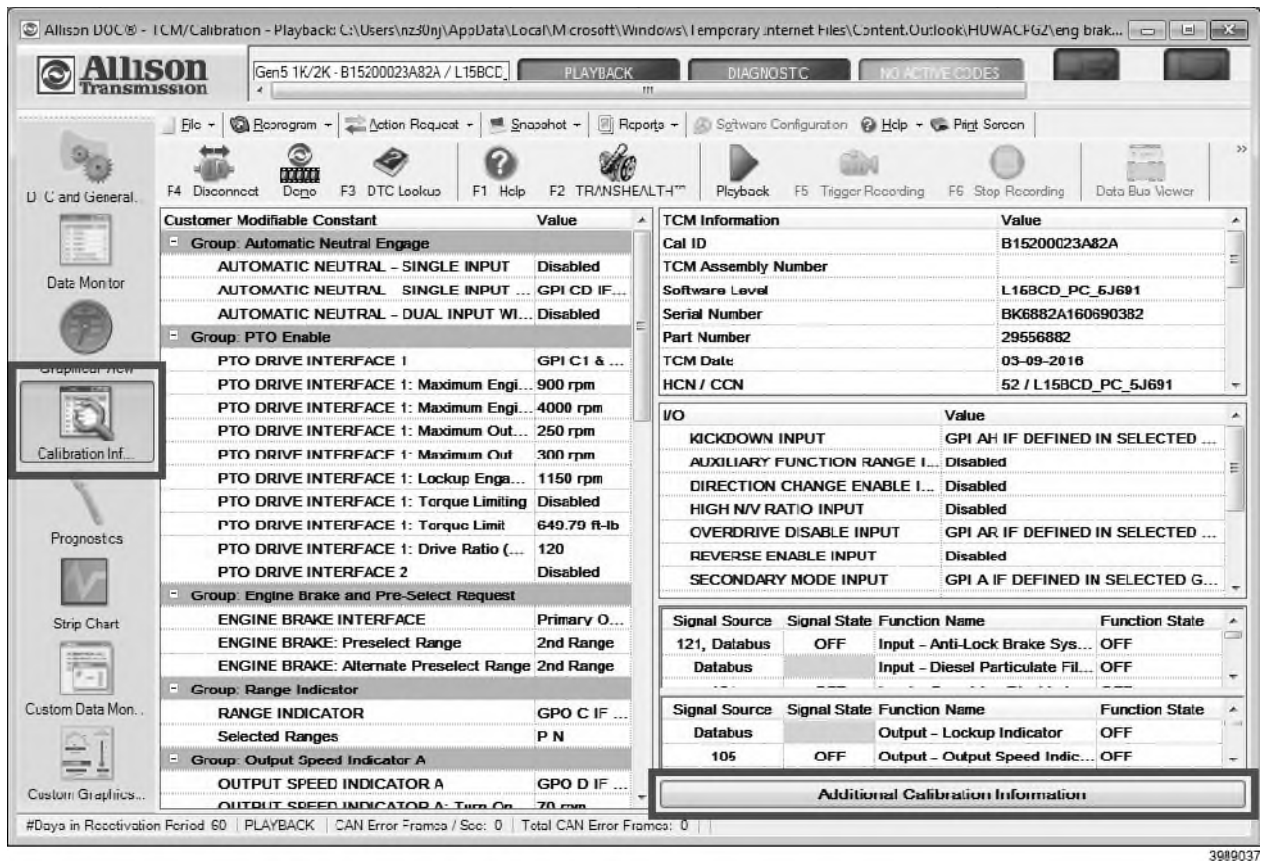
Figure 1. Calibration Information Tab

After reflashing the TCM, the technician should connect to the TCM using the Allison DOC® tool and look at the “Additional Calibration Information” located on the “Calibration Information” tab to verify that the following calibration parameters are set accordingly:

- Engine Governed Speed = 2600 rpm
- Primary Mode: Shift Speed = 2600 rpm
- Secondary Mode Shift Speed = 2200 rpm

After recalibrating, if the calibration parameters are not set as listed above, please call the Allison Technical Assistance Center (TAC) at 800-252-5283.
