SIL 2-EP-16, Rev. B  
September, 2017  
Page 1 of 16

**SUBJECT:** Replacing BCA (Bias-Control Assembly) Cards Inside of the Dual Power Inverter Module 2 (DPIM2)

**MODELS AFFECTED:** H 40/50 EP™ System Equipped with DPIM2

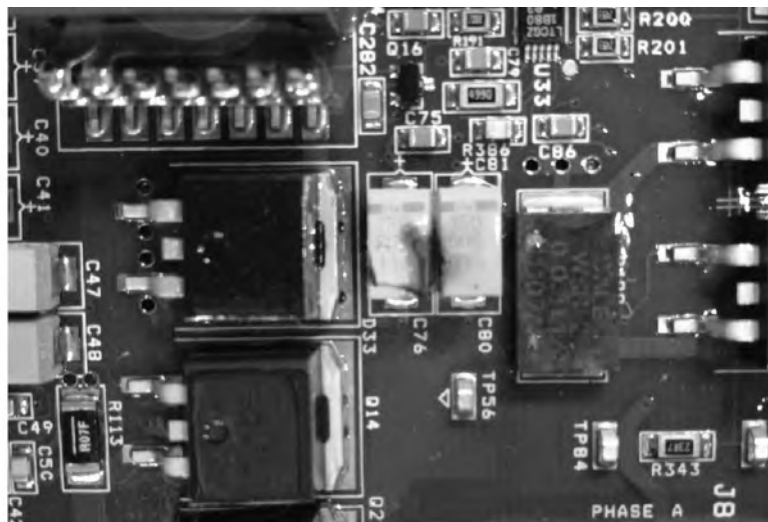
Figure 4. Damaged BCA Card

Condition: Fuse (10-40A) for 12V DPIM power or fuse (10A) for 12V DPIM wakeup fails whenever the DPIM 24-way connector is plugged in.

1. Check for smoke damage.
2. Inspect the BCA cards for damaged components (refer to Figure 4). Replace BCA card if damage is discovered and verify the repair. If damage is NOT found, continue troubleshooting per the below steps until the failed component is identified.
