Customer Satisfaction Program

17137 Battery Negative Cable Nut Under-Torqued

Reference Number: N172083050

Release Date: April 2017
Revision: 01

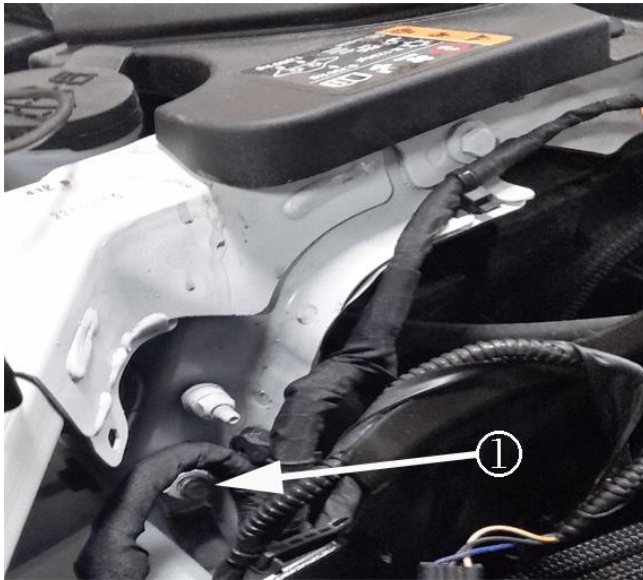
Condition	Certain 2017 model year Cadillac XT5 and GMC Acadia vehicles may have a condition in which the battery negative cable nut is under-torqued. In rare occurrences, this may lead to an increased potential for erratic, intermittent electrical symptoms including: door lock cycling, instrument cluster inoperative, unwanted downshifts, loss of radio display and audio, illumination of malfunction indicator lamp(s), driver information center messages, lights turning off, no start, loss of propulsion, and/or loss of power steering assist.
Correction	Torque the battery negative cable nut to specified torque.

2. Locate G105 (1).
3. Verify the nut for G105 is torqued to 22 Nm (16 lb ft).
 - If the nut for G105 is torqued to 22 Nm (16 lb ft), no further action is required.
 - If the torque on the nut for G105 is LESS than 22 Nm (16 lb ft), torque the nut to 22 Nm (16 lb ft).
4. Remove the fender covers and close the hood.
