Service Update

17056 Loss of Seat Belt Chime

Reference Number: N162063280

Release Date: April 2017

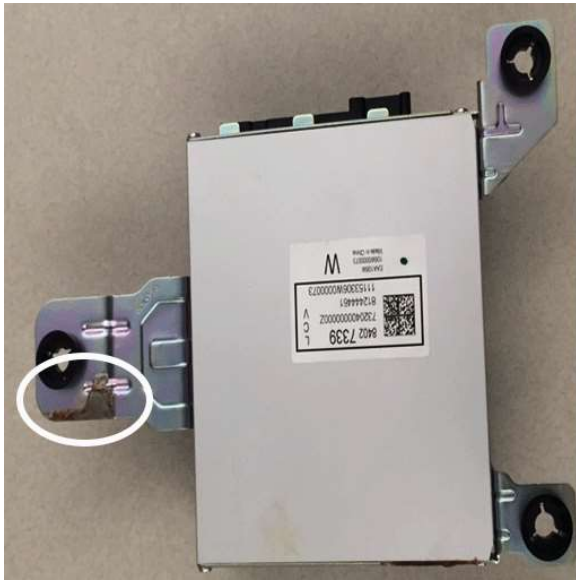
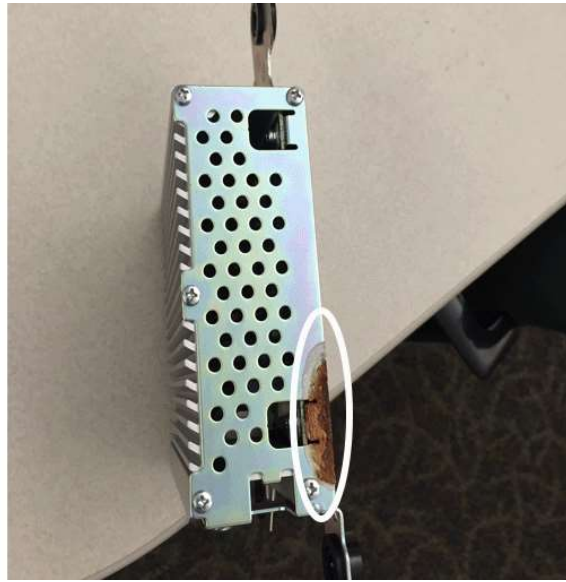
4753962

| Condition | Certain 2017 model year GMC Acadia vehicles may have a condition in which condensation from the HVAC module can leak into the housing of the active noise cancellation (ANC) module. This can lead to electronic failures inside the ANC module such as erratic audio from the speakers, popping noises, intermittently inoperative, to complete loss of audio. |

2. Inspect the ANC module for evidence of water damage.
 - If there is NOT evidence of water damage, proceed to the next step.
 - If there is evidence of water damage, replace the ANC module and proceed to the next step.
