# Customer Satisfaction Program

## 16147 Center High Mount Stop Lamp Water Leak

Reference Number: N162064340

Release Date: April 2017  
Revision: 01

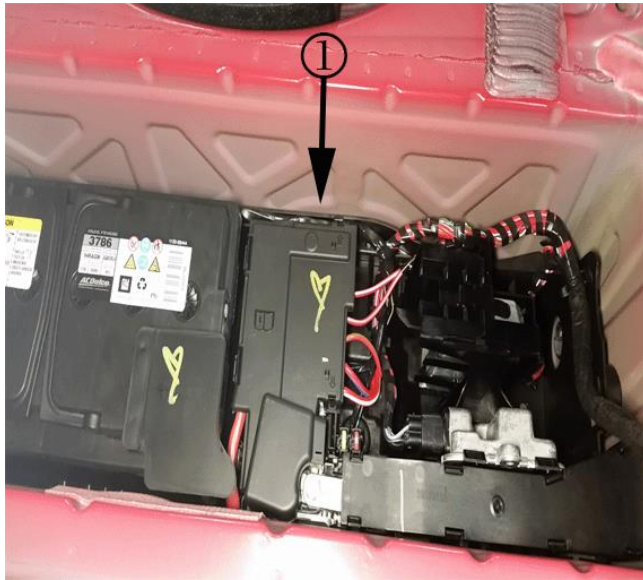
3. Inspect the battery tub (1) for the evidence of a water leak or standing water.
  - If evidence of a water leak or standing water is NOT found, proceed to step 14.
  - If evidence of a water leak or standing water is found, proceed to the next step.

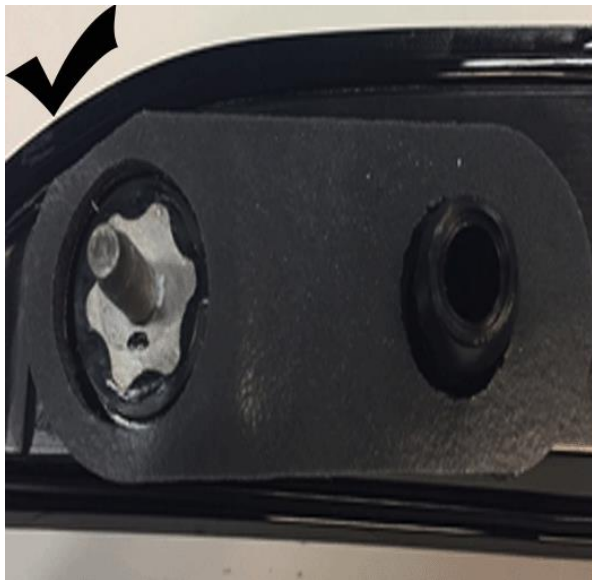
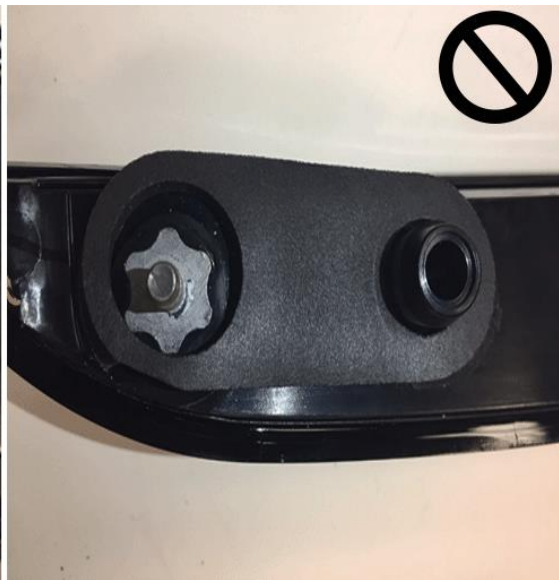
4641386

**Caution:** Make sure the gasket is centered and does NOT ride up the fastener joint. A water leak may occur if the gasket is not installed properly. Refer to the pictures above.

28. Install NEW gaskets on the high mount stop lamp.
