Product Emission Recall

17166 Malfunction Indicator Lamp (MIL) Illuminated - Connector Unseated

Reference Number: N172094630

Release Date: April 2017
Revision: 00

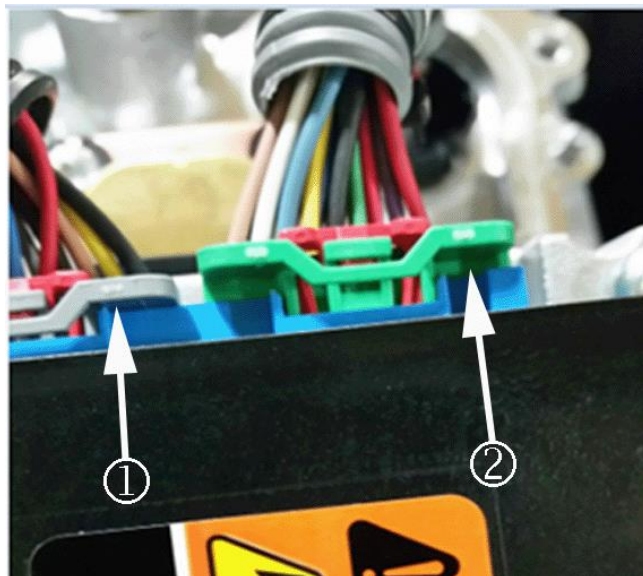
4782687

Note: The connector position assurance tab (CPA) may be fully engaged, but the connector may NOT be fully seated. In the picture above, the gray connector (1) is fully seated and the green connector (2) is NOT.

4. Ensure the drive motor power inverter module electrical connectors are fully seated.
 - If BOTH of the drive motor power inverter module electrical connectors are fully seated, proceed to step 10.
