Bulletin No.: 15285D  
Date: April 2017

# Service Bulletin

**SUBJECT: Special Coverage Adjustment - Excessive Engine Oil Consumption**

**MODELS: 2011 Chevrolet Equinox  
2011 GMC Terrain  
Equipped with 2.4L Engine (LAF)**

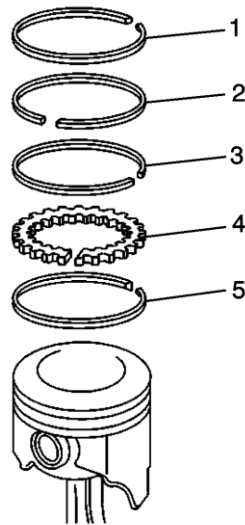
2146346

Some 2011 model year Chevrolet Equinox and GMC Terrain vehicles, equipped with a 2.4L engine, may exhibit excessive engine oil consumption (less than 2,000 miles per quart of engine oil), due to piston ring wear. If this condition is present, the oil can light may illuminate on the instrument panel or the following message may appear in the Driver Information Center: "Oil Pressure Low – Stop Engine".

- Engine Replacement
  - Technical Service Bulletin 13-06-01-003F placing a special emphasis on the PCV orifice between the #2 and #3 intake runners.
  - Piston and Connecting Rod Disassemble
  - Piston and Connecting Rod Assemble
  - Piston, Connecting Rod, and Bearing Installation (LAF, LAT, LE5, LE9, LEA, or LUK)
1. Remove the engine from the vehicle.
  2. Remove the pistons from the engine.
  3. Remove the pistons from the connecting rods.
  4. Discard the pistons and piston rings.

5. Install the new piston rings onto the new pistons.
6. Install the new pistons onto the connecting rods.
7. Assemble the engine.
8. Install the engine into the vehicle.
