MODEL  
2014-2016MY  
Forte (YD)

NUMBER  
157 (Rev 1, 09/26/2017)

## TECHNICAL SERVICE BULLETIN

SUBJECT: COMBINATION TSB / SERVICE ACTION: ENGINE  
VIBRATION AT IDLE (SA312)

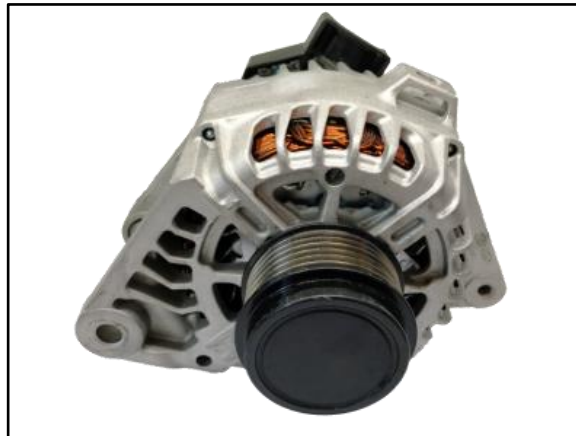
This bulletin provides the procedure to replace the alternator pulley on some 2014-2016MY Forte (YD) vehicles with 1.8L and 2.0L Nu engines, produced from February 18, 2013 through July 18, 2016, which may experience an unusual engine vibration at idle that is sometimes more prevalent under certain electrical loads. To correct this concern, replace the existing alternator pulley with an improved part. Before conducting the procedure, verify that the vehicle is included in the list of affected VINs.
