GROUP ENG	MODEL 2016-2017MY Optima (JF) 2017MY Sportage (QL)
	NUMBER 175	DATE August 2017

TECHNICAL SERVICE BULLETIN

SUBJECT: SERVICE ACTION: E-CVVT COVER INSPECTION
AND MOTOR PLUG REPLACEMENT (SA305)

P0010: 'A (Intake)' Camshaft Position Actuator Circuit (Bank 1)

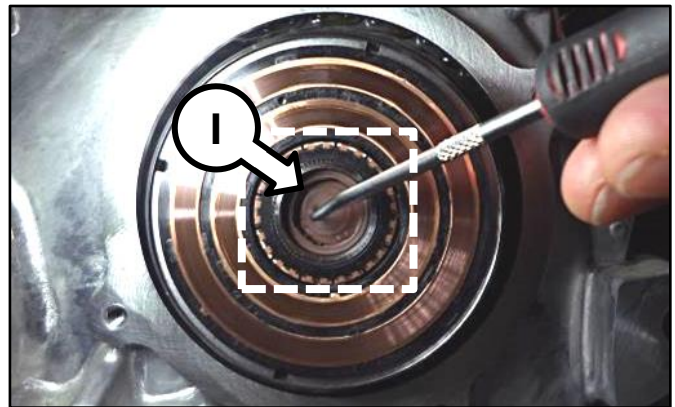
8. Remove the motor plug (I) by carefully breaking the center with a straight pick.

Wipe off any oil leakage when removing the motor plug.
Cover the motor shaft inlet with a clean shop towel.

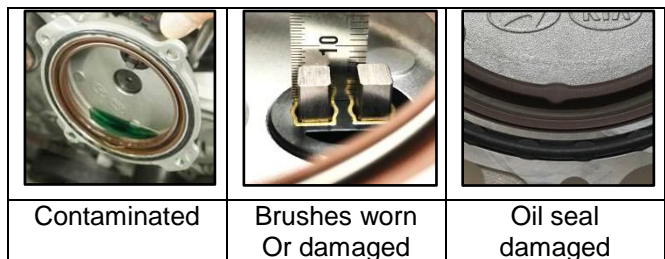
10. Inspect the E-CVVT cover.

- If there is no sign of oil leakage, contamination, and/or damage, replace only the cover O-ring.
- If there is an oil leak, contamination, and/or damage, replace the cover.

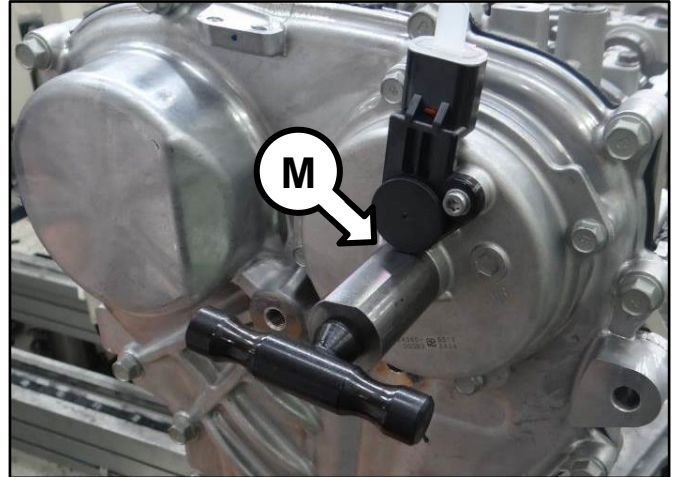
13. Install the new motor plug (M) by using the SST "A" of Required Tools.

Insert the plug onto the SST and then insert the SST into the E-CVVT cover opening.

Do not apply impurities (oil, cleaners) on the motor plug.
