GROUP <b>ENG</b>	MODEL <b>2016-2017MY Optima (JF, JFa), Sorento (UMa) 2017MY Sportage (QL)</b>
	NUMBER <b>175 (Rev 1, 09/20/2017)</b>	DATE <b>August 2017</b>
<b>TECHNICAL SERVICE BULLETIN</b>		
SUBJECT: <b>SERVICE ACTION: E-CVVT COVER INSPECTION AND MOTOR PLUG REPLACEMENT (SA305)</b>

This bulletin provides information regarding the inspection and/or replacement of the E-CVVT cover or O-ring and replacement of the motor plug on some 2016-2017MY Optima (JF, JFa), 2016-2017MY Sorento (UMa), and 2017MY Sportage (QL) vehicles, equipped with 2.4L GDI or 2.0T-GDI, which may exhibit a malfunction indicator light (MIL) ON with DTC P001000 and/or oil leakage in the E-CVVT motor plug of applicable vehicles. Follow the procedure outlined in this bulletin to inspect and/or replace the E-CVVT cover or O-ring and replace the motor plug to correct the concern. Before conducting the procedure, verify that the vehicle is included in the list of affected VINs.

## SERVICE ACTION: E-CVVT COVER INSPECTION AND MOTOR PLUG REPLACEMENT (SA305)

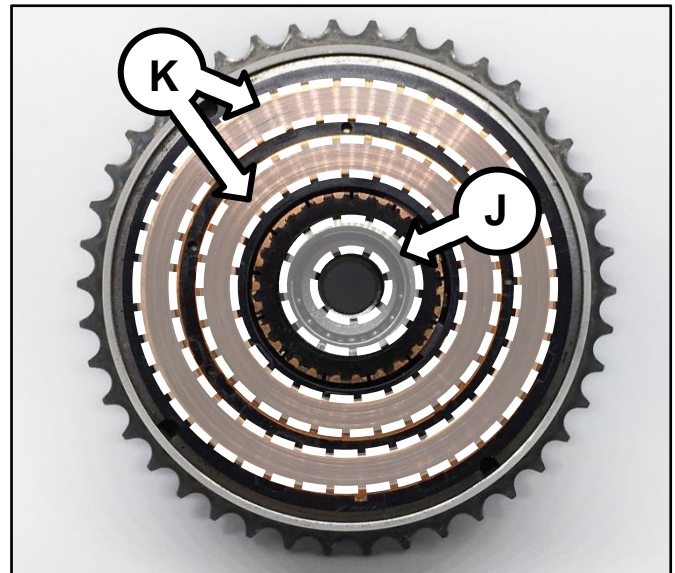
9. Using brake cleaner, spray directly on the motor plug assembly seat (J) inside the motor shaft and clean. Spray brake cleaner on a shop towel to wipe and clean the commutators (K).

Remove any residual oil or fluid in the motor shaft to prevent plug from becoming displaced.

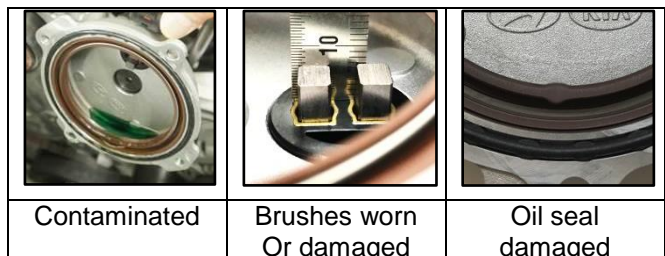
10. Inspect the E-CVVT cover.

- If there is no sign of oil leakage, contamination, and/or damage, replace only the cover O-ring.
- If there is an oil leak, contamination, and/or damage, replace the cover.
