GROUP ENG	MODEL 2017MY Forte (YDm) 2.0L MPI
	NUMBER 176	DATE September 2017
TECHNICAL SERVICE BULLETIN		
SUBJECT: SERVICE ACTION: ELECTRIC THERMOSTAT REPLACEMENT (SA308)

This issue number is SA308.

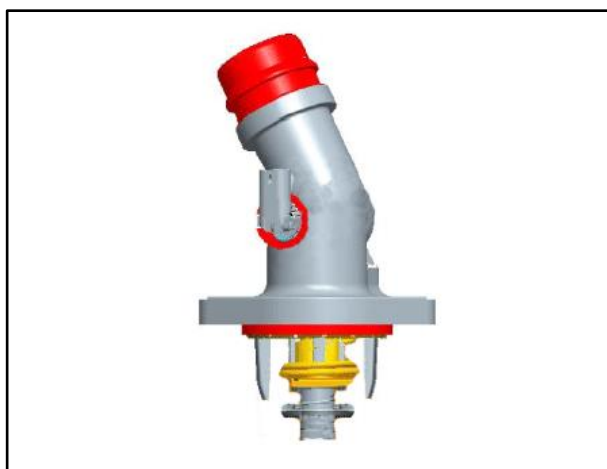
Electric Thermostat

This bulletin provides the procedure to replace the electric thermostat on 2017MY Forte (YDm) 2.0L MPI vehicles, produced from May 23, 2016 through March 15, 2017, which may exhibit a Malfunction Indicator Lamp (MIL) ON with DTC P0128. This may be due to engine coolant intrusion through the thermostat Teflon® seal resulting in abnormal operation of the thermostat. To correct this concern, replace the thermostat assembly. Before conducting the procedure, verify that the vehicle is included in the list of affected VINs.

DTC P0128 – Coolant Thermostat (below Thermostat Regulating Temperature)
