External Body Service Lift Bolt Installation for Meridian FEL

Date: August 30, 2017
Bulletin Name: FEL-TSIB-050
Models: Meridian FEL 78
Model Year: 2015-2017
Units Affected: Vehicles with external body service lifts

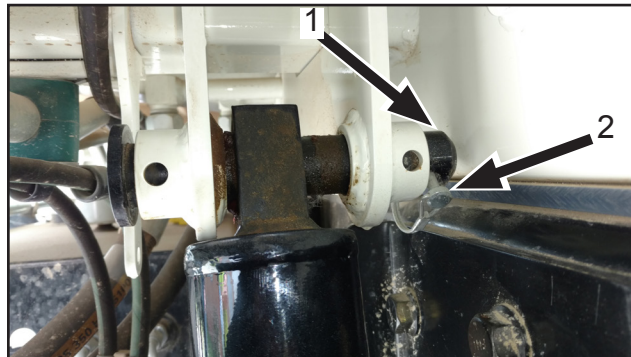
Figure 2

3. Inspect if the cylinder pin (Figure 2, Item 1) is installed for the upper cylinder assembly. (Inspect both service lift cylinder assemblies.)
 - If the cylinder pin is missing or damaged, order the replacement part before proceeding with this installation instruction. Vehicle cannot be used in service until all parts are installed.
4. Remove the round snapper pin (Figure 2, Item 2) from the upper pin on the body lift cylinder. Discard the snapper pin.

5. Install replacement cylinder pin as needed.
