SERVICE BULLETIN

Classification: AT17-001	Reference: NTB17-016	Date: February 17, 2017
-----------------------------	-------------------------	----------------------------

2017 ARMADA; SHIFT SHOCK WITH DOWN SHIFT

APPLIED VEHICLES: 2017 Armada (Y62)
APPLIED VIN: Built before JN8AY2N(**)H9 003181
APPLIED DATE: Built before October 31, 2016

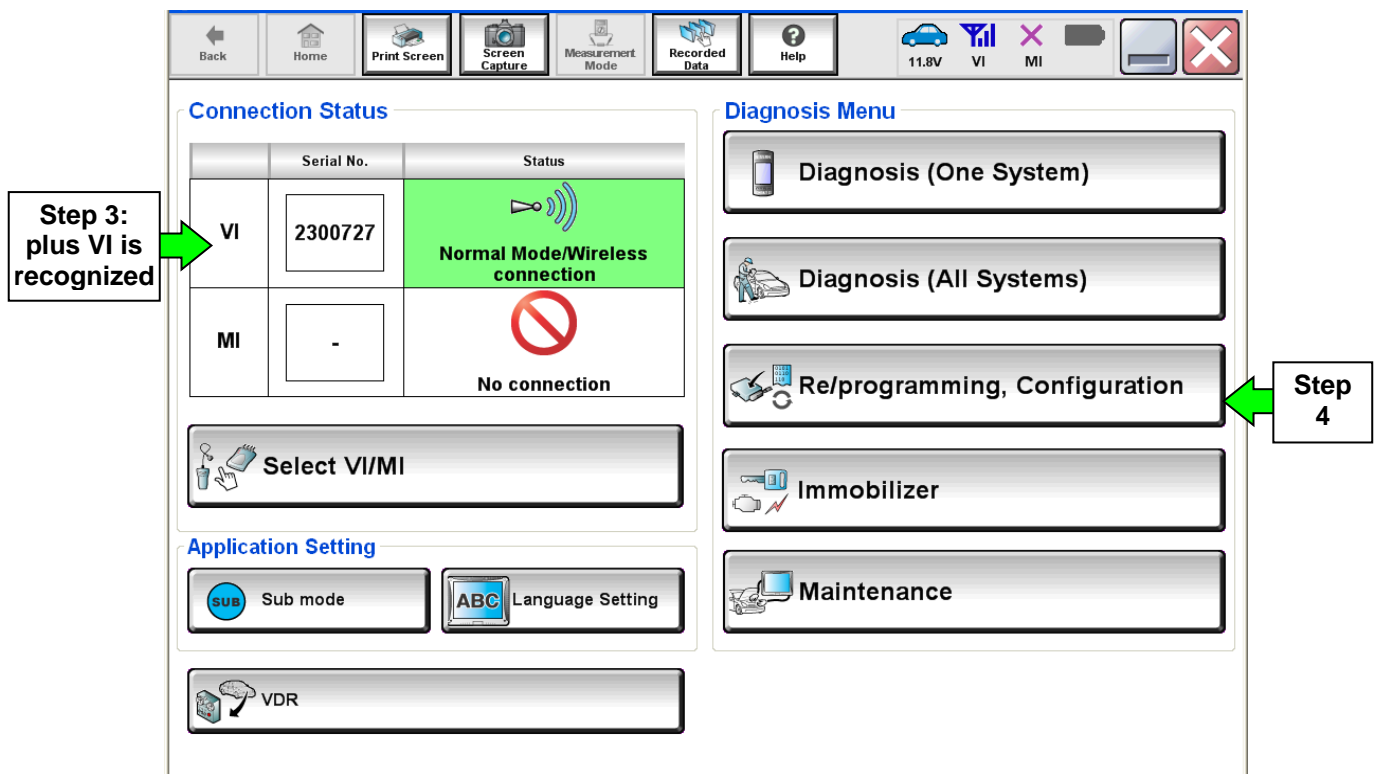
Figure 1

1. Connect the plus VI to the vehicle and open/start CONSULT-III plus.
2. Confirm the ignition is ON, with engine OFF.
3. Confirm the plus VI is recognized.
 - The **Serial No.** will display when the plus VI is recognized.
4. Select **Re/programming, Configuration**.

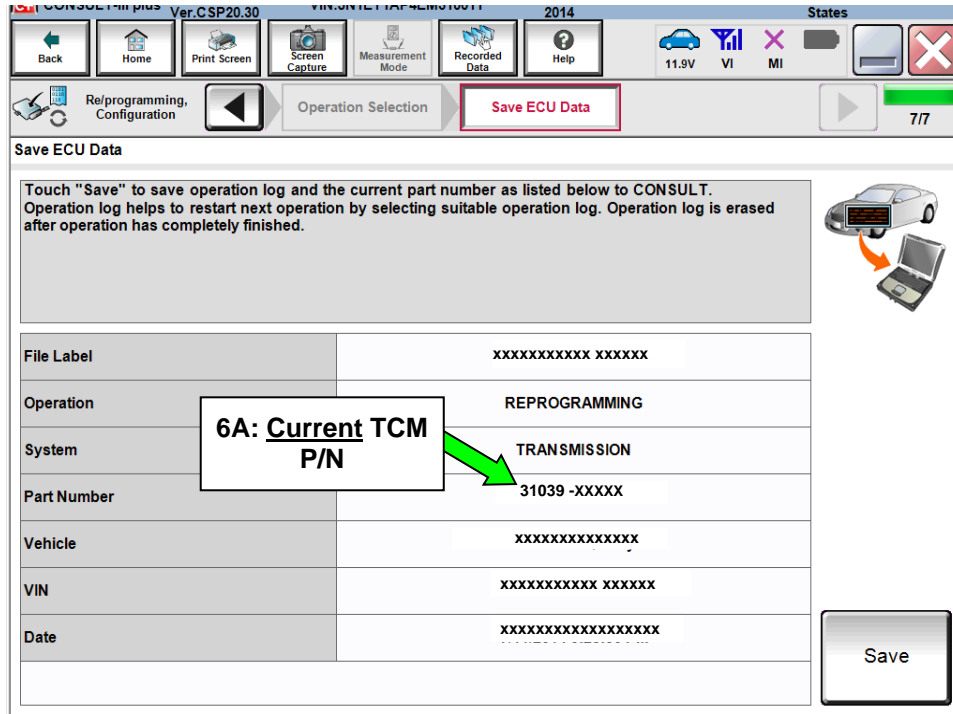
Figure 2

6. When you get to the screen shown in Figure 2, confirm this bulletin applies as follows.

A. Find the TCM **Part Number** and write it on the repair order.

B. Compare the P/N you wrote down to the numbers in the **Current TCM Part Number** column in **Table A** below.

- If there is a match, continue with the reprogramming procedure.
- If there is not a match, this bulletin does not apply. Refer to ASIST for further diagnosis.

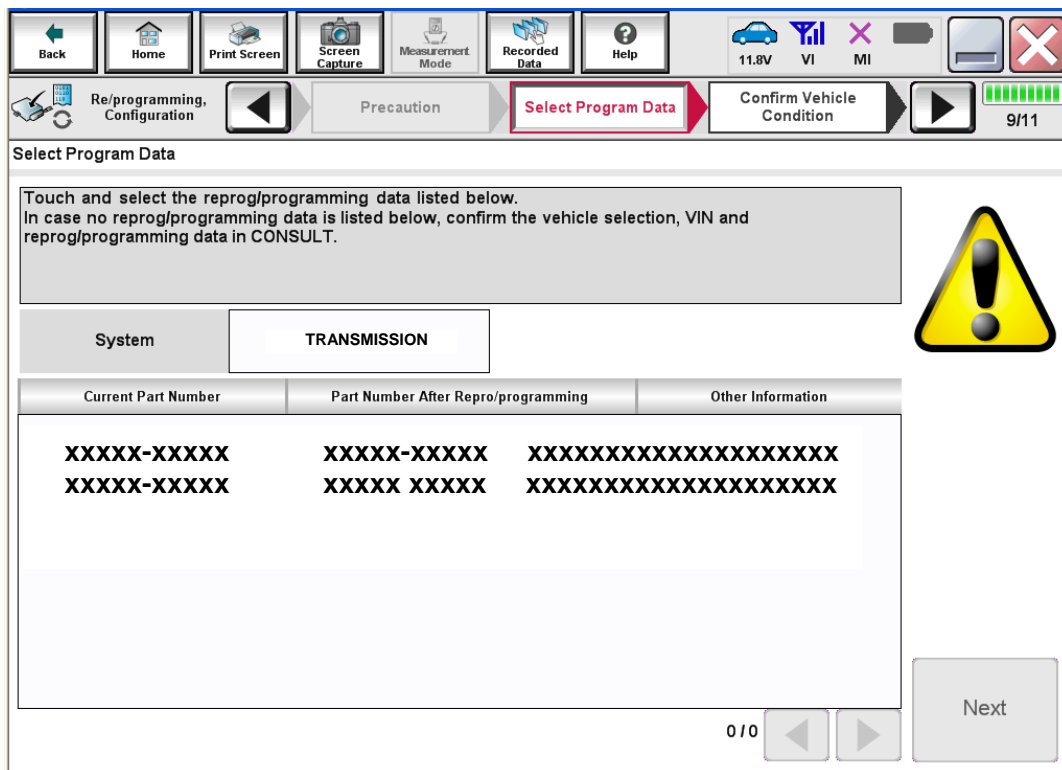
- In some cases, more than one new P/N for reprogramming is available.
 1. If more than one new P/N is available, the screen in Figure 3 displays.
 2. Select and use the reprogramming option that **does not** have the message “Caution! Use ONLY with NTBXX-XXX”.
- If you get this screen and it is blank (no reprogramming listed), it means there is no reprogramming available for this vehicle. Close C-III plus and refer back to ASIST for further diagnosis.

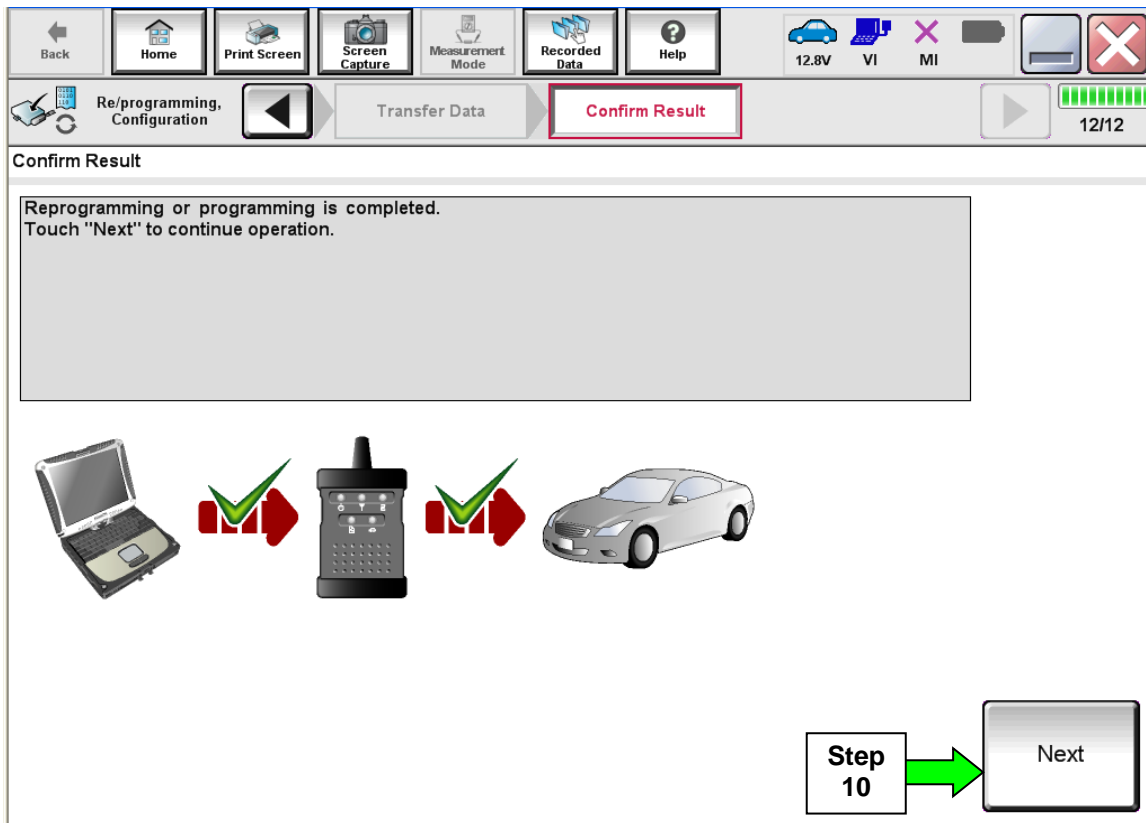
8. When the screen in Figure 4 displays, reprogramming is complete.

NOTE: If the screen in Figure 4 does not display (indicating that reprogramming did not complete), refer to TCM recovery on the next page.

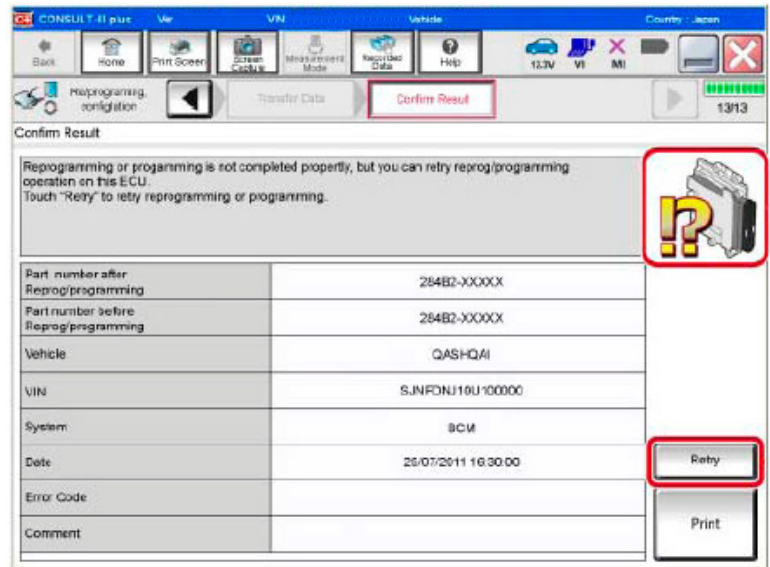
Figure 5

If reprogramming does not complete and the “!” icon displays as shown in Figure 5:

- Check battery voltage (12.0 - 15.5 V).
- Ignition is ON, engine OFF.
- External Bluetooth® devices are OFF.
- All electrical loads are OFF.
- **Select retry and follow the on screen instructions.**
- **“Retry” may not go through on first attempt and can be selected more than once.**

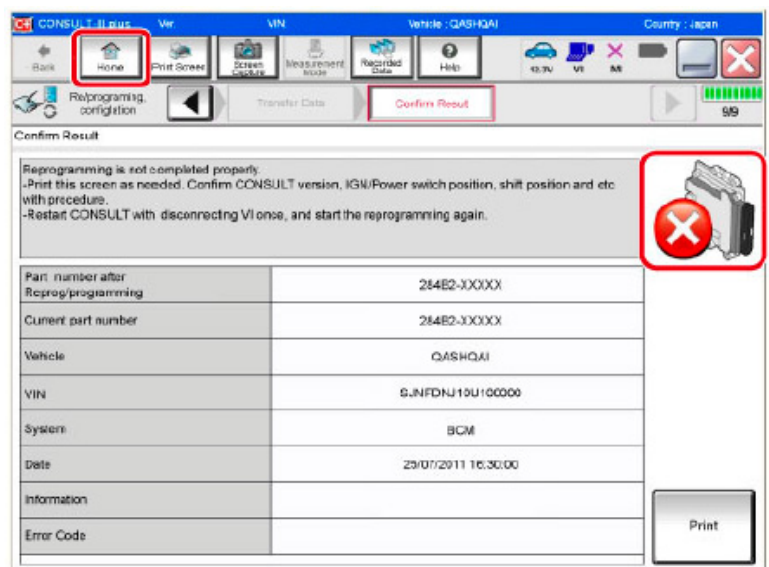
Figure 6

If reprogramming does not complete and the “X” icon displays as shown in Figure 6:

- Check battery voltage (12.0 - 15.5 V).
- CONSULT A/C adapter is plugged in.
- Ignition is ON, engine OFF.
- Transmission is in Park.
- All C-III plus / VI cables are securely connected.
- All C-III plus updates are installed.
- **Select Home, and restart the reprogram procedure from the beginning.**

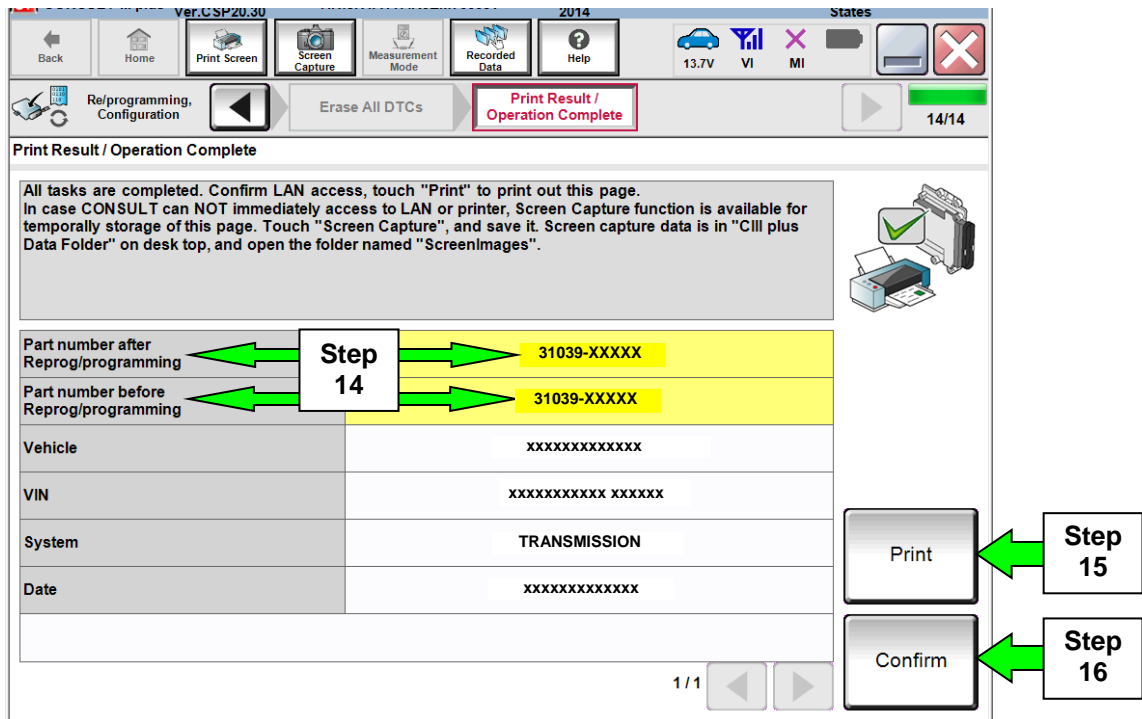
11. Follow the on-screen instructions to **Confirm Shift Lever Position Display**.
12. Follow the on-screen instructions to **Erase DTCs**.
13. When the entire reprogramming process is complete, the screen in Figure 7 will display.
14. Verify the before and after part numbers are different.
15. Print a copy of this screen (Figure 7) and attach it to the repair order for warranty documentation.
16. Select **Confirm**.
