SERVICE BULLETIN

| Classification: EC17-008 | Reference: NTB17-021 | Date: February 23, 2017 |

2017 SENTRA; MIL ON WITH DTC P0606

APPLIED VEHICLES: 2017 Sentra (B17)
APPLIED ENGINE: MR16DDT (4 Cylinder Turbo Engine)
APPLIED TRANSMISSION: RS6F94R (M/T)

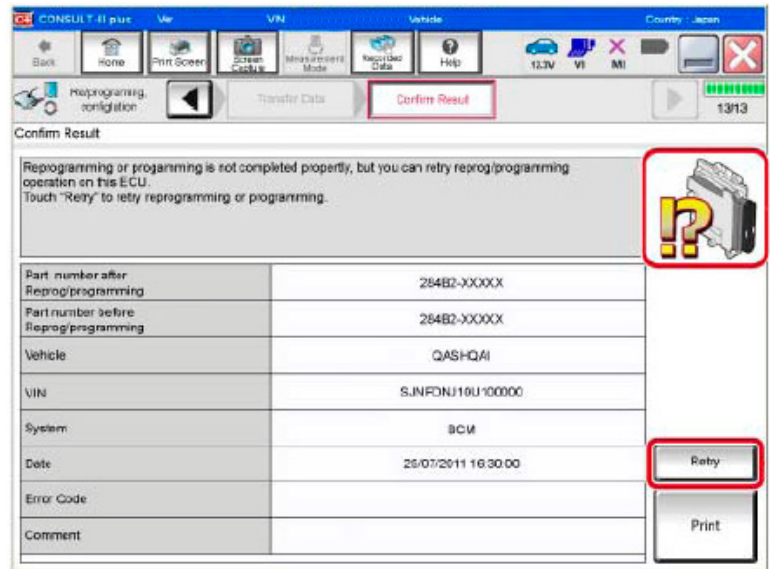
Figure 5

If reprogramming does not complete and the “!” icon displays as shown in Figure 5:

- Check battery voltage (12.0–15.5 V).
- Ignition is ON, engine OFF.
- External Bluetooth® devices are OFF.
- All electrical loads are OFF.
- **Select retry and follow the on screen instructions.**
- “Retry” may not go through on first attempt and can be selected more than once.

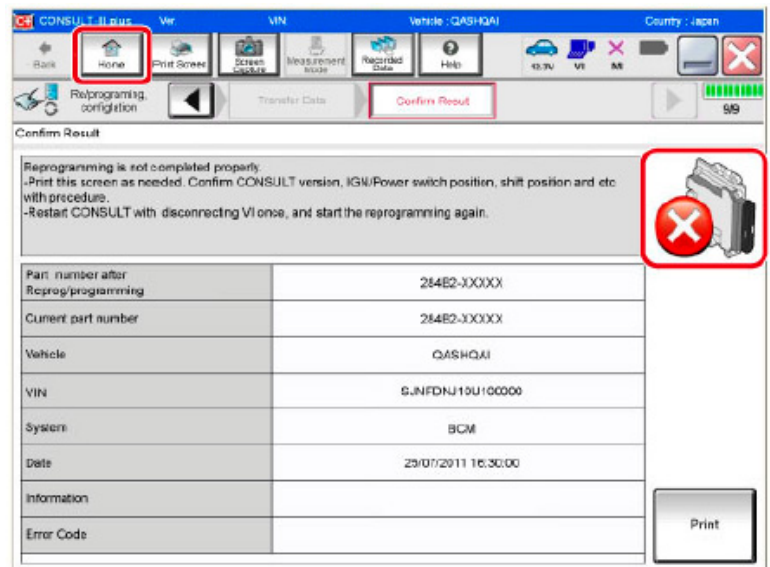
Figure 6

If reprogramming does not complete and the “X” icon displays as shown in Figure 6:

- Check battery voltage (12.0 – 15.5 V).
- CONSULT A/C adapter is plugged in.
- Ignition is ON, engine OFF.
- Transmission is in Park.
- All C-III plus / VI cables are securely connected.
- All C-III plus updates are installed.
- **Select Home, and restart the reprogram procedure from the beginning.**
