SERVICE BULLETIN

Classification: EC17-002	Reference: NTB17-065	Date: June 14, 2017
-----------------------------	-------------------------	------------------------

2017 TITAN XD; MIL ON WITH DTC P0605

APPLIED VEHICLES: 2017 Titan XD (A61)
APPLIED ENGINE: Cummins (5.0L V8) Diesel

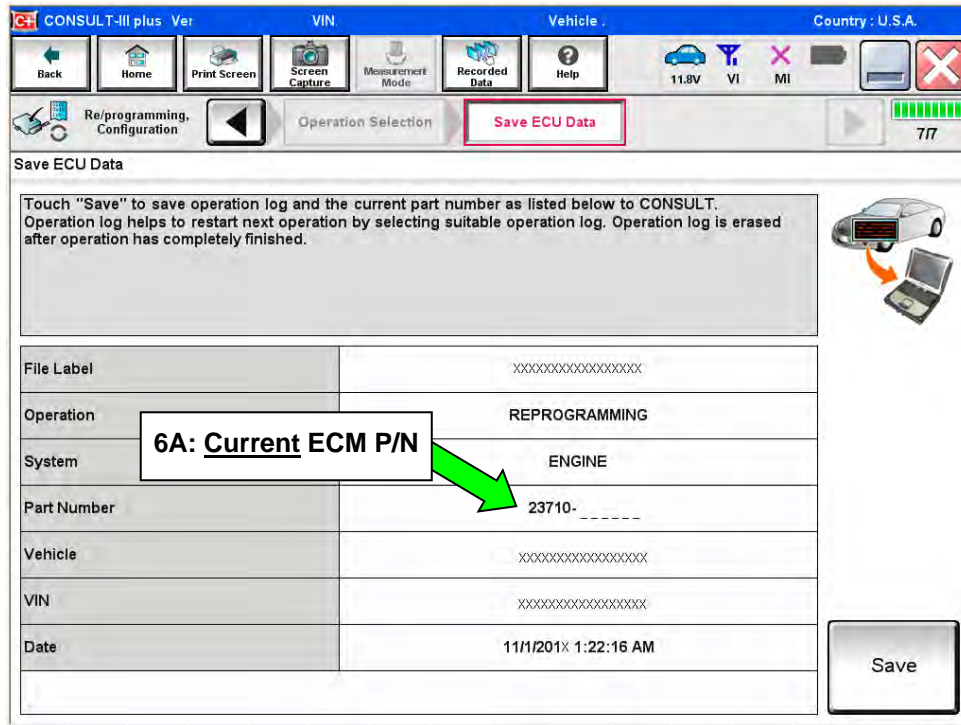
Figure 2

6. When you get to the screen shown in Figure 2, confirm this bulletin applies as follows.

A. Find the ECM **Part Number** and write it on the repair order.

B. Compare the P/N you wrote down to the numbers in the **Current ECM Part Number** column in **Table A** below.

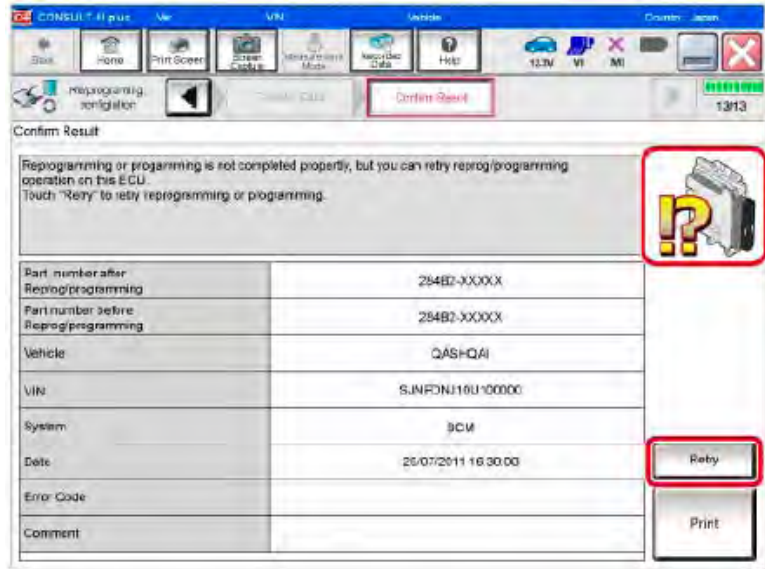
Figure 5

If reprogramming does not complete and the “!?” icon displays as shown in Figure 5:

- Check battery voltage (12.0 - 15.5 V).
- Ignition is ON, engine OFF.
- External Bluetooth® devices are OFF.
- All electrical loads are OFF.
- **Select retry and follow the on screen instructions.**
- “Retry” may not go through on first attempt and can be selected more than once.

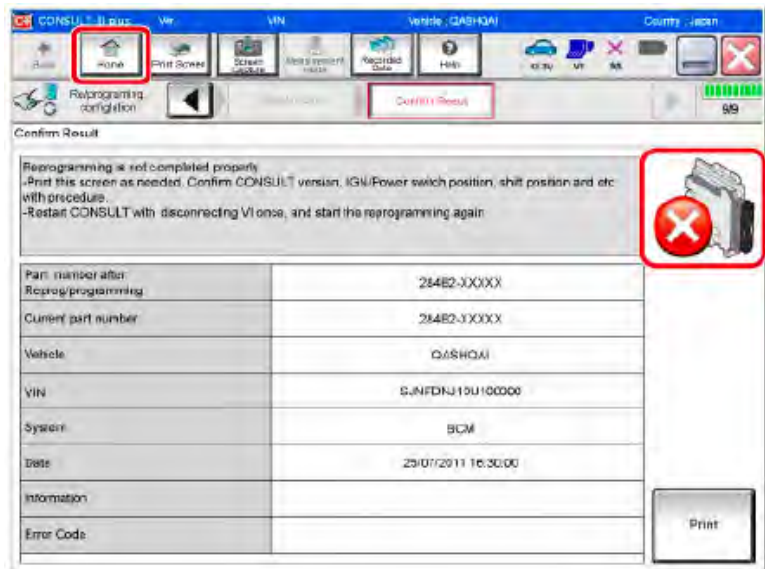
Figure 6

If reprogramming does not complete and the “X” icon displays as shown in Figure 6:

- Check battery voltage (12.0 - 15.5 V).
- CONSULT A/C adapter is plugged in.
- Ignition is ON, engine OFF.
- Transmission is in Park.
- All C-III plus / VI cables are securely connected.
- All C-III plus updates are installed.
- **Select Home, and restart the reprogram procedure from the beginning.**
