SERVICE CAMPAIGN BULLETIN

NTB17-071

VOLUNTARY SERVICE CAMPAIGN 2012-2014 TITAN, FRONTIER, AND XTERRA; AIR BAG DIAGNOSIS SENSOR UNIT

CAMPAIGN ID #: P7318

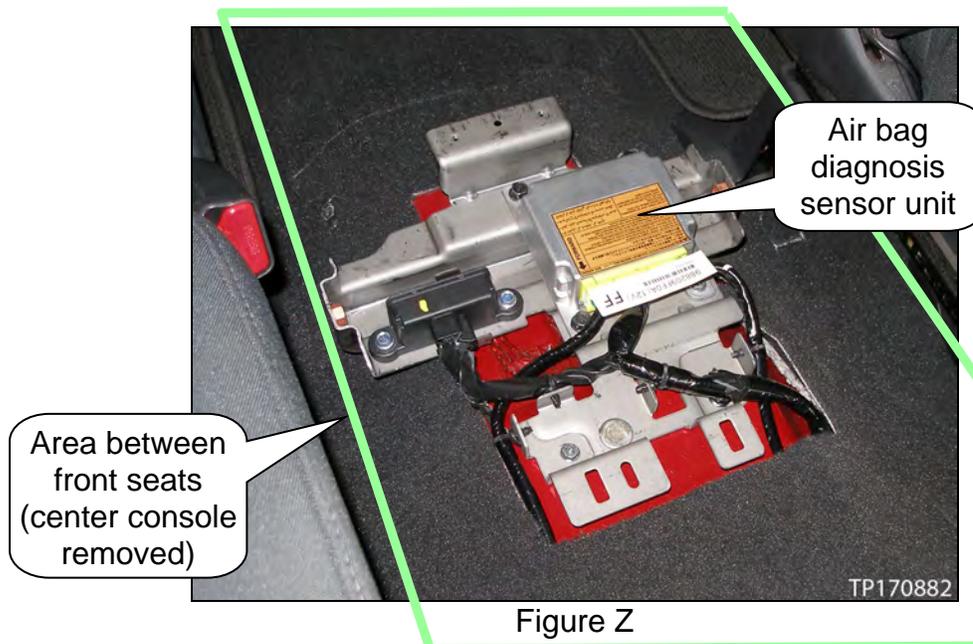
- The air bag diagnosis sensor unit does not need to be removed, only accessed.
- The air bag diagnosis sensor unit in the vehicle being worked on may differ slightly to the one shown in Figure Z below.

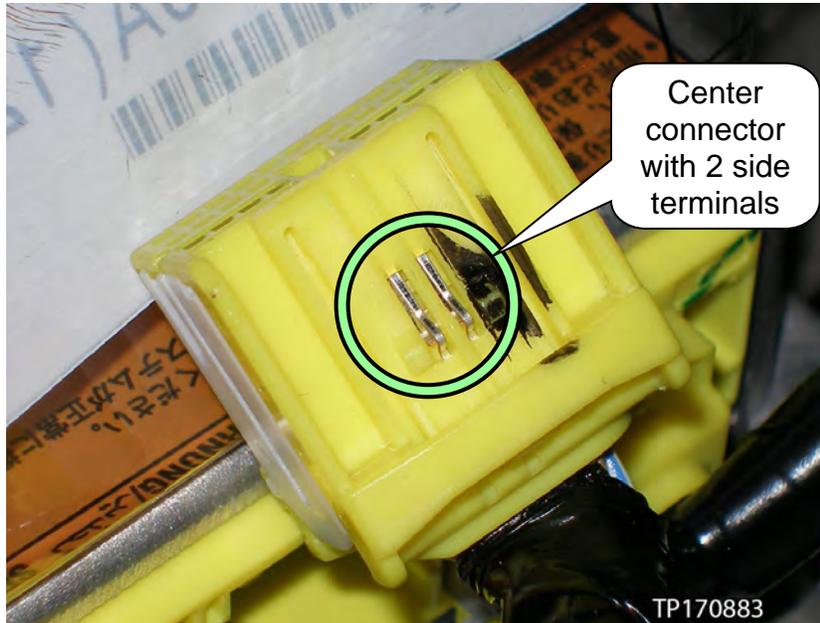
Figure AA

1. Disconnect the air bag diagnosis sensor unit's center connector.
 - Notice the two (2) terminals on the top side of the connector.
