# SERVICE BULLETIN

Classification: ST14-009a	Reference: NTB14-053a	Date: July 10, 2017
------------------------------	--------------------------	------------------------

## 2014-2017 ALTIMA; HYDRAULIC ELECTRIC POWER STEERING SERVICE INFORMATION

**APPLIED VEHICLES:** 2014-2017 Altima (L33)

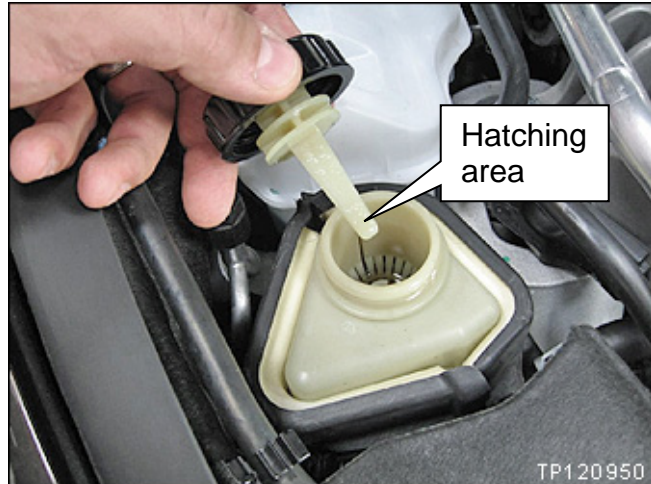
Figure 1

Check the fluid level of the Hydraulic Electric Power Steering (H-EPS) system.

- Check fluid level with the ignition OFF and fluid temperature between 0 – 30°C (32 – 86°F).
- Power steering fluid level should be within the hatching area of the indicator on the power steering reservoir tank cap.
- If fluid is needed, use only genuine NISSAN E-PSF or equivalent.

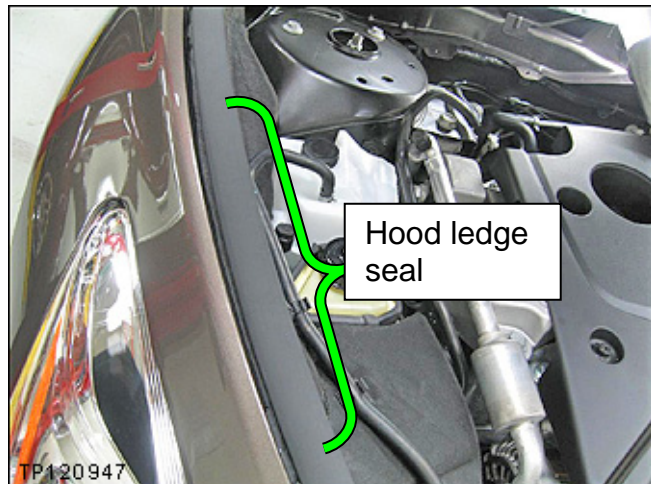
Figure 2

Make sure the right front hood ledge seal (passenger side) is installed correctly.

- Install the seal correctly
- or
- If damaged, replace the seal
- or
- If missing, install a seal.

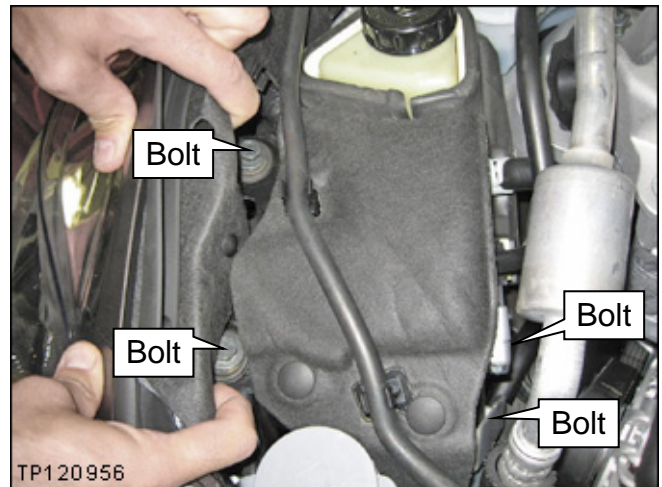
Figure 3

Make sure there is no binding on the H-EPS pump mounting isolator as follows:

- a. Loosen the four (4) H-EPS pump mounting bolts.
- b. Move the H-EPS pump a small amount from side to side.
- c. Tighten the mounting bolts.

Mounting bolts torque:

13.5 N•m (1.4 kg-m, **10 ft-lb**)

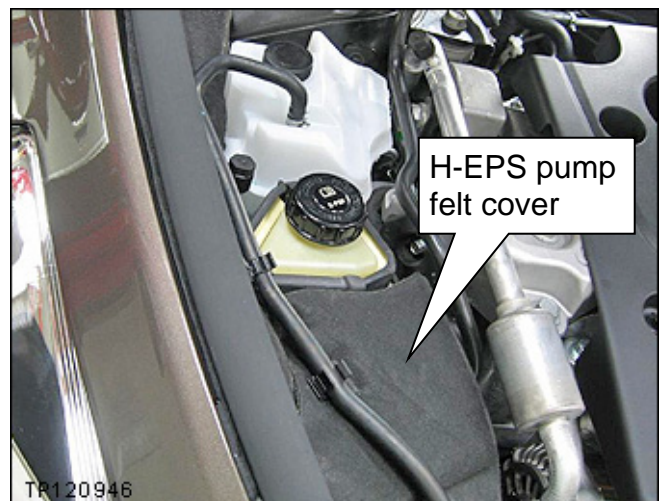
Figure 4

Make sure the H-EPS pump felt cover is installed correctly.

- Install the felt cover correctly
- or
- If damaged, replace the felt cover
- or
- If missing, install a felt cover.

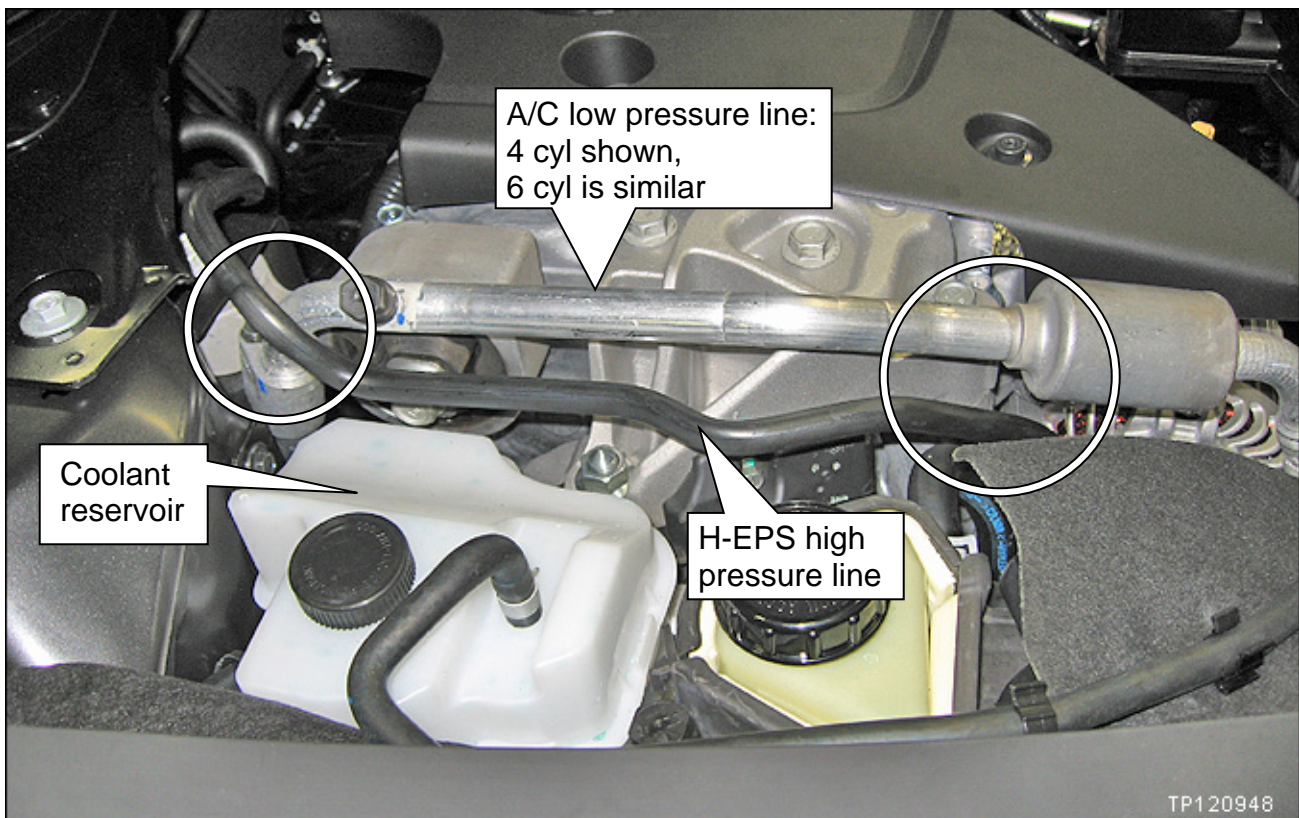
Figure 5

Check the H-EPS high pressure line and the A/C low pressure line. Make sure they are **not** touching each other (see Figure 5).

Check the H-EPS high pressure line and coolant reservoir. Make sure they are **not** touching each other (see Figure 5).

- a. Check the two locations circled in Figure 5.
- b. If the lines are touching, reposition the lines so they are **not** touching.

- a. Make sure the coolant reservoir is mounted correctly; its locator boss must be seated in the mounting hole.
- b. If needed, reposition the H-EPS line so it is **not** touching the reservoir.

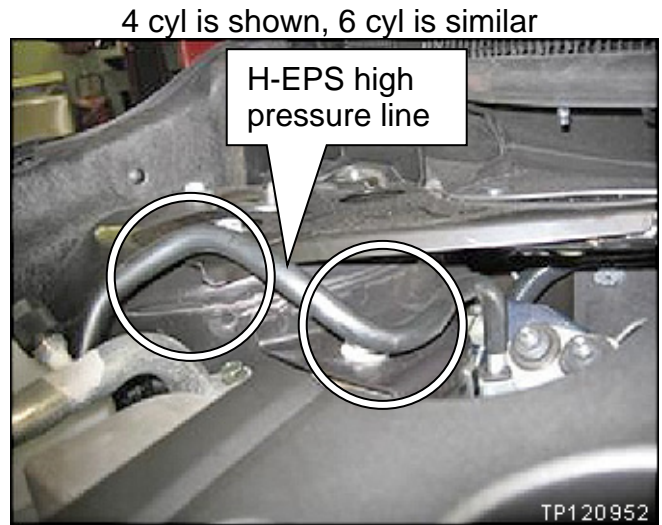
Figure 6

Make sure the H-EPS high pressure line is **not** touching the strut tower brace or the torque rod mounting bracket.

- a. Check the two locations circled in Figure 6.
- b. If needed, reposition the H-EPS high pressure line so it is **not** touching.

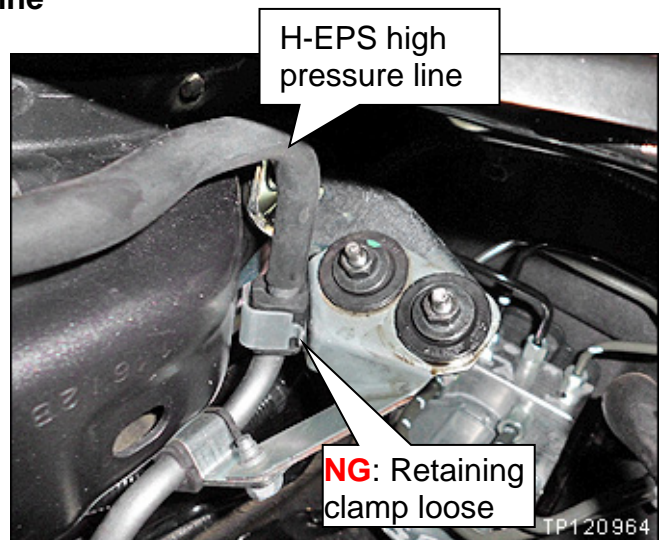
Check the H-EPS high pressure line retaining clamp shown in Figure 7.

- a. Make sure the clamp is secured correctly.
  - Figure 7 shows a clamp that **is not** secured correctly.
- b. If the clamp is loose like the one shown in Figure 7, replace the H-EPS high pressure line.
  - Refer to the Electronic Service Manual (ESM), section **ST-Steering System**, for replacement information.

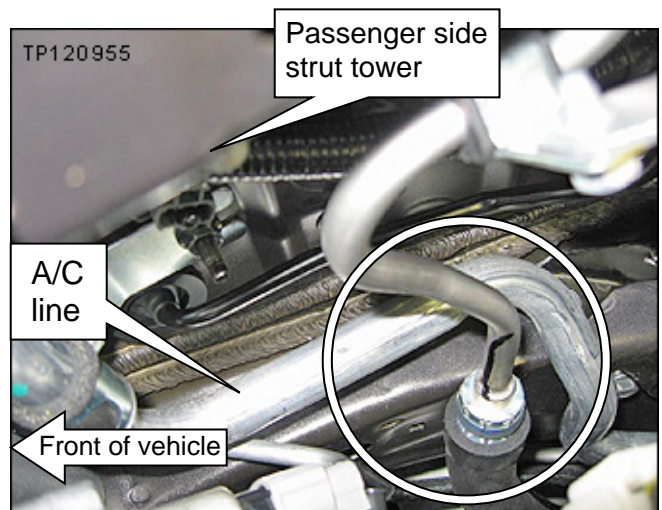
Make sure the H-EPS high pressure line is not touching the A/C line or vehicle body.

**NOTE:** The view in Figure 8 is downward from the inboard side of the passenger side strut tower.

- a. Check the area circled in Figure 10.
- b. If needed, reposition the lines so they are **not** touching.
- c. If needed, reposition the H-EPS line so it is **not** touching the vehicle body.

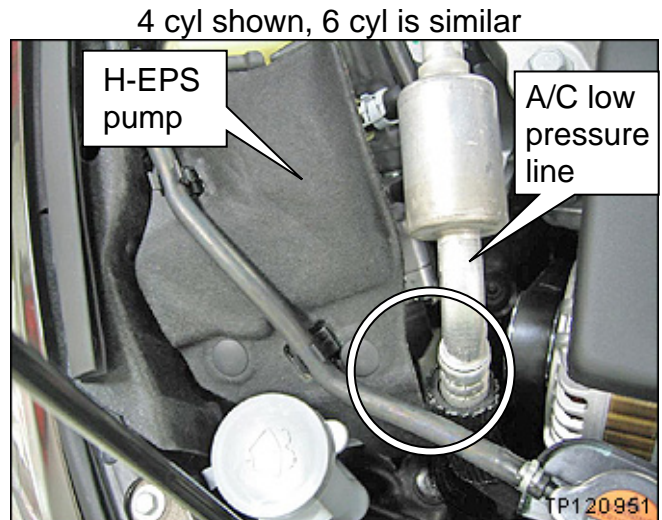
Figure 11

Make sure the A/C low pressure line is **not** touching the H-EPS pump.

- Check the location circled in Figure 8.
- If needed, reposition the A/C low pressure line so it is **not** touching the H-EPS pump.

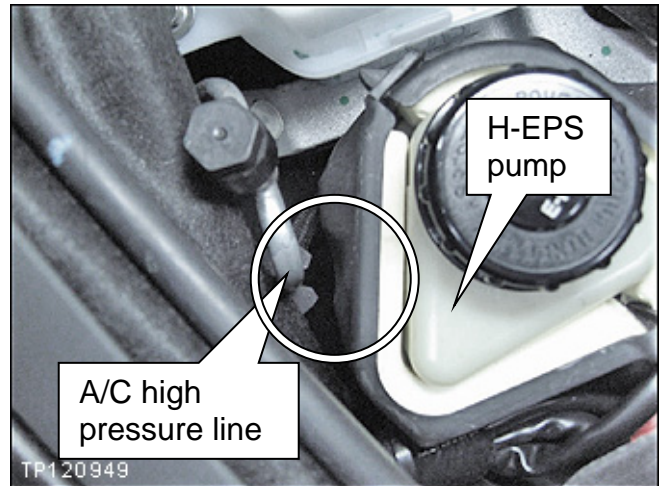
Figure 12

Make sure the A/C high pressure line is **not** touching the H-EPS pump.

- Check the location circled in Figure 9.
- Wiggle the H-EPS pump and observe the A/C high pressure line. If it moves, it is touching.
- If needed, reposition the A/C high pressure line so it is **not** touching the H-EPS pump.

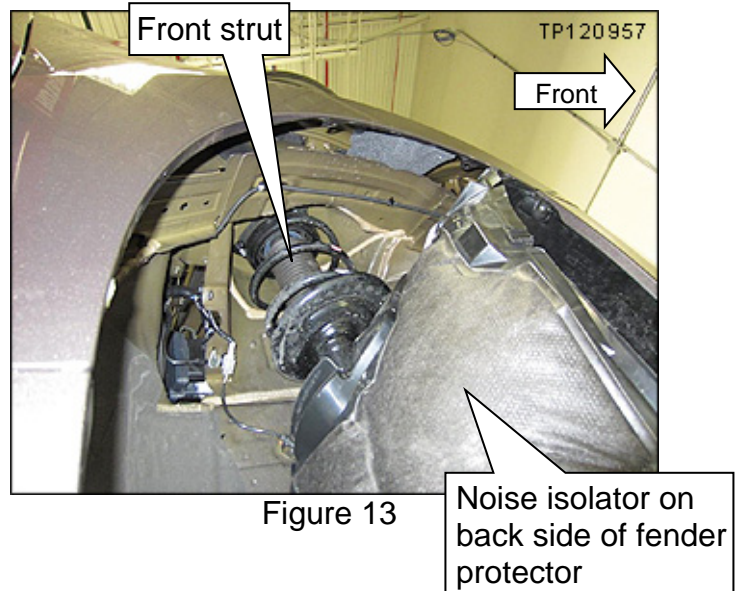
Figure 13

Make sure the noise insulator is installed inside the RH (passenger side) front fender protector:

- Remove the passenger side front wheel.
  - Partially remove the fender protector.
    - Refer to the ESM, section **EXT-Exterior**, as needed.
  - Confirm the insulator is in place.
    - Make sure the insulator is installed correctly
- or
- If damaged or missing, replace the fender protector with insulator.

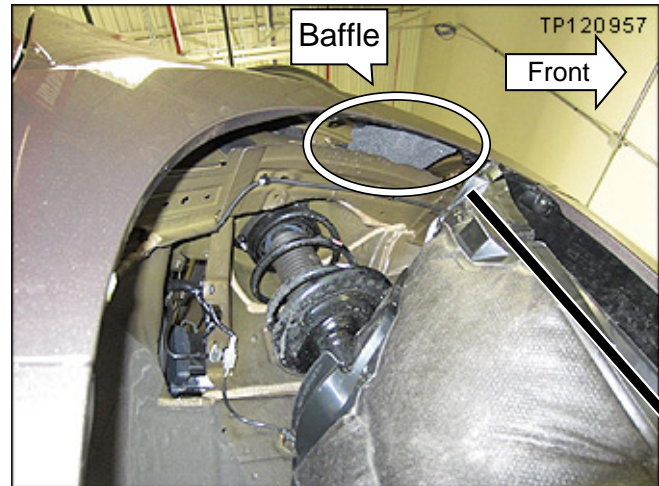
Figure 14

Make sure the baffle is positioned properly inside the RH (passenger side) front fender.

- a. Make sure the baffle is flush against the fender.
- b. There should be no gap between the fender protector and baffle when the fender protector is installed.
- c. If needed, reposition the baffle or install a new one.

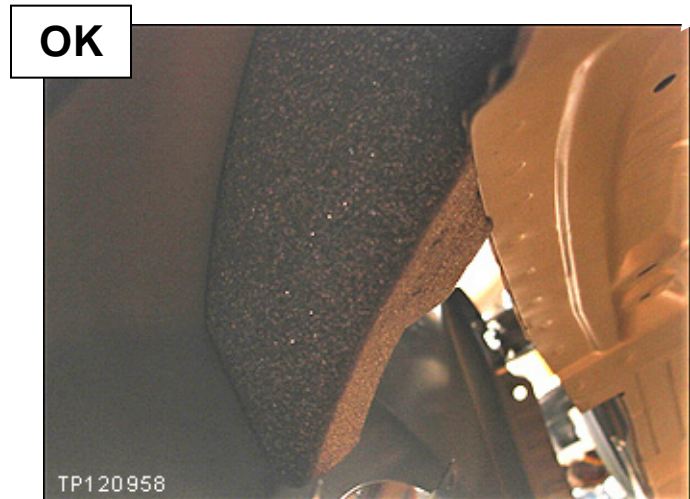
Figure 15 – baffle is **installed correctly**.

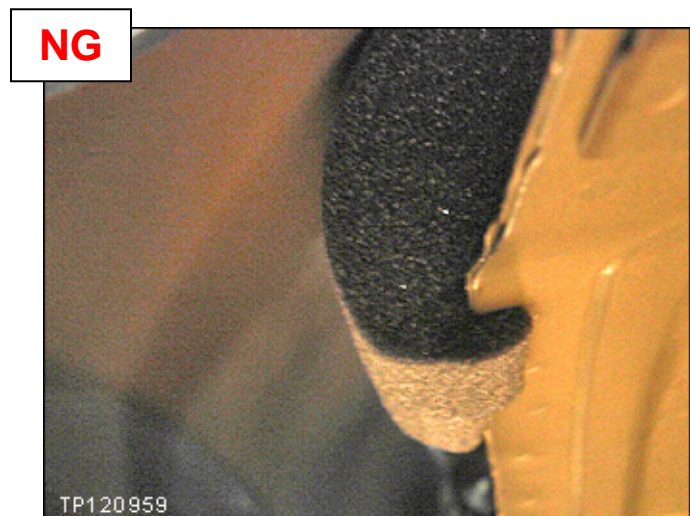
Figure 16 – example of a baffle **installed incorrectly**.

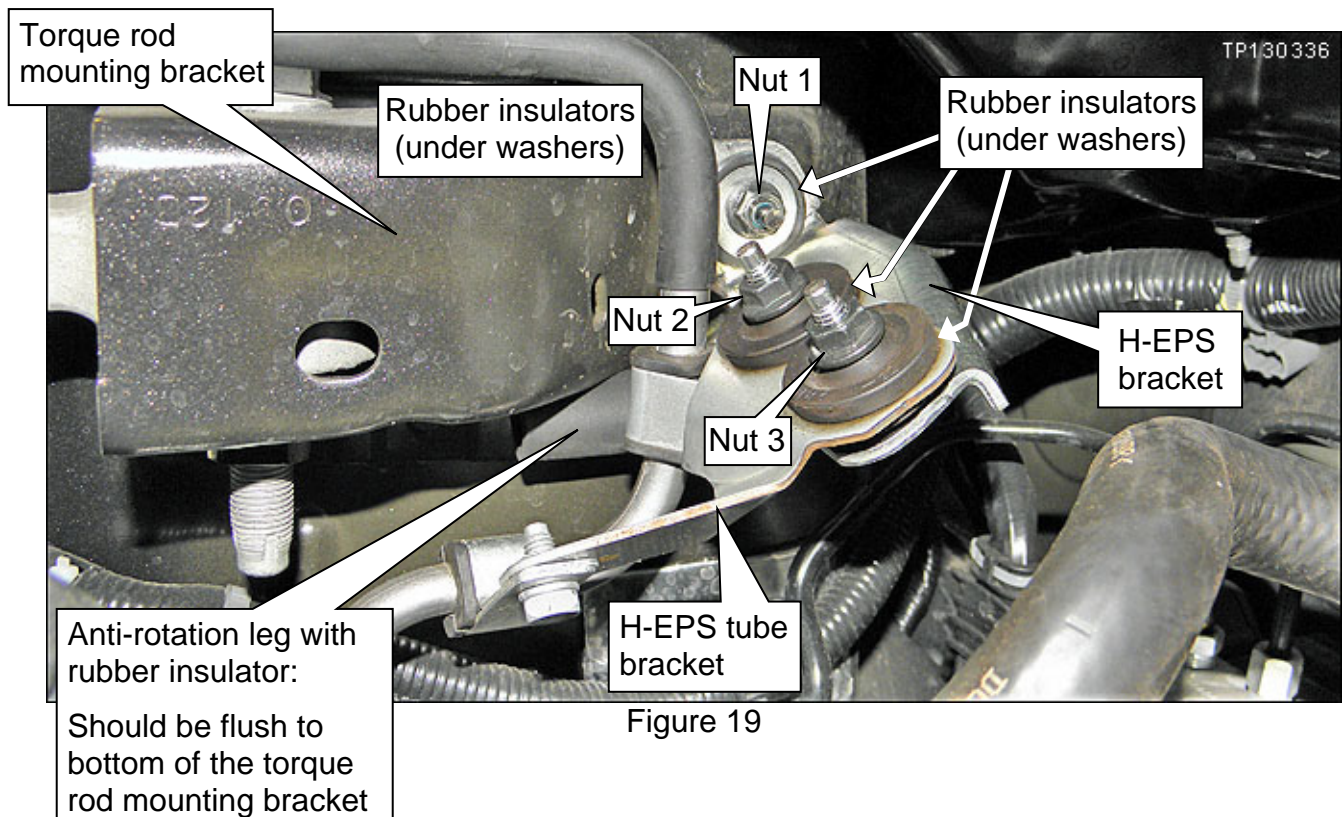
Check torque of all three (3) H-EPS bracket nuts:

Nut 1 torque: 8 N•m (0.81 kg-m, **5.9 ft-lb, 71 in-lb**)

Nuts 2 & 3 torque: 4.9 N•m (0.49 kg-m, **3.6 ft-lb, 43 in-lb**)

Make sure the H-EPS bracket and the H-EPS tube bracket are not touching (see Figure 19).

Make sure the anti-rotation leg of the H-EPS bracket is flush to the bottom of the torque rod mounting bracket (see Figure 19).

- a. Make sure there is a gap between the brackets all the way around.
- b. Make sure the rubber insulators are seated properly.
- c. If needed, reposition the brackets so they are not touching.

- a. Check the position the H-EPS bracket, make sure its anti-rotation leg is flush to the bottom of the torque rod mounting bracket.

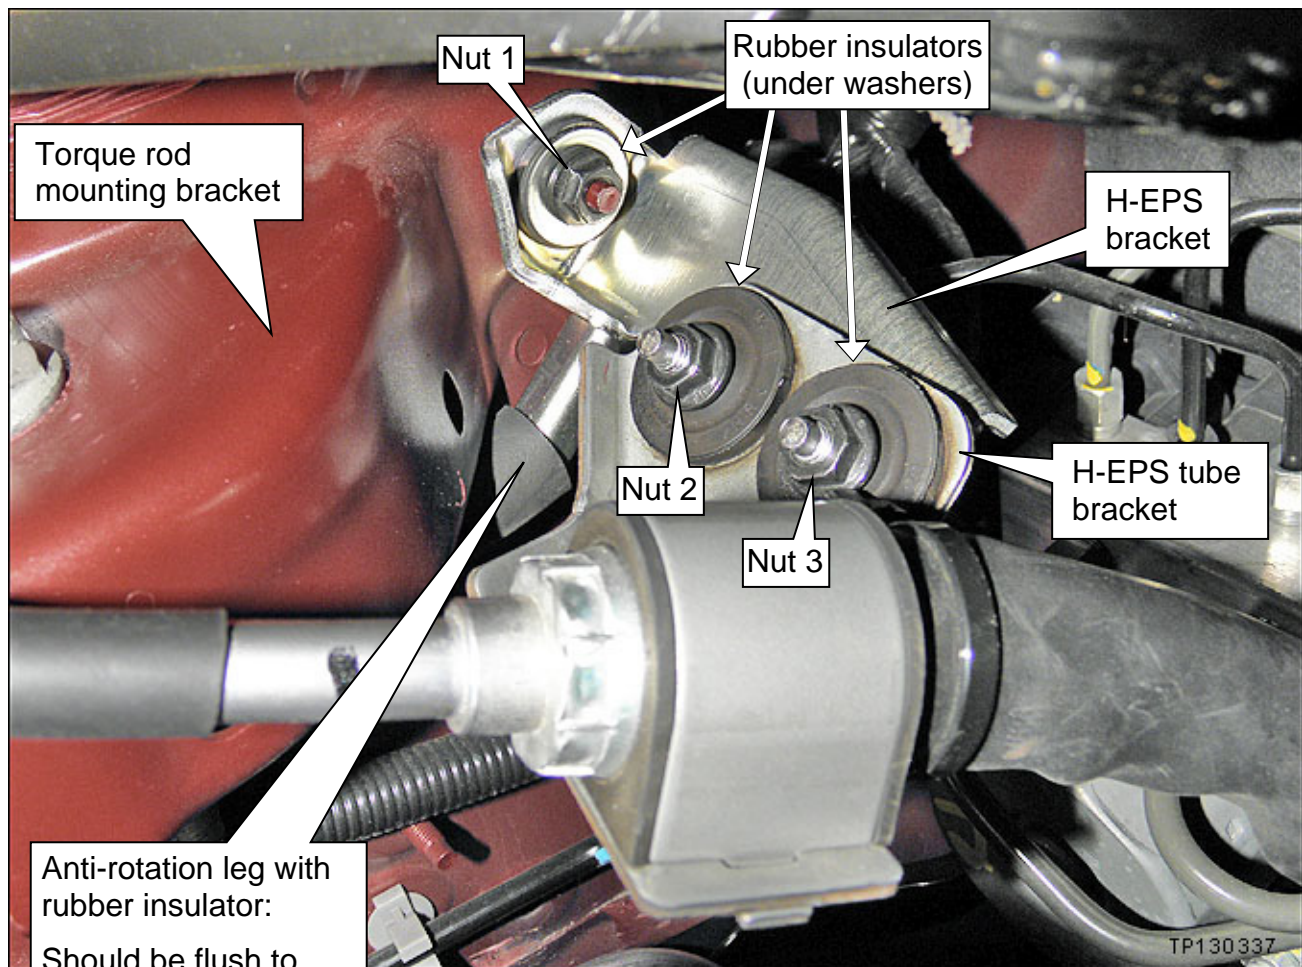
Figure 20

Check torque of all three (3) H-EPS bracket nuts:

Nut 1 torque: 8 N•m (0.81 kg-m, **5.9 ft-lb, 71 in-lb**)

Nuts 2 & 3 torque: 4.9 N•m (0.49 kg-m, **3.6 ft-lb, 43 in-lb**)

Make sure the H-EPS bracket and the H-EPS tube bracket are not touching (see Figure 20).

Make sure the H-EPS bracket's anti-rotation leg is flush to the bottom of the torque rod mounting bracket (see Figure 20).

Anti-rotation leg with rubber insulator:  
Should be flush to bottom of the torque rod mounting bracket

- Make sure there is a gap between the brackets, all the way around.
- Make sure the rubber insulators are seated properly.
- If needed, reposition the brackets so they are not touching.

- Check the position the H-EPS bracket, make sure its anti-rotation leg is flush to bottom of the torque rod mounting bracket.

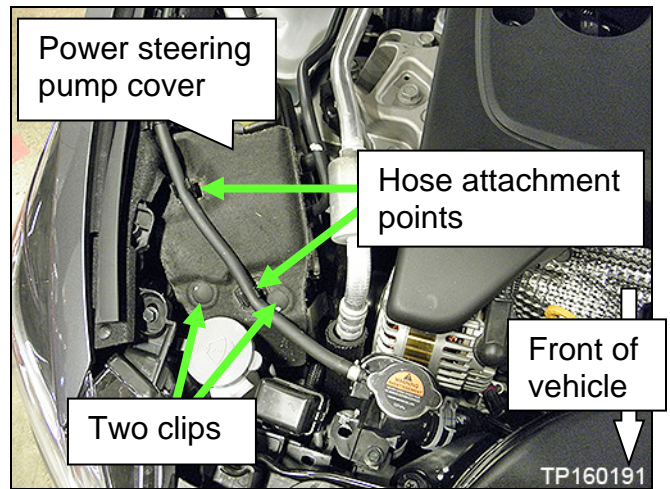
Figure 21

1. Remove the power steering pump cover (if equipped) to access the power steering pump motor housing.
  - Two hose attachment points and two clips.

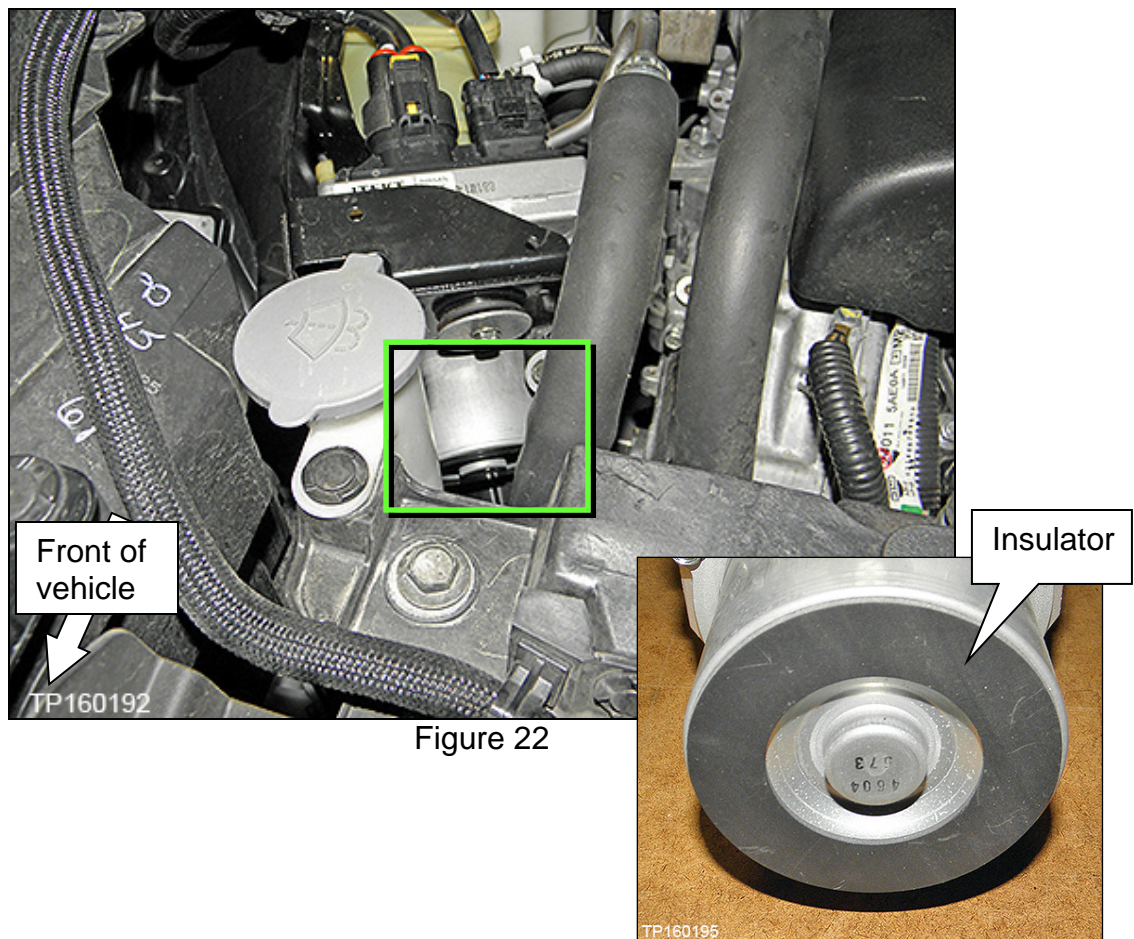
Figure 22

2. Locate the power steering pump motor housing and confirm an insulator is installed.

3. If missing, install an insulator.
