SERVICE BULLETIN

Classification: EL15-002e	Reference: NTB15-009e	Date: July 13, 2017
------------------------------	--------------------------	------------------------

NAVIGATION SYMPTOMS WHEN SD CARD IS MISSING OR WRONG CARD INSTALLED

APPLIED VEHICLES: 2015-2017 Murano (Z52)
2016 Murano Hybrid (Z52)
2016-2017 LEAF (ZE0)
2016-2017 Maxima (A36)
2017 GT-R (R35)

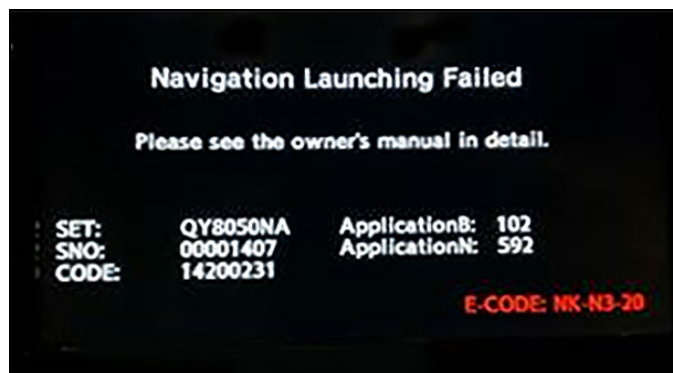
If the wrong SD Map Card has been inserted into the Navi/audio unit:

- A “Navigation Launching Failed” screen will be shown (Figure 1).

If the SD Map Card has been removed from a Navigation/audio unit and was:

- **Mixed up with other SD Map Cards**

- Continue to insert individual SD Map Cards until one can be found that the error message in Figure 1 is not displayed.

- Check the “Unit code” (page 3) and then look up the correct SD card part number with **SD Card Numbers by Unit Code** starting on page 5.

- Check the ECU Part Number (page 4) with CONSULT-III plus (C-III plus) under **Diagnosis(One System) / MULTI AV / ECU Identification**, and then look up correct SD card part number with **SD Card Numbers by Unit Code** starting on page 5.

- Order a new SD Map Card from Nissan. This is not covered under warranty.
- Use the Unit Code, or the Multi AV ECU part number to determine the correct SD Card Part Number to order. Refer to **SD Card Numbers by Unit Code** starting on page 5.
